AS-BUILT REPAIR QUANTITY TABLE

PROJECT NO. I-5889A
BUNCOMBE COUNTY
 BRIDGE NO. 352

BENT 4
 SPAN D SIDE

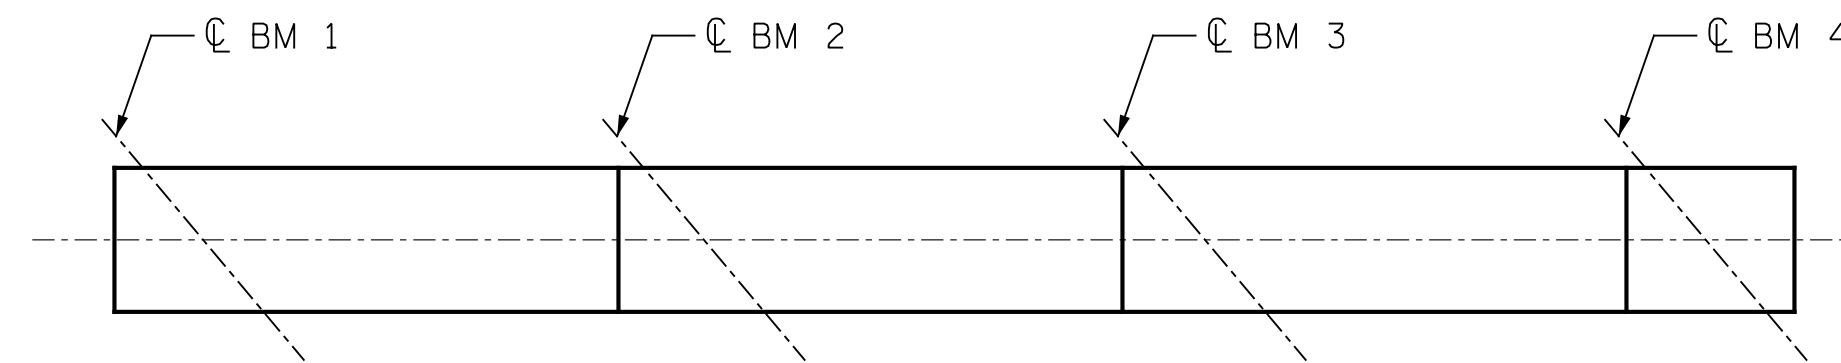
BENT 4
(SPAN D SIDE)

BENT 4 REPAIRS	QUANTITIES				
	ESTIMATE		ACTUAL		
SHOTCRETE REPAIRS	AREA SF	VOLUME CF	AREA SF	DEPTH FT	VOLUME CF
CAP (VERTICAL FACE)	17.0	8.5			
CAP (HORIZONTAL, CORNER)	0	0			
COLUMN	0	0

VALUES IN CHART REPRESENT ESTIMATED REPAIR TOTALS AFTER REMOVAL OF UNSOUND CONCRETE, MIN. OF 1" BEHIND REBAR AND MIN. 2" CL TO SAWCUT. SEE REPAIR DETAILS.

FOR CONCRETE REPAIR DETAILS, SEE "TYPICAL CAP & COLUMN REPAIR DETAILS" SHEET.

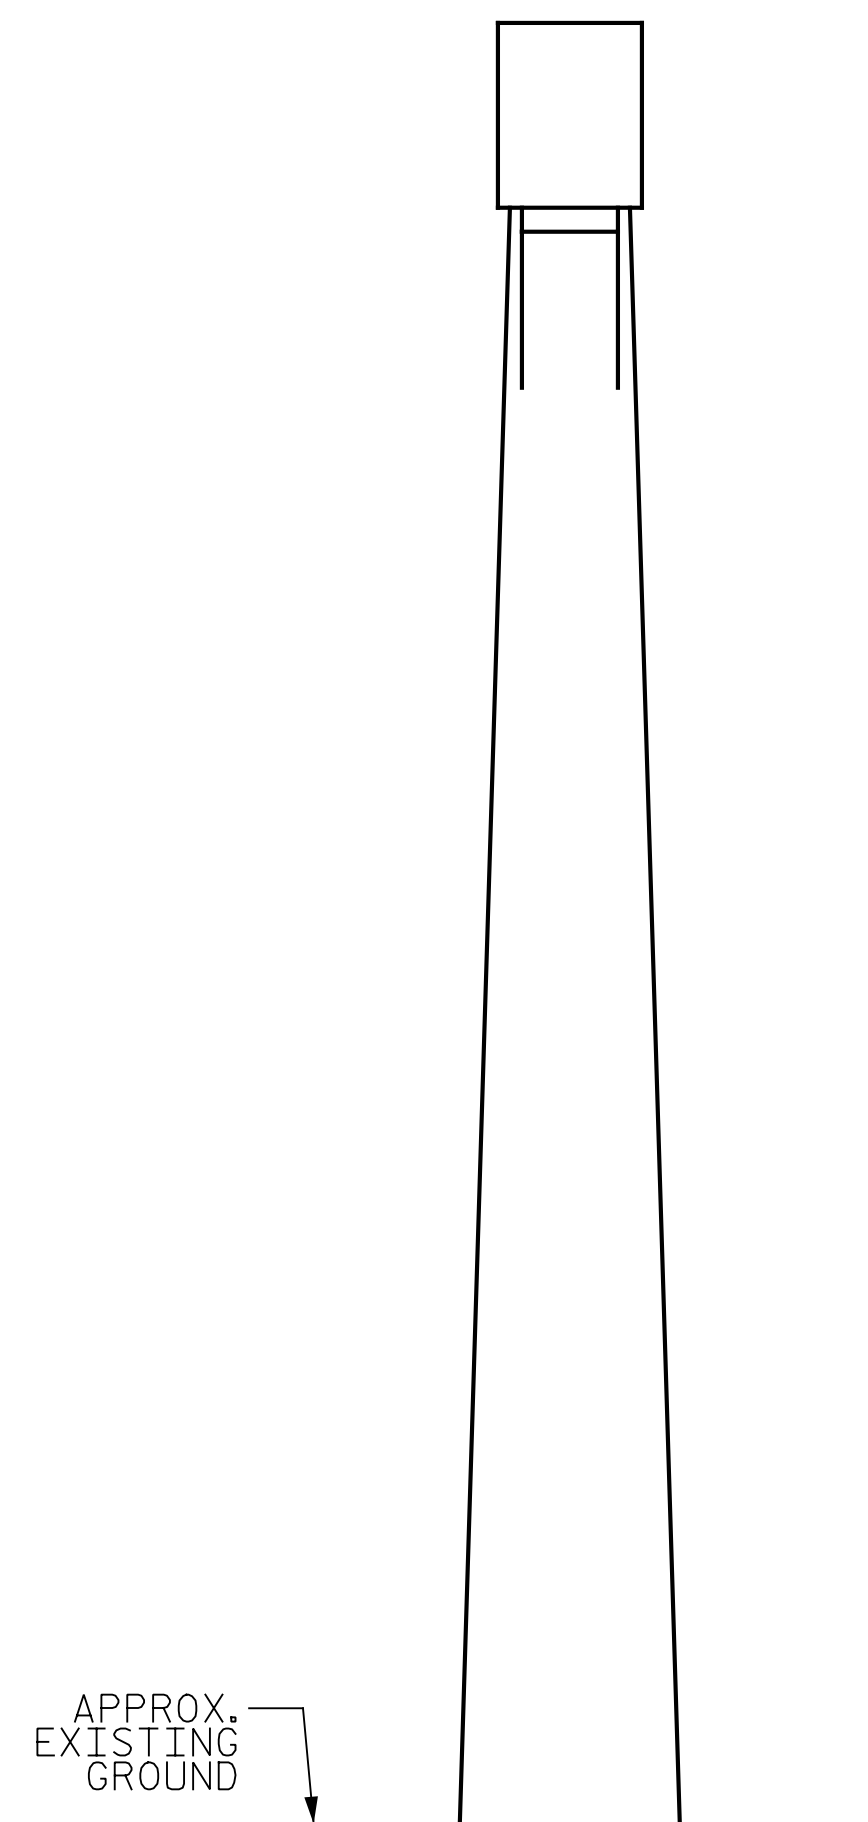
END VIEW
(NORTH FACE)

TOP OF CAP
