PROJECT NO. I-5889A
BUNCOMBE COUNTY
 BRIDGE NO. 356

STATE OF NORTH CAROLINA
 DEPARTMENT OF TRANSPORTATION
 RALEIGH

BENT 5
 SPAN F SIDE

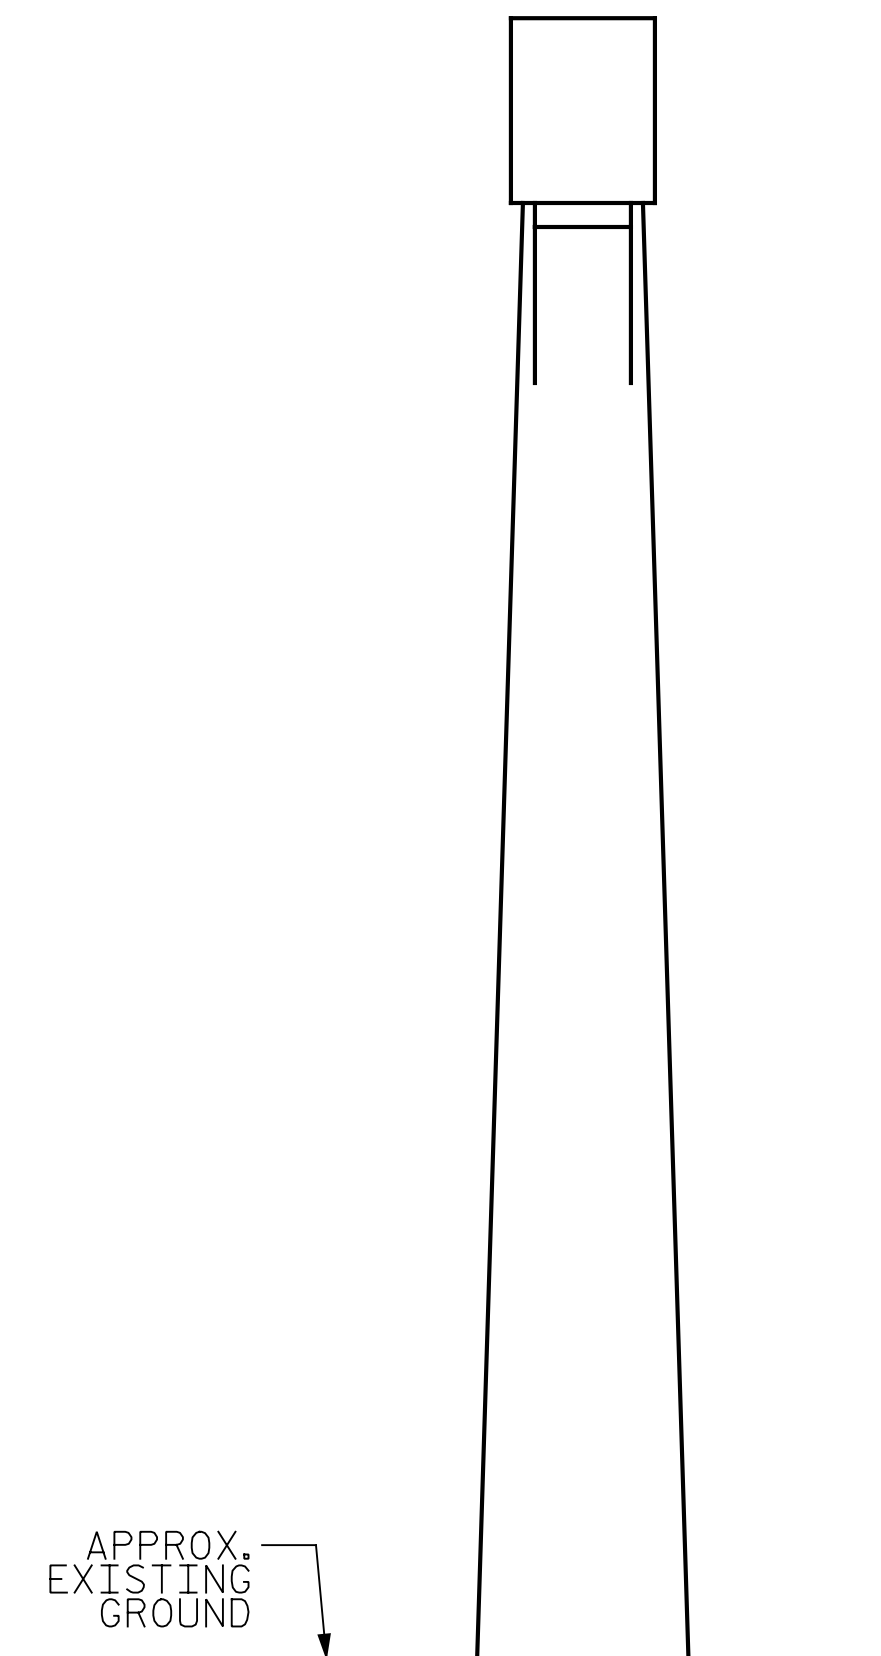
END VIEW
(SOUTH FACE)

BOTTOM OF CAP

- SHOTCRETE REPAIR

- CONCRETE REPAIR

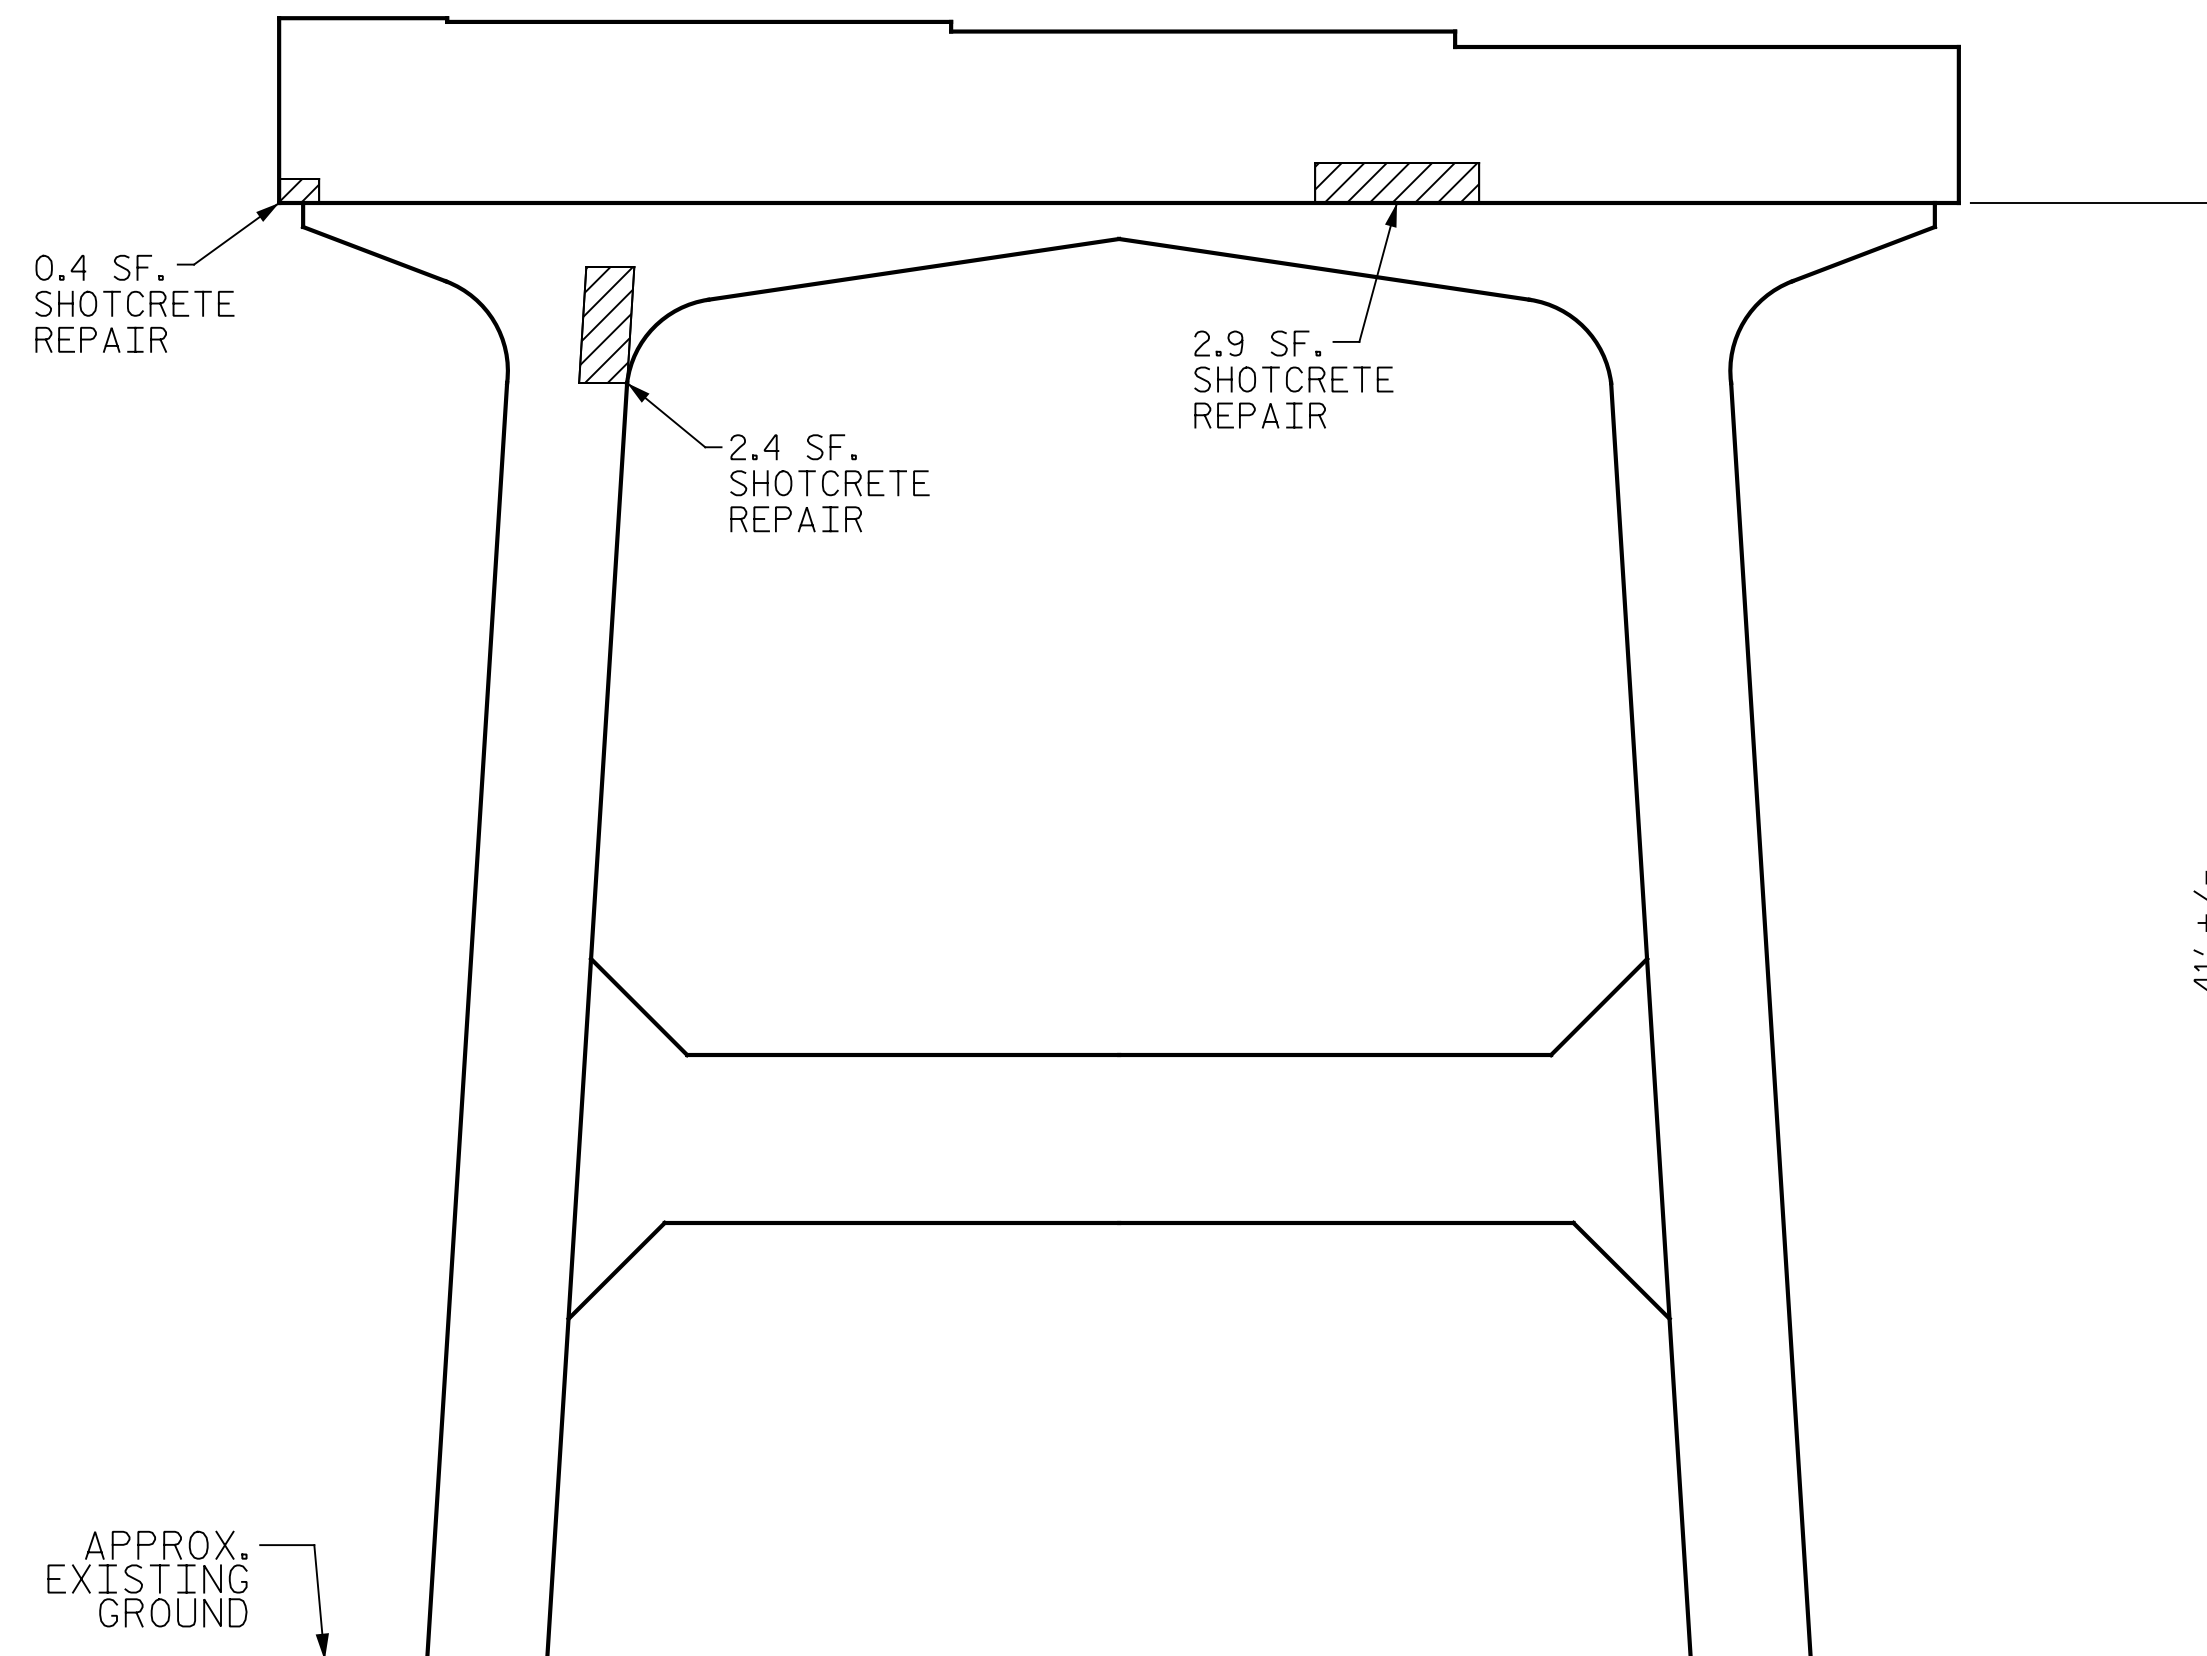
SPAN F
(EAST FACE)

BENT 5
(SPAN F SIDE)
