PROJECT NO. I-5889A
BUNCOMBE COUNTY
 BRIDGE NO. 356

**BENT 7
 SPAN H SIDE**

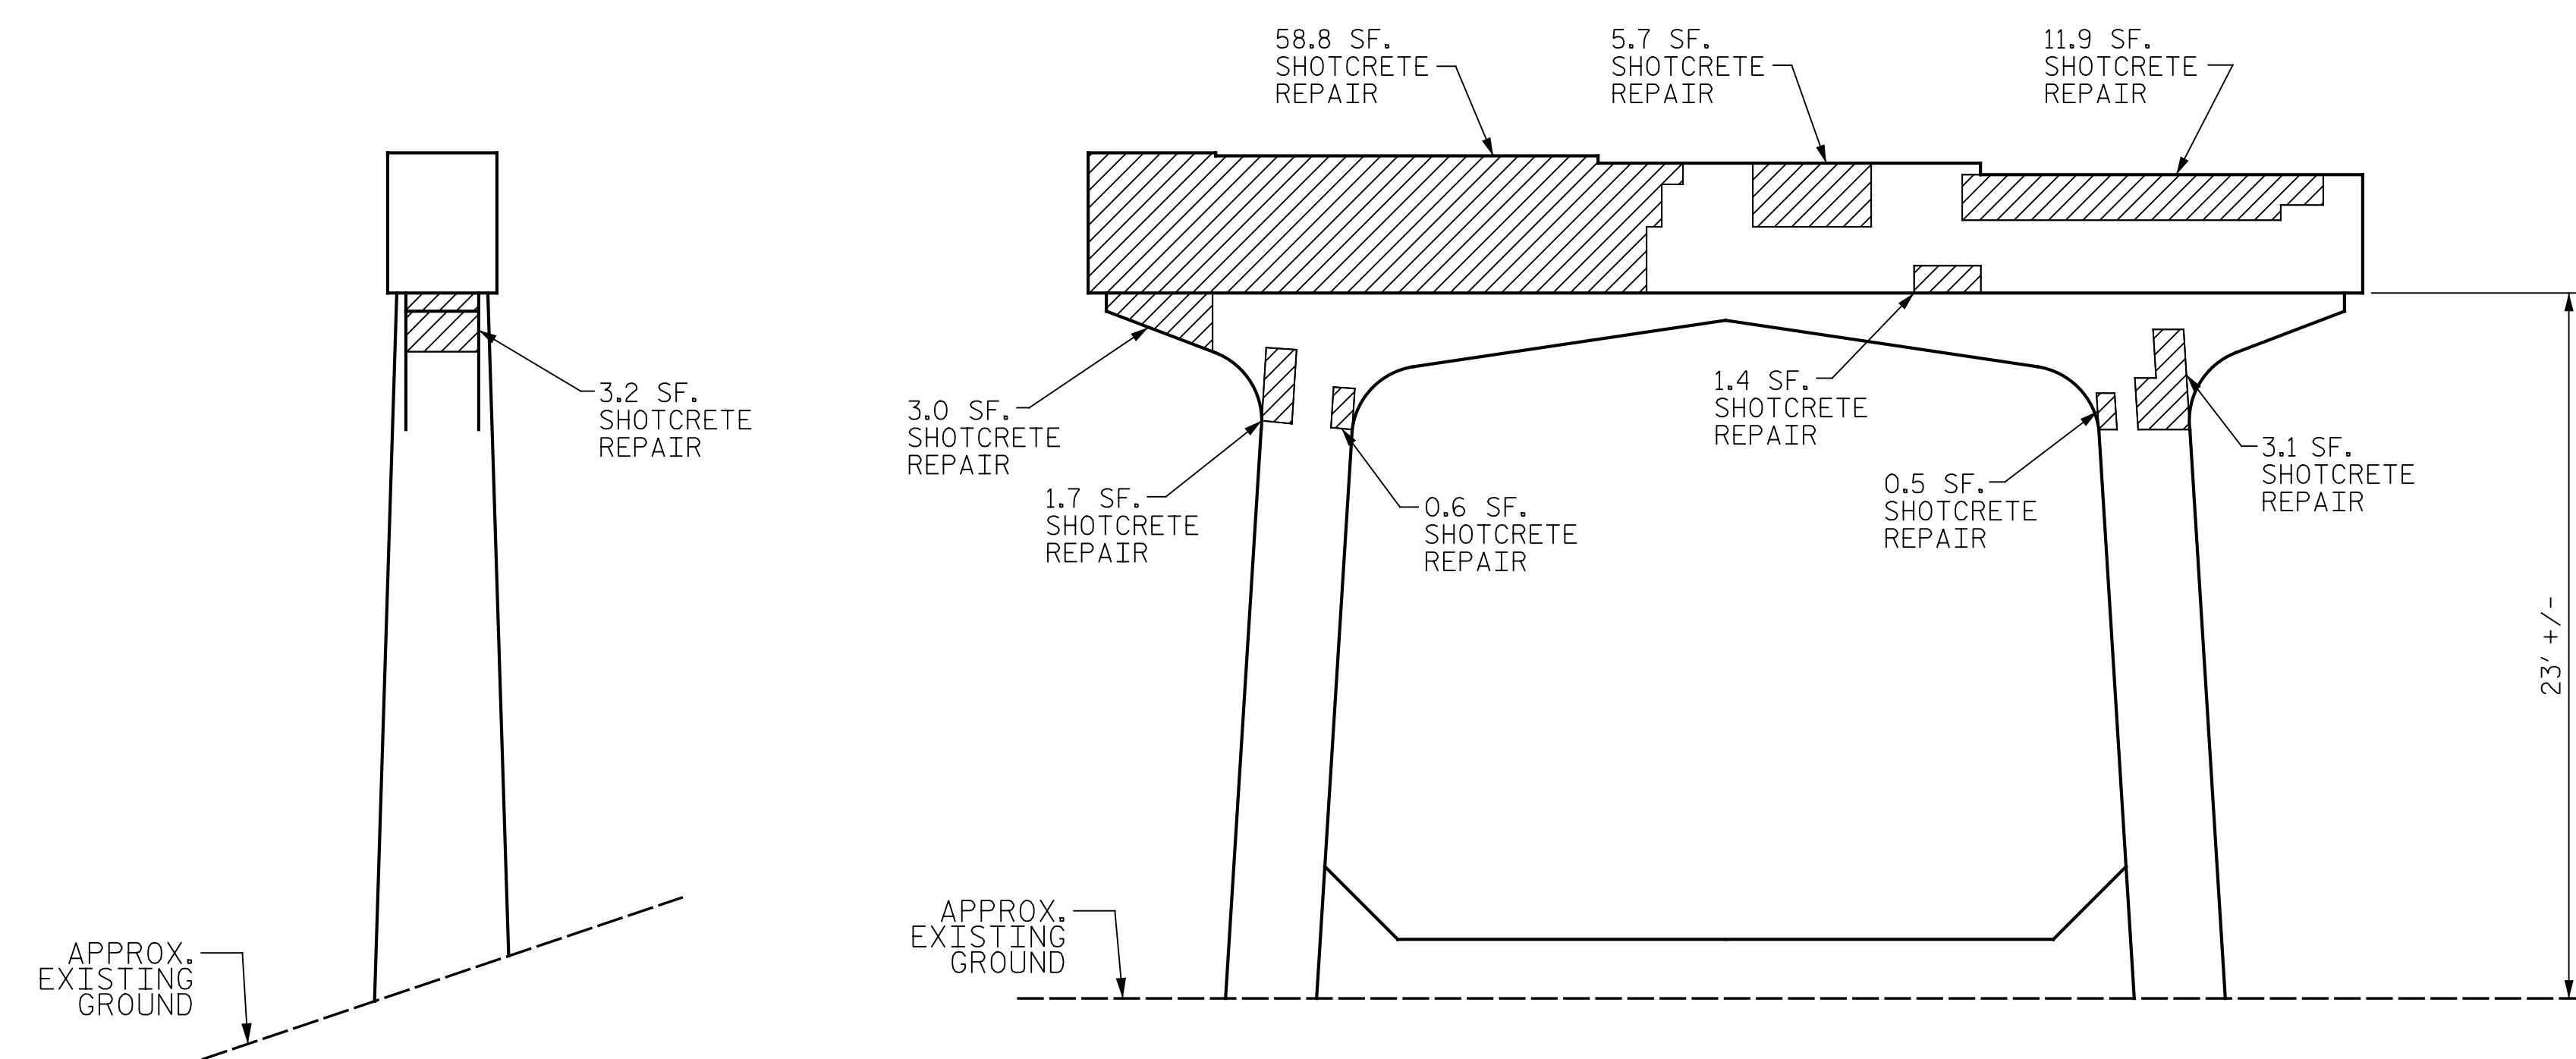
- SHOTCRETE REPAIR

- CONCRETE REPAIR

BOTTOM OF CAP

END VIEW
(SOUTH FACE)

SPAN H
(EAST FACE)

BENT 7
(SPAN H SIDE)
