AS-BUILT REPAIR QUANTITY TABLE

PROJECT NO. I-5889A
BUNCOMBE COUNTY
 BRIDGE NO. 366

BENT 2
 SPAN B SIDE

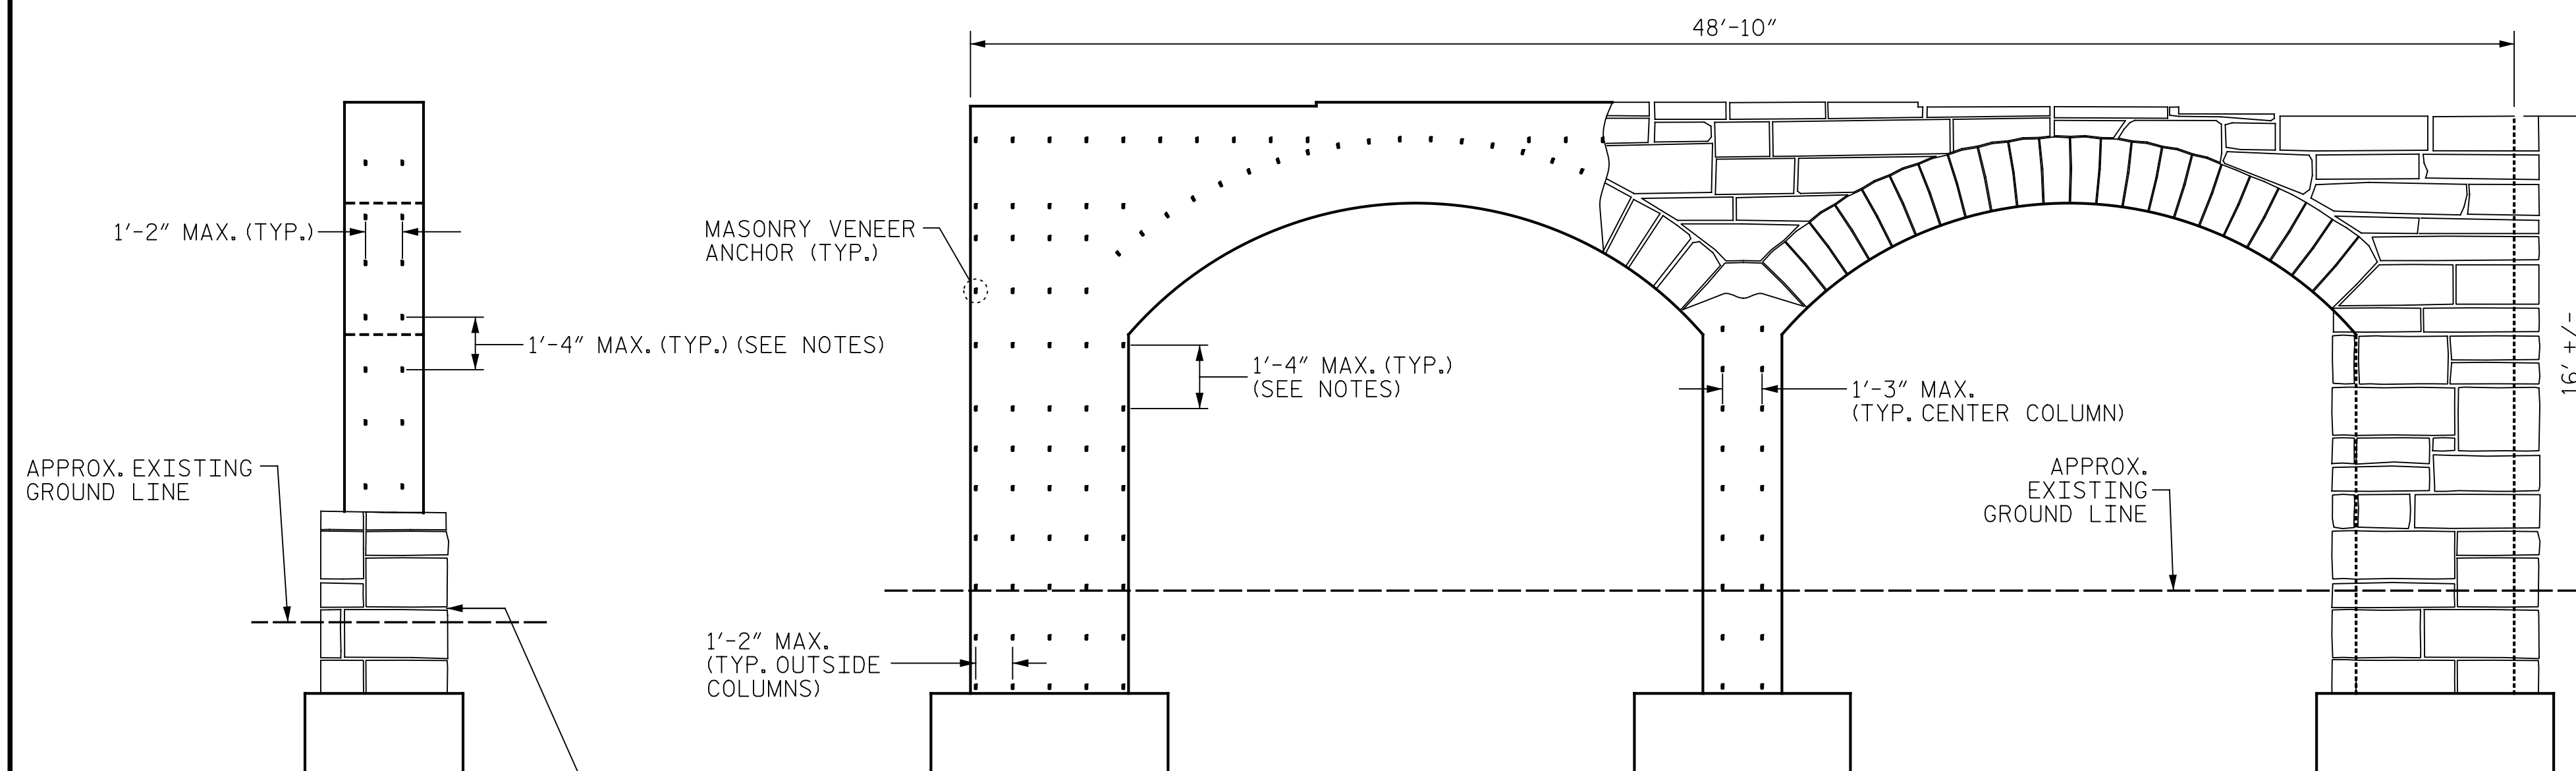
ELEVATION
(WEST FACE)

END VIEW
(NORTH FACE)
