PROJECT NO. I-5889A
BUNCOMBE COUNTY
 BRIDGE NO. 378

STONE VENEER
 BENT DETAILS
 BENT 1 SPAN A FACE

REVISIONS						SHEET NO.
NO.	BY:	DATE:	NO.	BY:	DATE:	S-202
1			3			TOTAL SHEETS
2			4			208

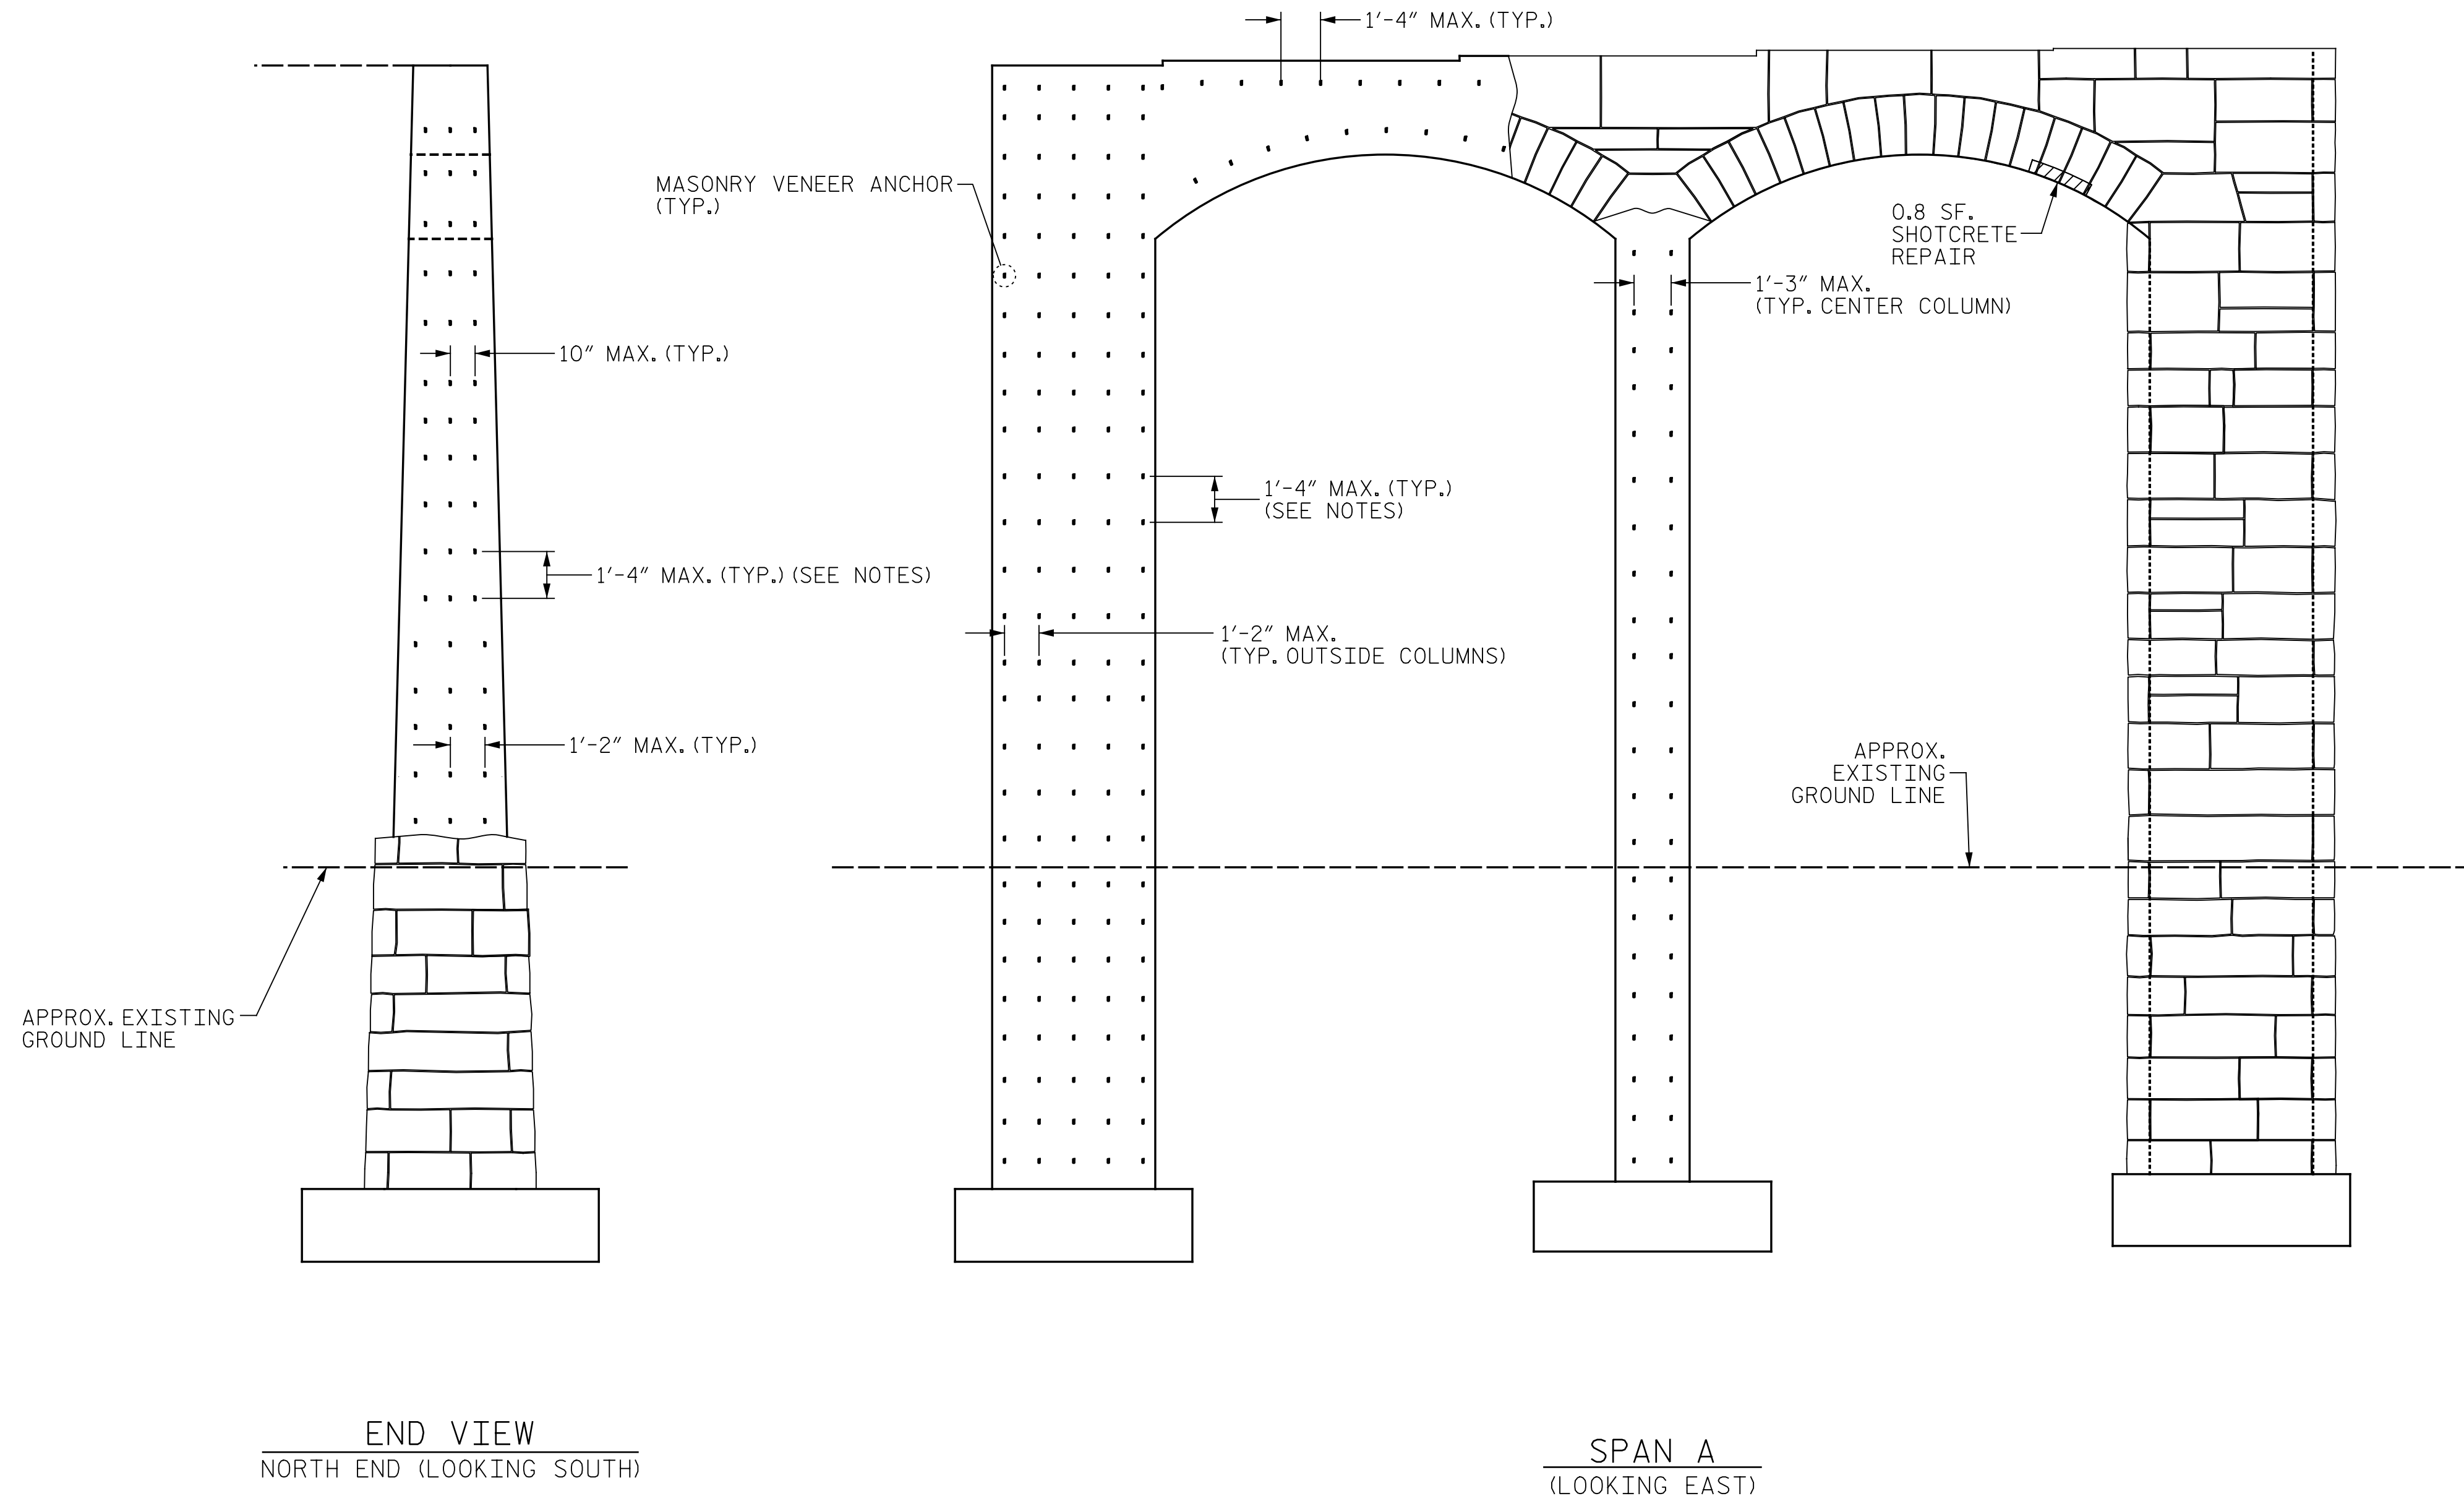
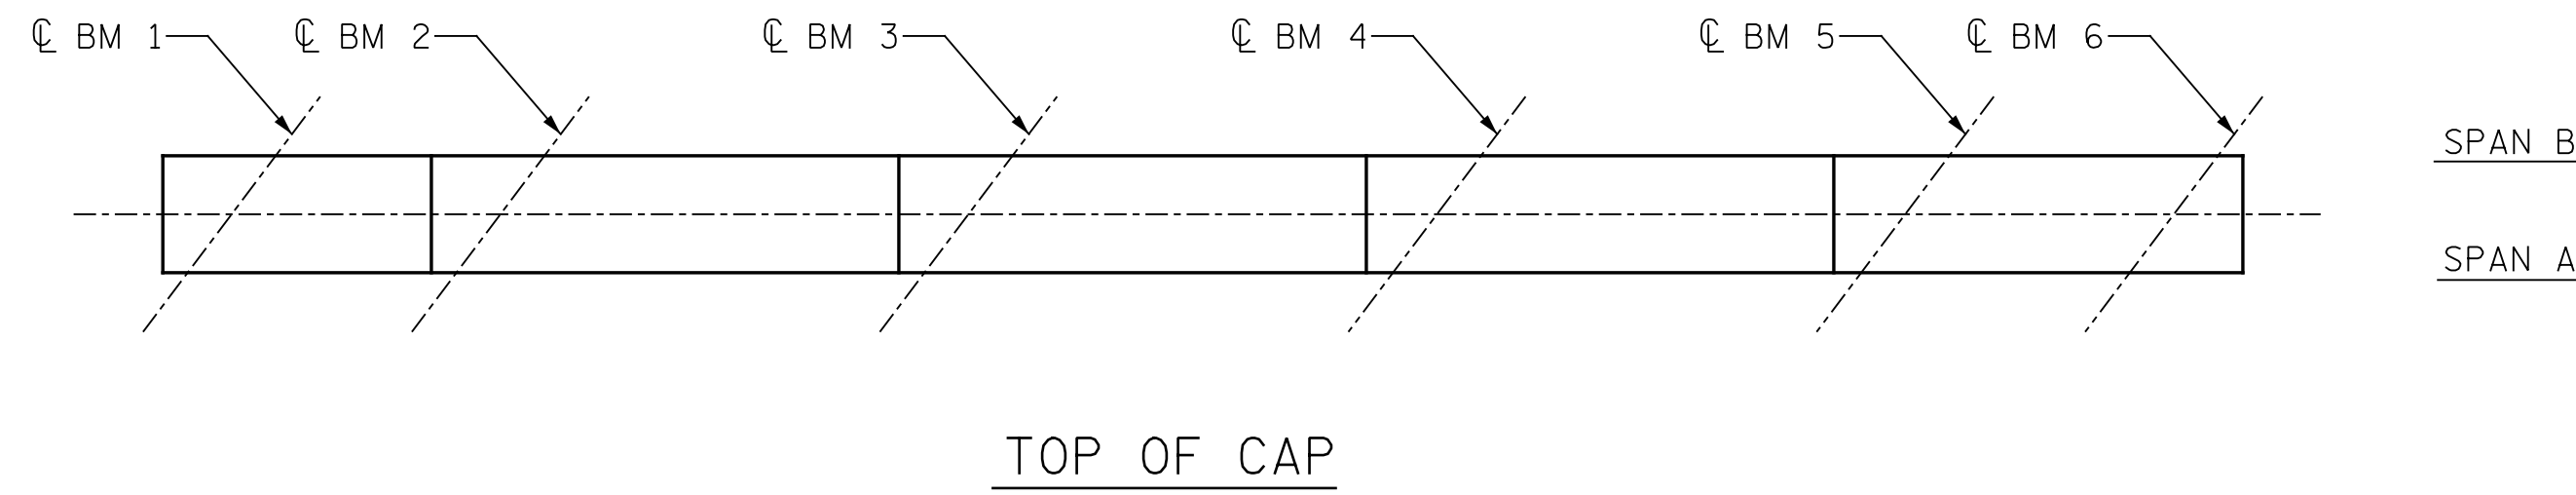
BENT 1

FOR BENT REPAIRS, SEE "TYPICAL CAP AND COLUMN REPAIR DETAILS" SHEET.

- SHOTCRETE REPAIR
- CONCRETE REPAIR
