Preliminary Site Assessment

**US 401 (Raeford Road) from West Hampton Oaks Drive to East of
Fairway Drive in Fayetteville**

**Parcel 332 – Waterville Equities I LLC Property
2605 Raeford Road, Fayetteville, North Carolina**

State Project No. U-4405

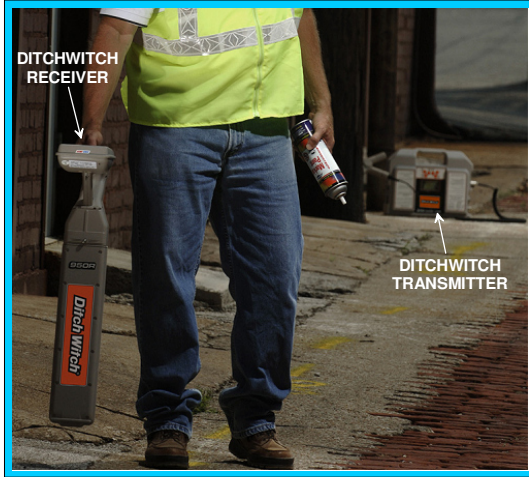
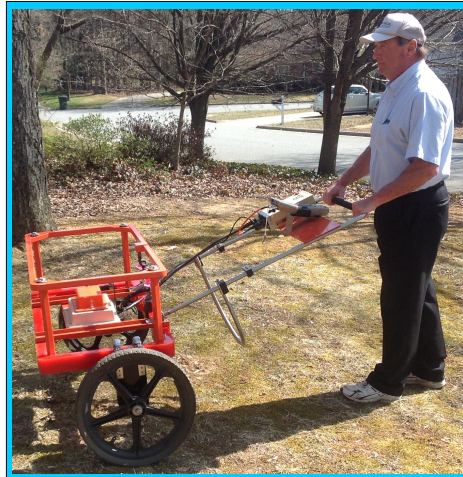
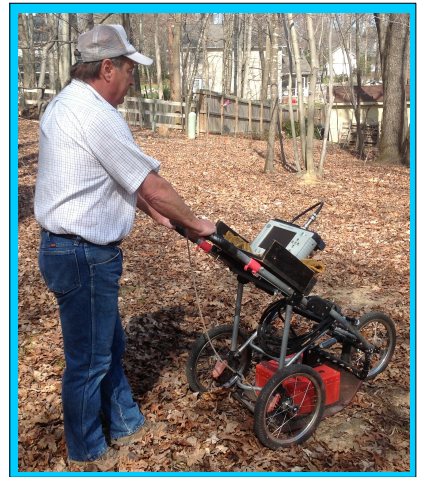
DITCHWITCH UTILITY LOCATOR

EM61 METAL DETECTOR

GROUND PENETRATING RADAR UNIT

The photographs show the DitchWitch 910 utility line locator, the Geonics EM61-MK2A metal detector and the GSSI SIR-3000 ground penetrating radar (GPR) unit that were used to conduct the geophysical investigation across the area of interest at Parcel 332.

Following the UST investigation, areas around the proposed Terracon soil borings were scanned with the GPR unit and a DitchWitch 910 utility locator for buried utility line clearance and no further discussion regarding the utility clearance work will be made in this report. Photographs of the geophysical equipment used for the investigation and of the site are presented in Figure 1.

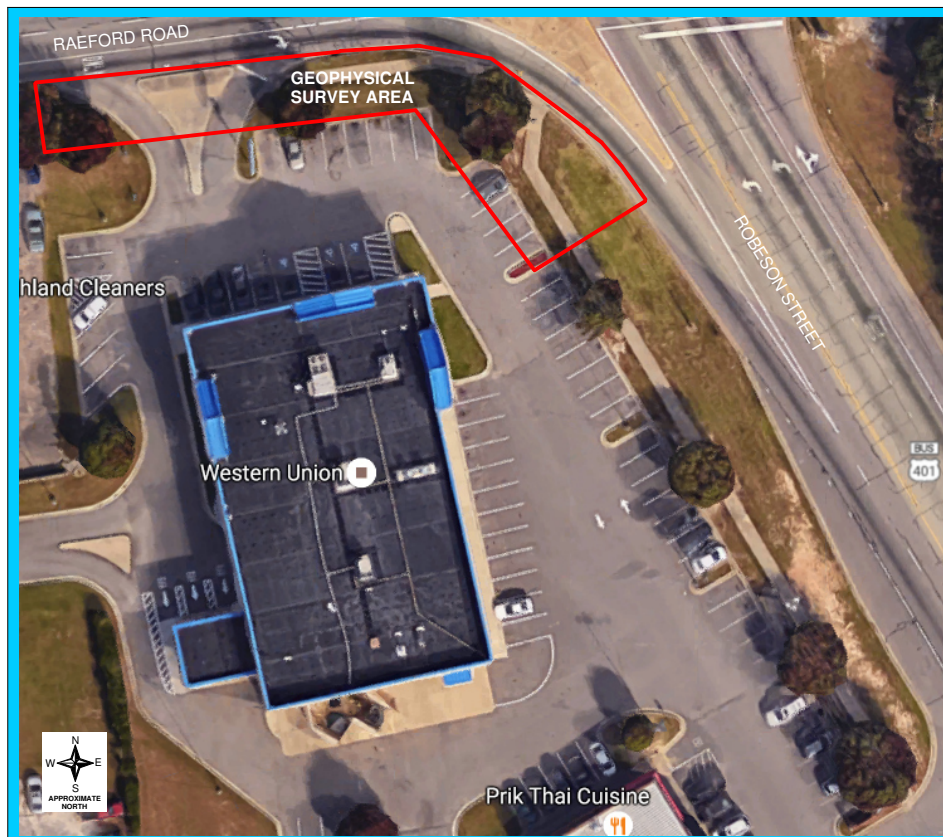
The red polygon in the aerial photograph represents the approximate perimeter of the geophysical survey area at the Waterville Equities I LLC property (Parcel 332) located along Raeford Road in Fayetteville, North Carolina.

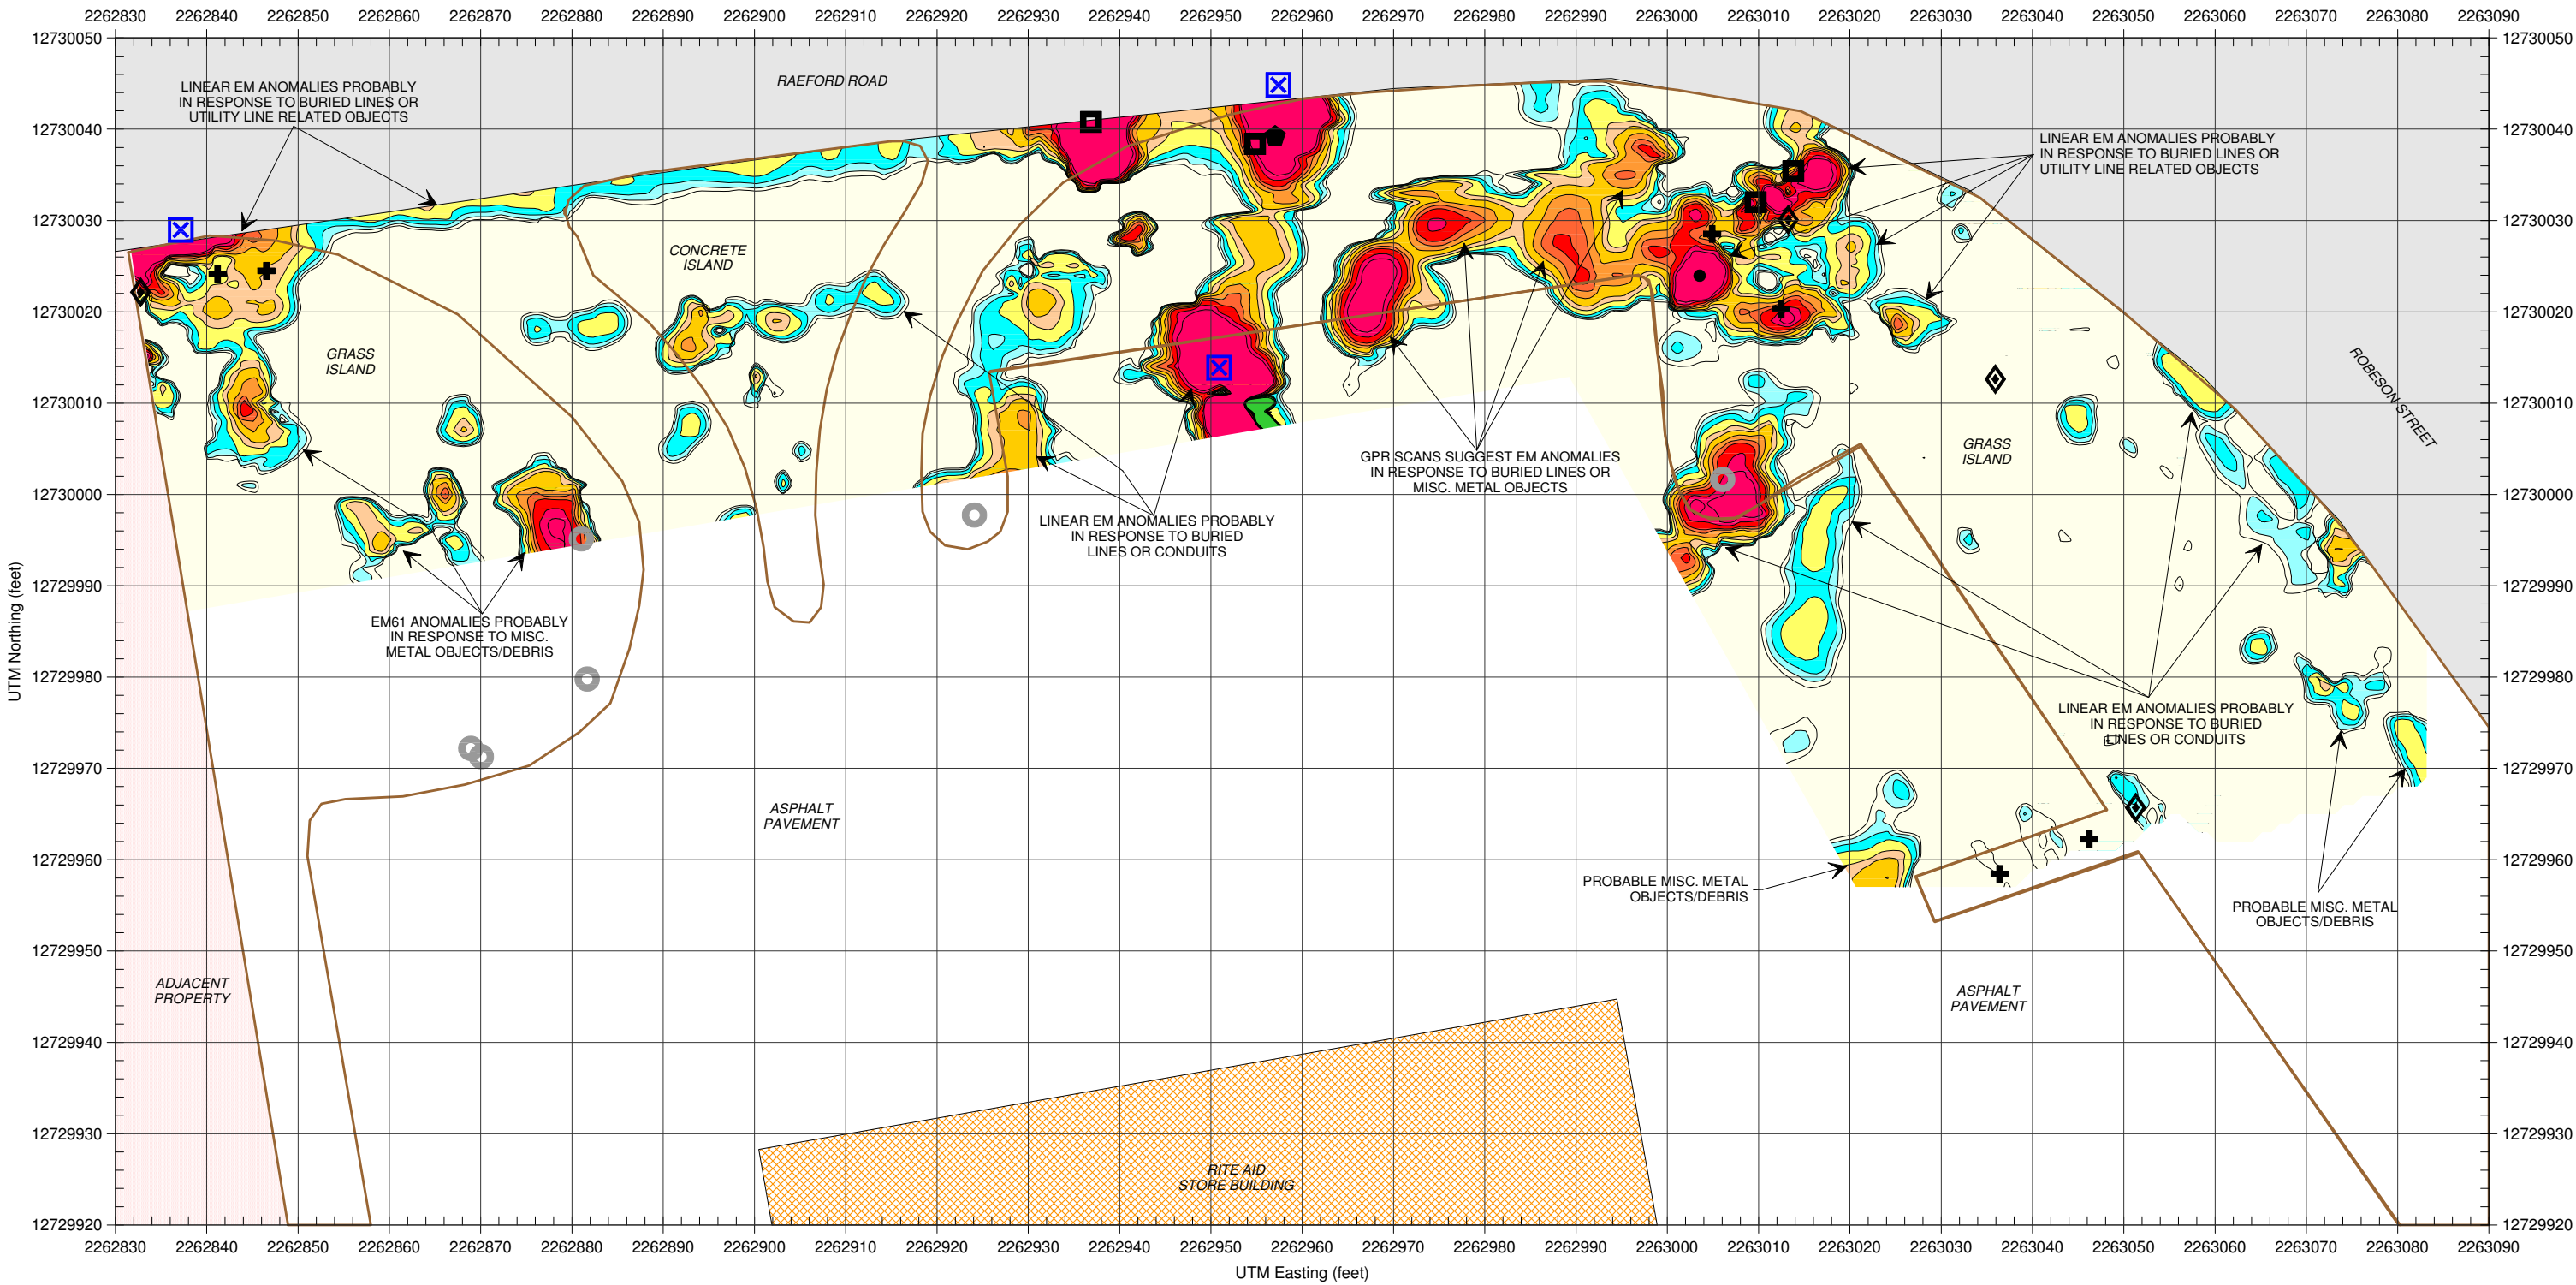
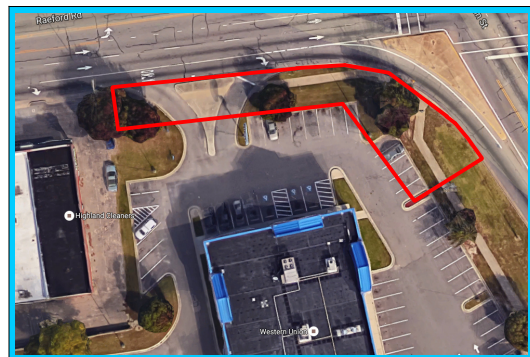
**EM61-MK2A METAL DETECTION
(EARLY TIME GATE RESULTS)**

The red polygon in the aerial photograph represents the approximate perimeter of the geophysical survey area at Parcel 332.

The contour plot shows the early time gate (most sensitive) response of the Geonics EM61-MK2A metal detection instrument in millivolts (mV). The early time gate response shows buried, metallic objects regardless of size. The EM61 survey was conducted on October 19, 2016. Ground penetrating radar (GPR) scans were conducted across selected EM61 anomalies and areas containing reinforced concrete on October 26, 2016 using a Geophysical Survey Systems SIR 3000 instrument with a 400 MHz antenna.

Contour plots of the EM61 early time gate results and the EM61 differential results are presented in **Figures 2 and 3**, respectively. The early time gate results represent the most sensitive component of the EM61 instrument and detect metal objects regardless of size. The early time gate response can be used to delineate metallic conduits or utility lines, small, isolated, metal objects and areas containing insignificant metal debris. The differential results are obtained from the difference between the early time gate channel and late time gate channel of the EM61 instrument. The differential results focus on the larger metal objects such as drums and UST-size objects and ignore the smaller, insignificant, metal objects or debris.

The linear, EM61 early time gate anomalies intersecting UTM coordinates 2262877-E 12730032-N, 2262902-E 12730018-N, 2262927-E 12730016-N, 2262955-E 12730025-N, 2262979-E 12730029-N, 2263016-E 12729995-N, and 2263067-E 12729995-N are probably in response to buried lines or conduits.

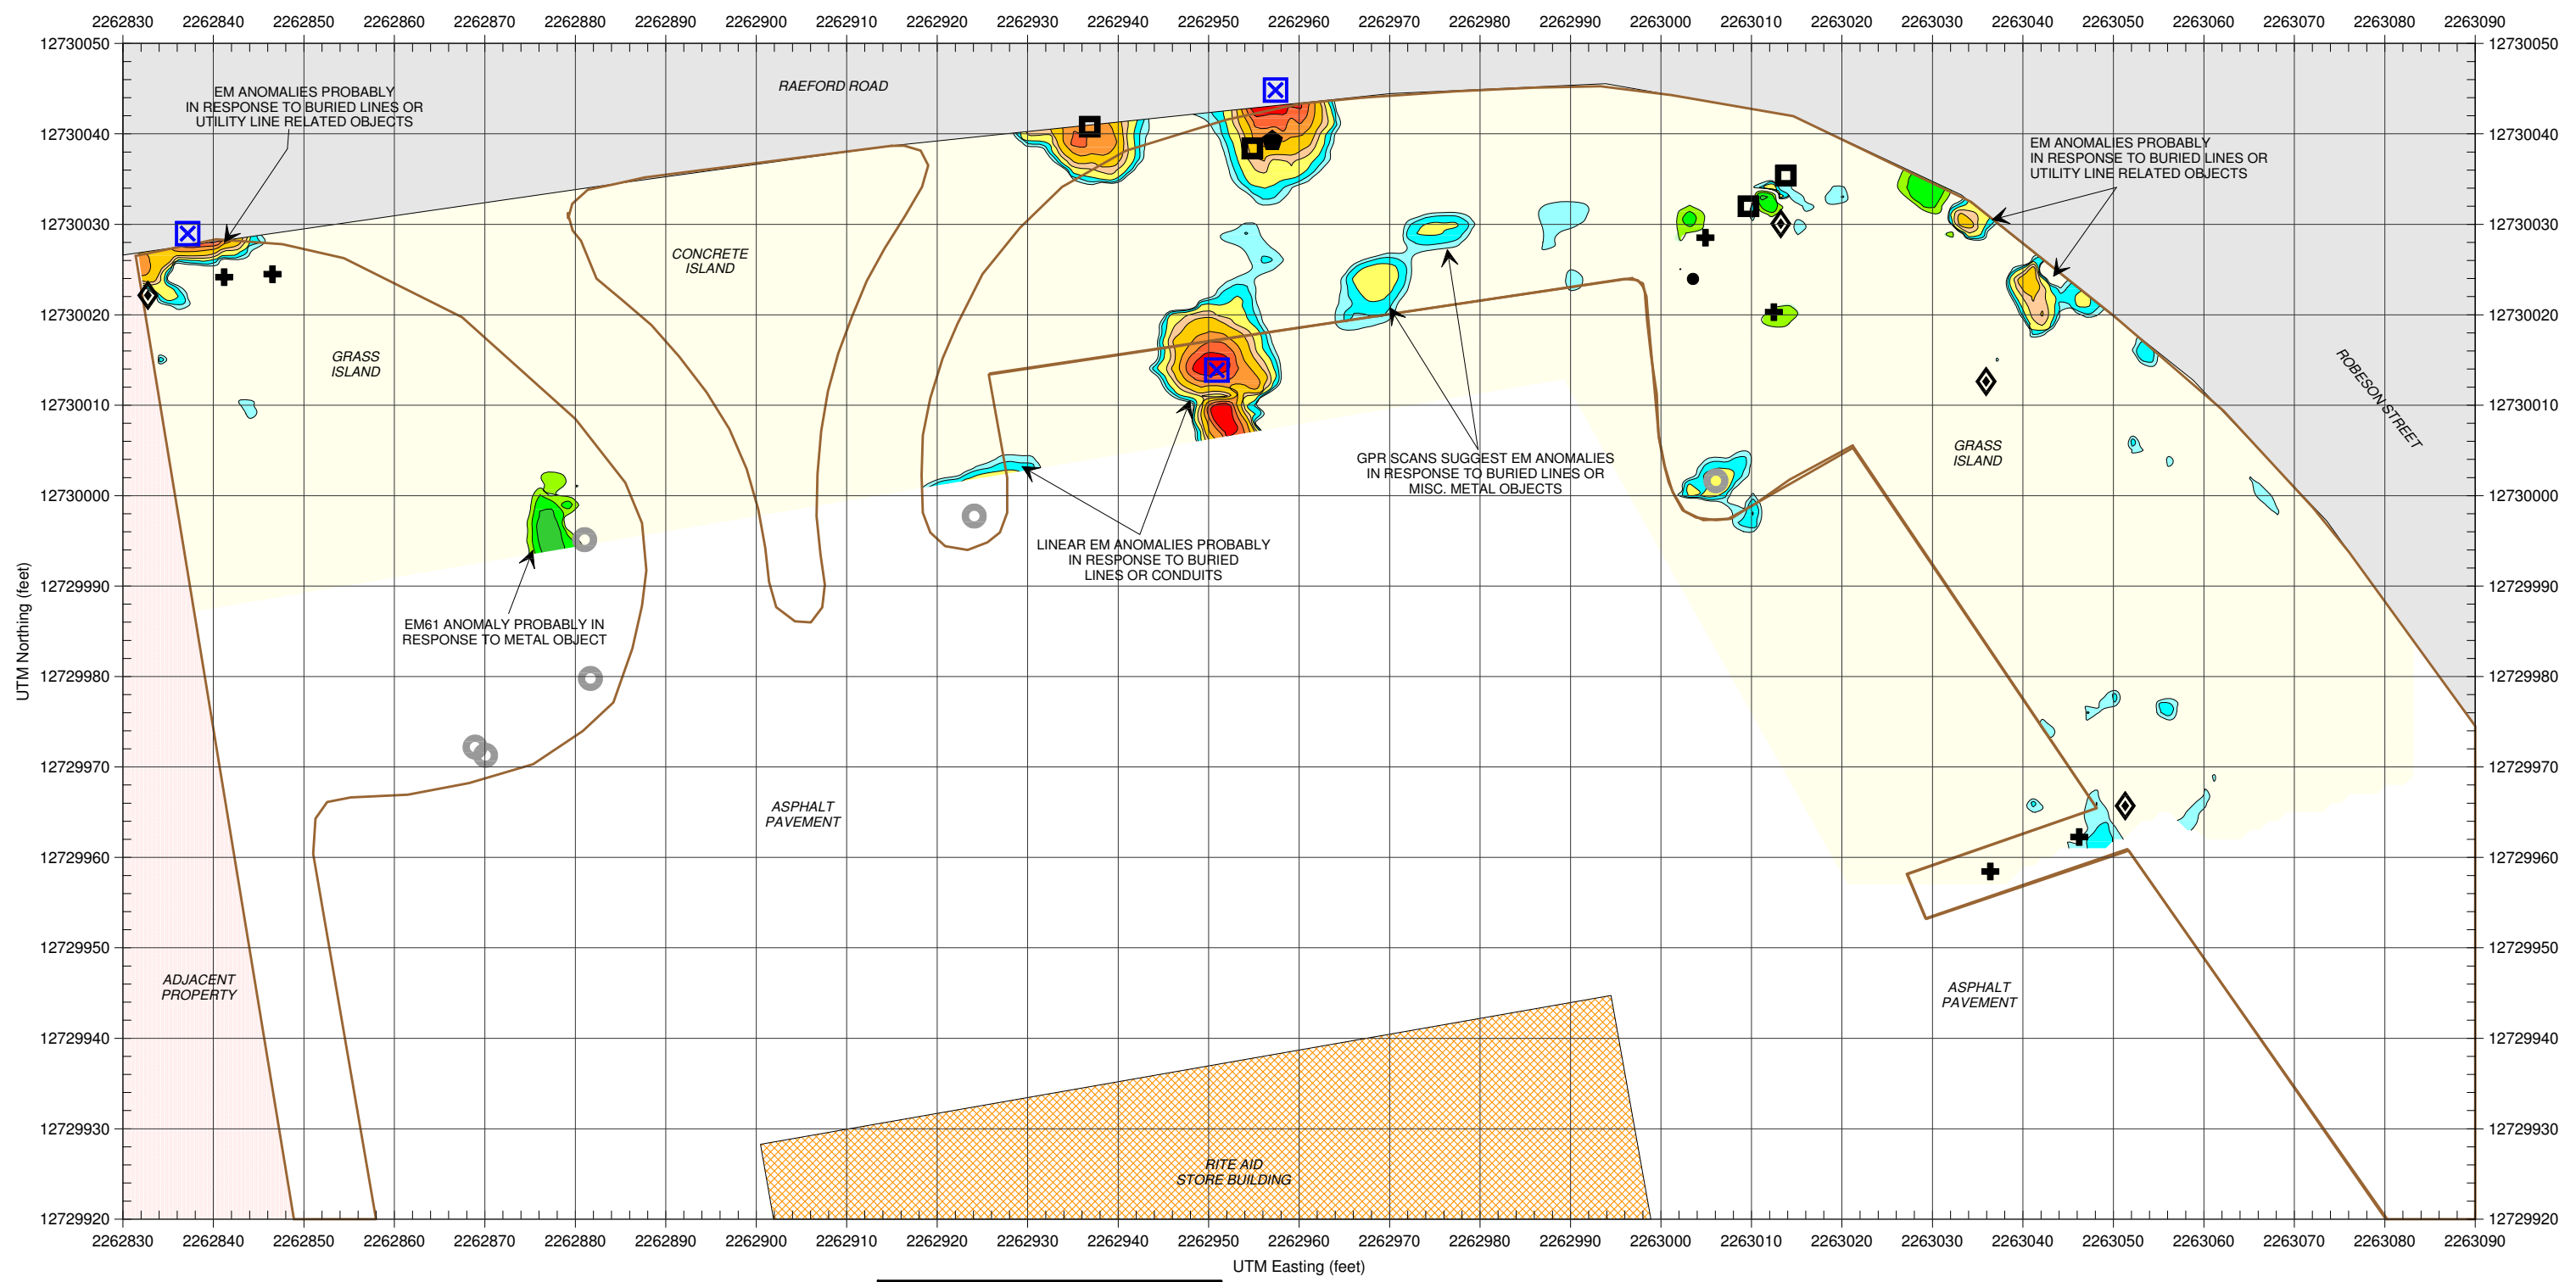
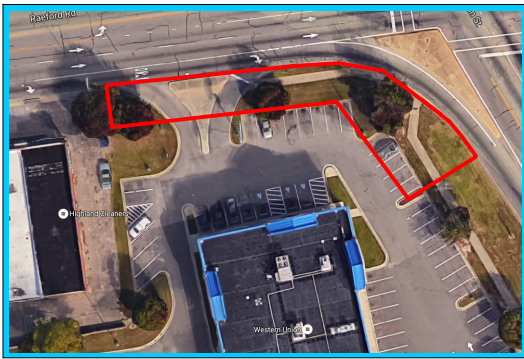
11/11/16 336-286-9718 FIGURE 3

The red polygon in the aerial photograph represents the approximate perimeter of the geophysical survey area at Parcel 332.

Note: The contour plot shows the differential response between the top coil and the late time gate channel of the Geonics EM61-MK2A metal detection instrument in millivolts (mV). The differential response focuses on larger, buried, metallic objects such as drums and USTs and ignores smaller miscellaneous, buried, metal debris. The EM61 survey was conducted on October 19, 2016. Ground penetrating radar (GPR) scans were conducted across selected EM61 anomalies and areas containing reinforced concrete on October 26, 2016 using a Geophysical Survey Systems SIR 3000 unit with a 400 MHz antenna.

**EM61-MK2A METAL DETECTION
(DIFFERENTIAL RESULTS)**

GPR data suggest the EM61 differential anomalies centered near coordinates 2262968-E 12730023-N, 2262975-E 12730029-N and 2262989-E 12730030-N are in response to portions of buried conduits or miscellaneous metal objects. The remaining EM61 anomalies are probably in response to utility line-related objects, known surface objects, buried miscellaneous objects, or portions of conduits. The EM61 and GPR investigation suggests the proposed ROW/PUE area does not contain metallic USTs. Please refer to Figures 2 and 3 for additional (detailed) information regarding the geophysical findings at this site.
