REFERENCE: B-5818

**STRUCTURE**  
**SUBSURFACE INVESTIGATION**

COUNTY ANSON  
 PROJECT DESCRIPTION BRIDGE NO. 11 ON NC 109  
OVER DEADFALL CREEK

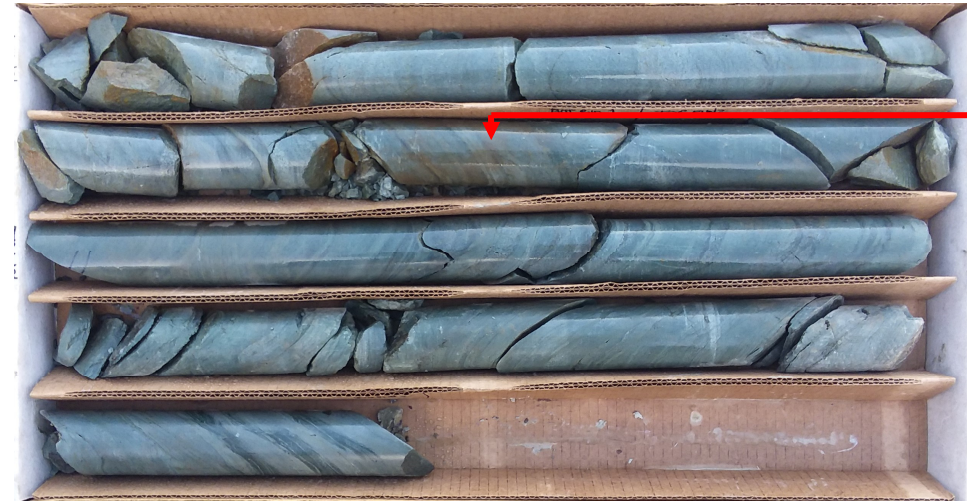
**CORE PHOTOGRAPHS:  
B-5818 | 45771.1.1  
B2-A : -L- Station 28+09, 12' LT**

**Begin Run 1  
9.7 feet**

**End Run 1 &  
Begin Run 2  
12.7 feet**

**End Run 2  
17.7 feet**

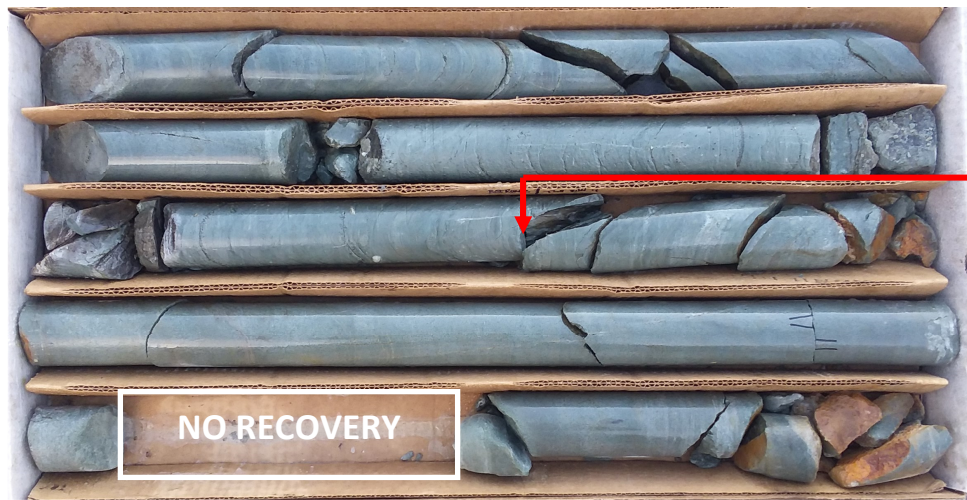
**Begin Run 3  
17.7 feet**

**End Run 3 &  
Begin Run 4  
22.7 feet**

**End Run 4  
27.7 feet**

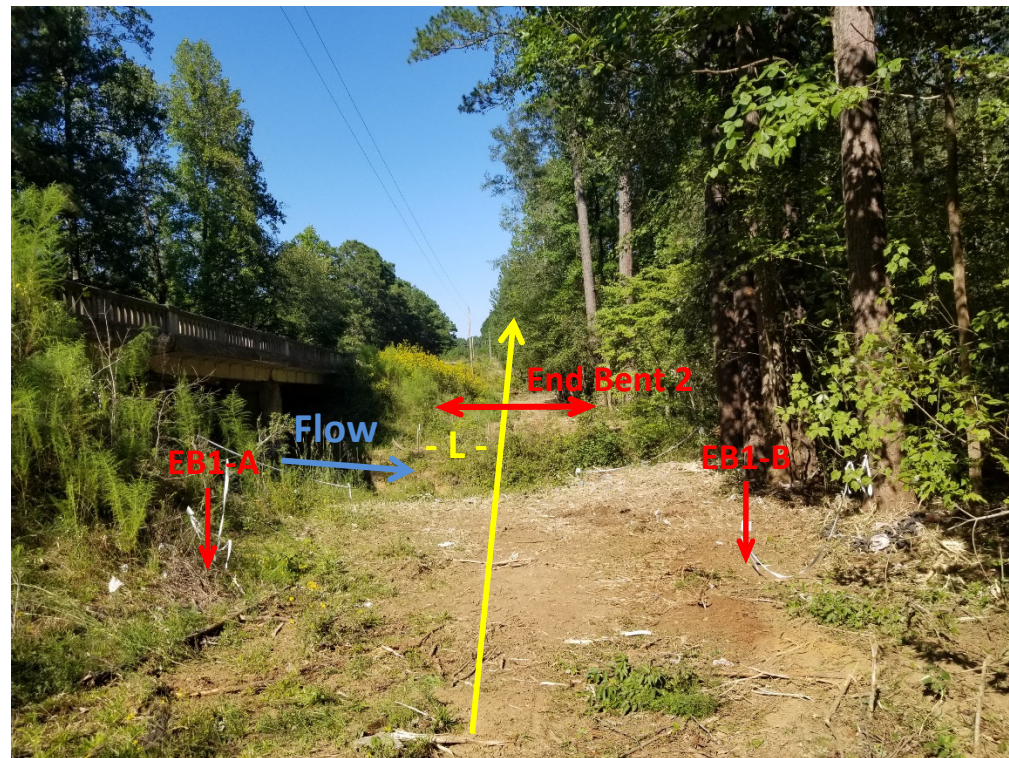
Photograph No. 1: View at End Bent 1 looking north

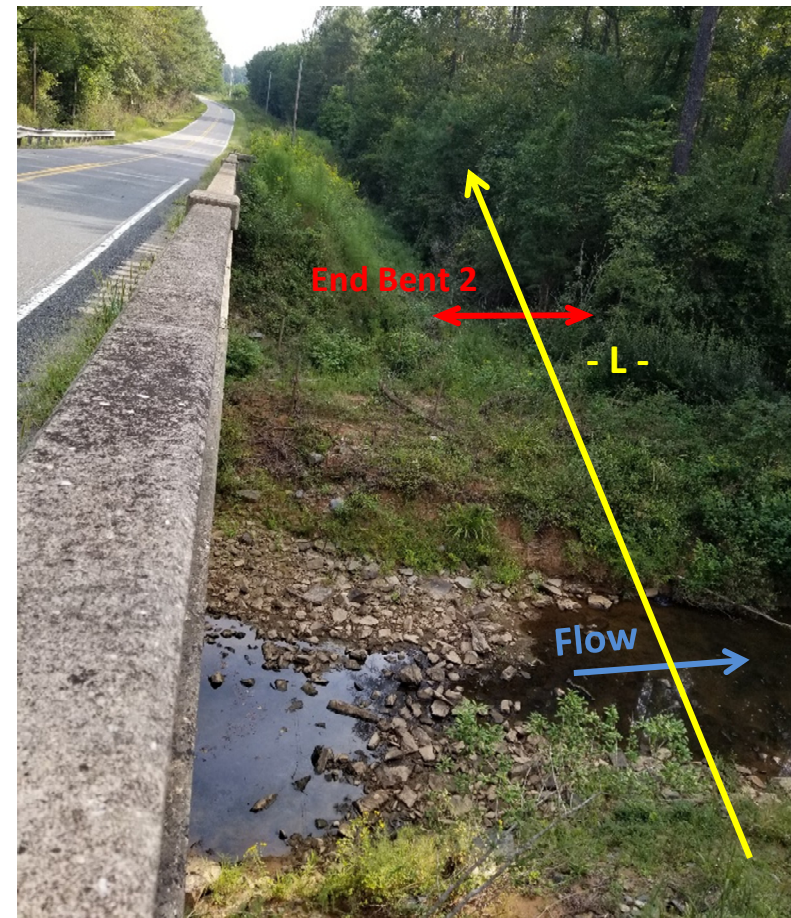
Photograph No. 3: View of End Bent 2 looking north

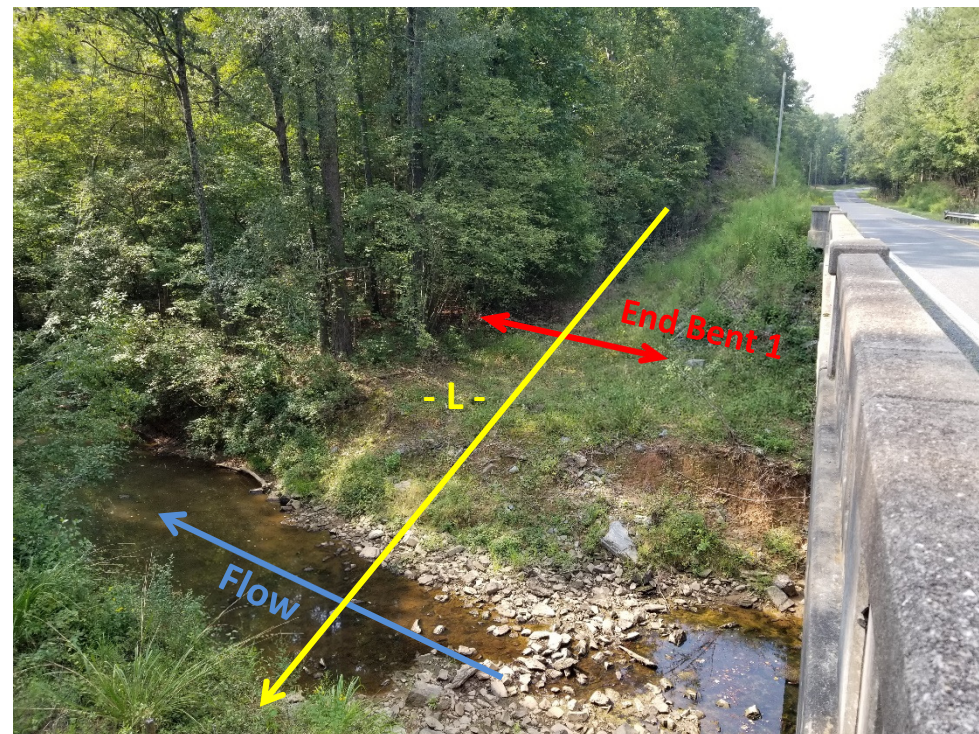
Photograph No. 2: View looking south at End Bent 1
