BENT 1 NORTHBOUND

PROJECT NO. I-5746C MECKLENBURG COUNTY BRIDGE No. 590330

STATE OF NORTH CAROLINA DEPARTMENT OF TRANSPORTATION

> BENT 1 NORTHBOUND SPAN B FACE

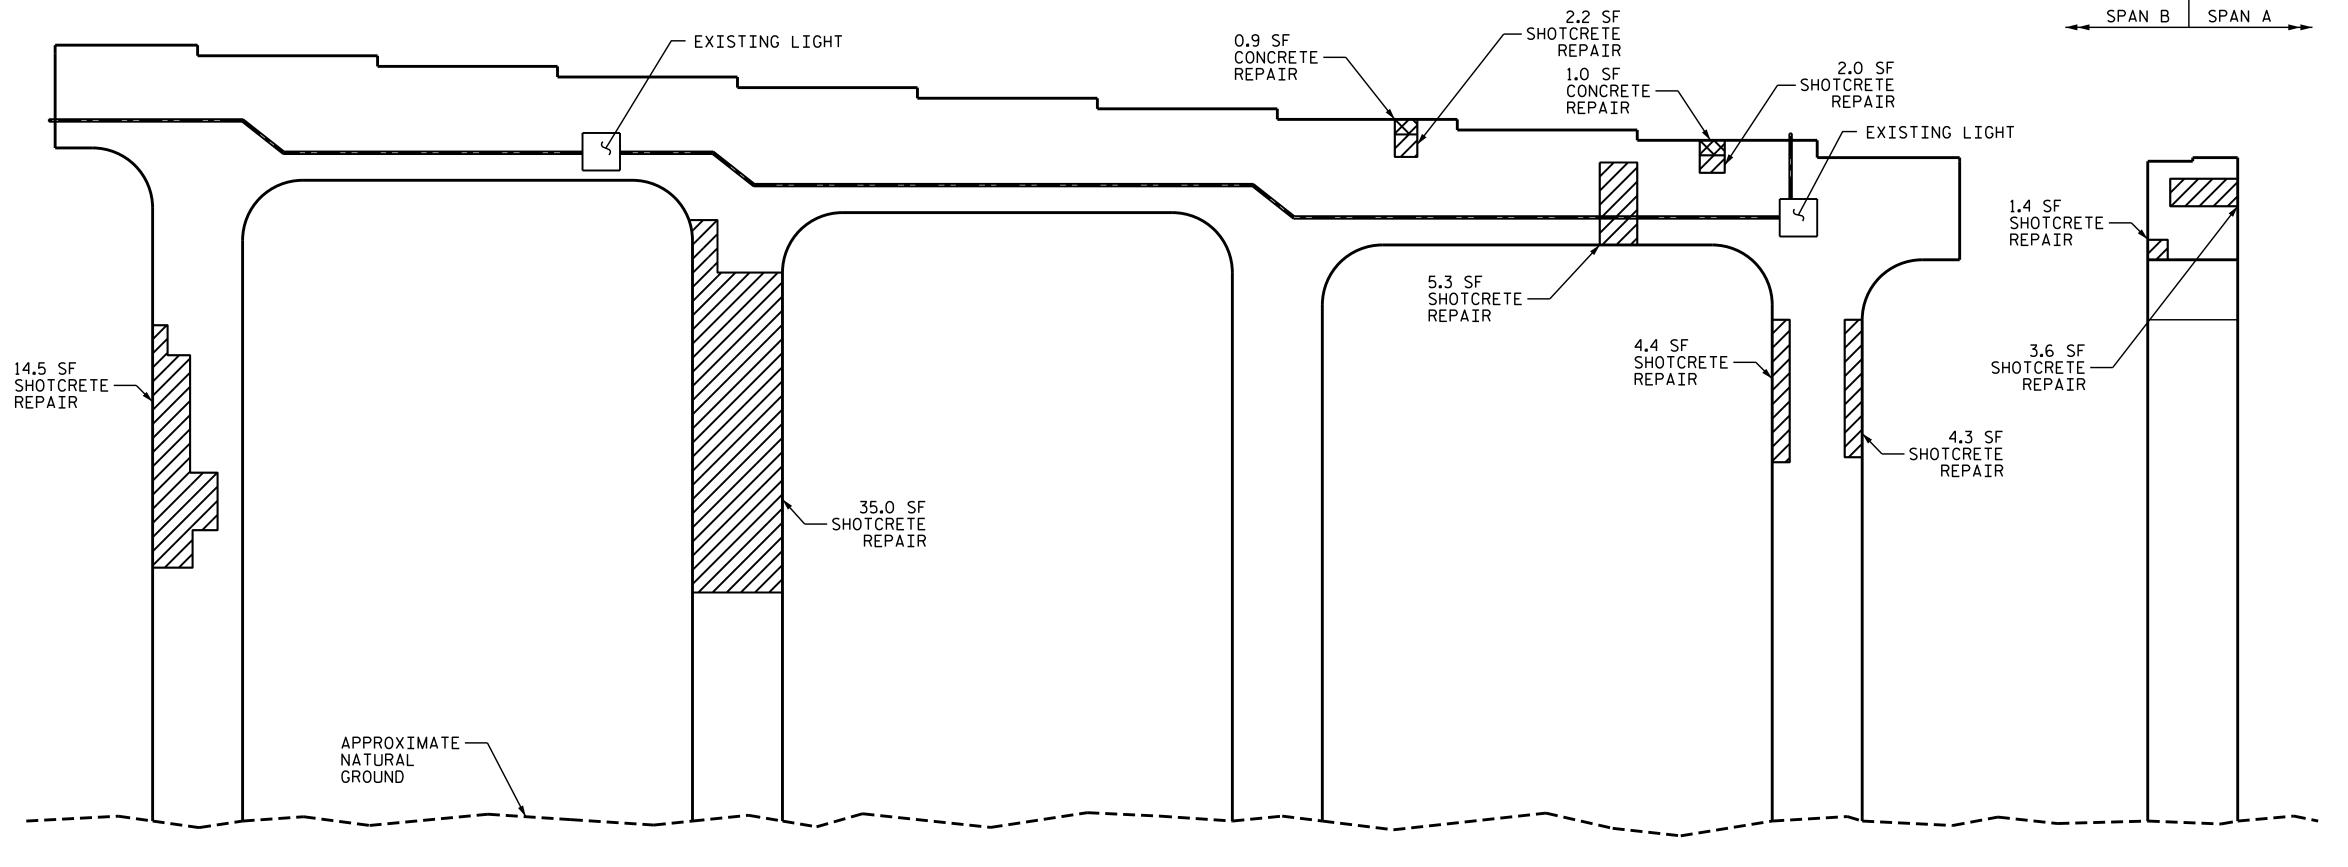
ELEVATION

SHOTCRETE REPAIR AREA

CONCRETE REPAIR AREA

---- EPOXY RESIN INJECTION (ERI)
