PROJECT NO. <u>I-5746C</u> <u>MECKLENBURG</u> COUNTY BRIDGE NO: <u>590332</u>							
02EE938FAB674C5	SHEET 2 OF 6							
SEAL 35647	STATE OF NORTH CAROLINA DEPARTMENT OF TRANSPORTATION RALEIGH							
8/23/2021	BENT 16 SPAN S FACE							
		SHEET NO.						
ACUMENT NOT CONCERED	NO. BY:	REVIS DATE:	NO. BY:	DATE:	S10-106			
DOCUMENT NOT CONSIDERED FINAL UNLESS ALL	1		3		TOTAL SHEETS			
SIGNATURES COMPLETED	2		4		274

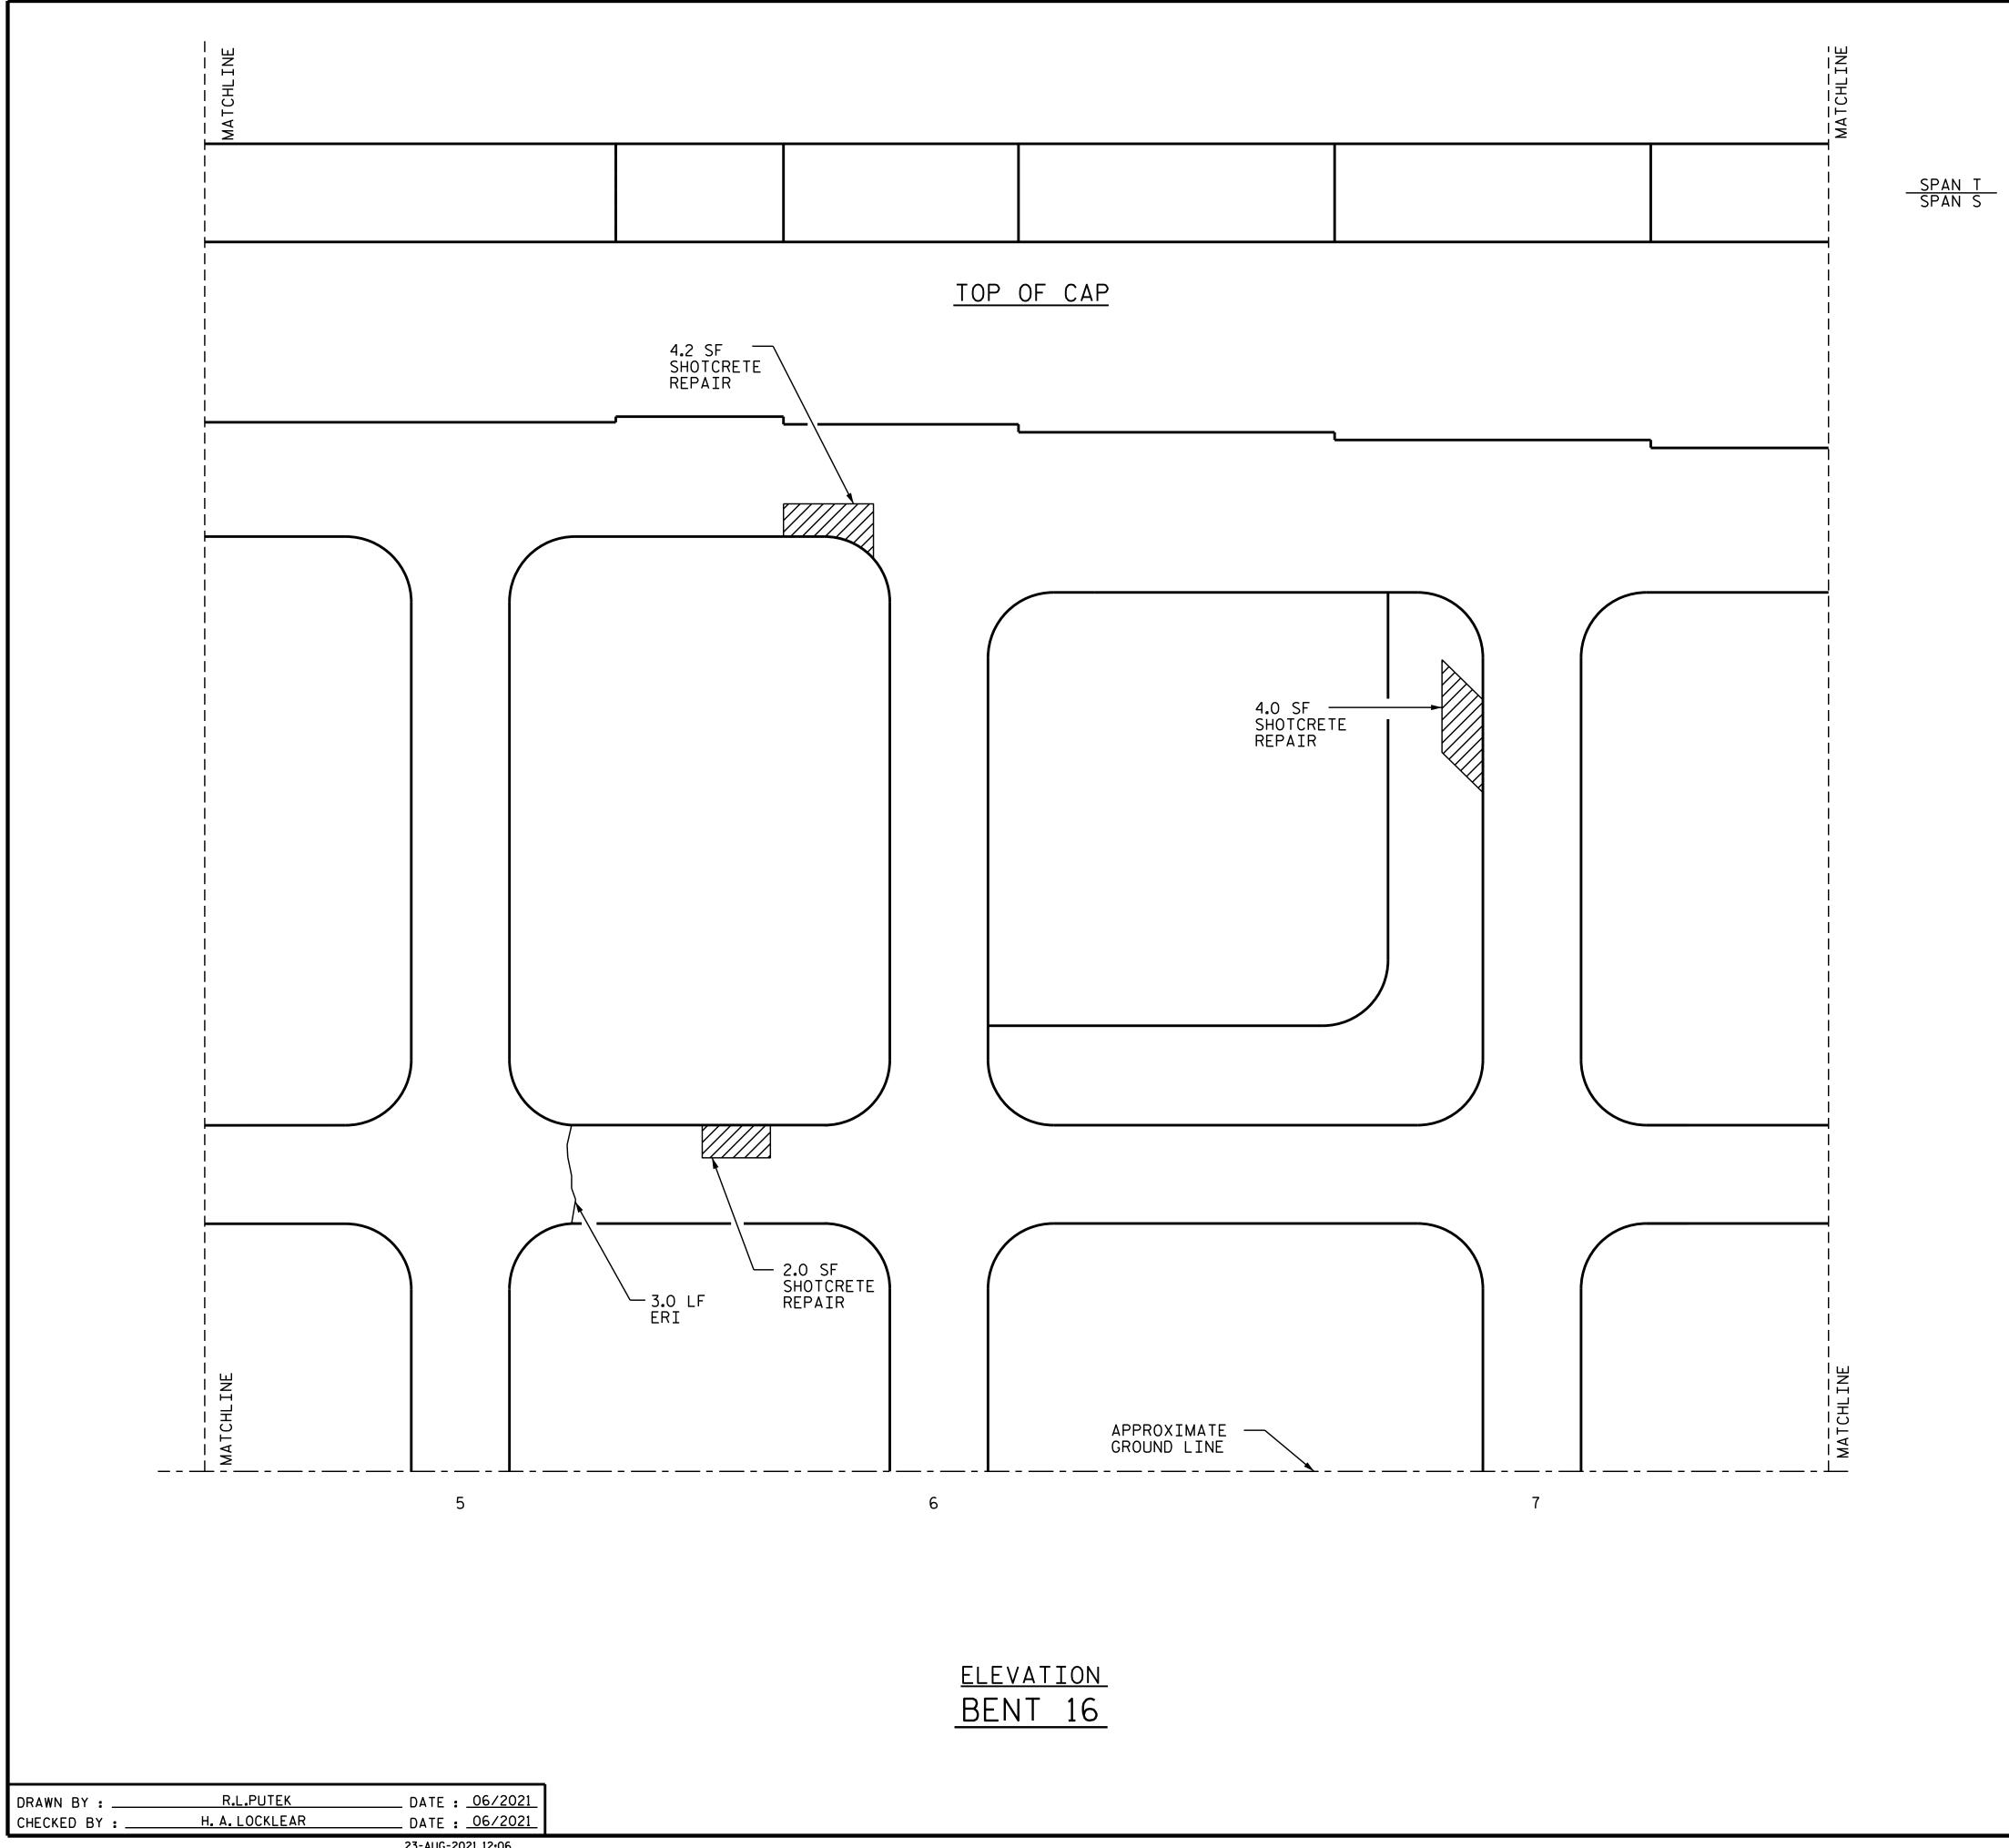
VALUES IN CHART REPRESENT ESTIMATED REPAIR TOTALS AFTER REMOVAL OF UNSOUND CONCRETE, MIN. OF 1" BEHIND REBAR AND 2" MIN. CLEAR TO SAWCUT. FOR REPAIR DETAILS, SEE ``TYPICAL CAP AND COLUMN REPAIR DETAILS" SHEET.

CLEAN AND REMOVE DEBRIS FROM THE TOP OF THE CAP AND STRUTS AND APPLY EPOXY PROTECTIVE COATING.EPOXY COATING SHALL BE APPLIED TO THE TOP SURFACE OF THE CAP AND STRUTS. THE CONTRACTOR SHALL NOT COAT THE AREA OF THE CAP BENEATH THE MASONRY PLATES. FOR EPOXY COATING, SEE SPECIAL PROVISIONS.
