Preliminary Site Assessment

Parcel 155 – Joey M. Godfrey

2042 Old US 221, Rutherfordton, North Carolina

State Project No. R-2233BB WBS Element: 34400.1.S5 December 1, 2017 Terracon Project No. 71177323

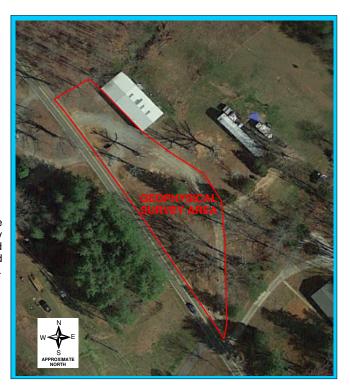
GEOPHYSICAL SURVEY AREA

The red polygon in the aerial photograph represents the approximate perimeter of the geophysical survey area at the Joey M. Godfrey property (Parcel 155) located at 2042 Old US 221 in Rutherford County, North Carolina. The geophysical investigation was conducted on July 27 and August 2, 2017.

The geophysical investigation was conducted to determine if buried, metallic, underground, storage tanks (USTs) are present beneath the proposed Right-of-Way (ROW) and PUE areas of the site. The perimeter of the geophysical survey area (approximate ROW & PUE areas) is shown as a red polygon in the aerial photograph presented in **Figure 1**. The property consists of a metal garage surrounded by flay-lying grass and gravel-covered surfaces.
