STATE OF NORTH CAROLINA
DEPARTMENT OF TRANSPORTATION

TIP NO: B-5353
WBS: 46067.1.1
COUNTY: Guilford
DIVISION 7
DESCRIPTION: Replace Bridge 147 on US 29/US70/I-85 BUS over US 311

SUBJECT: **GeoEnvironmental Report for Planning**

Hazardous Materials Report

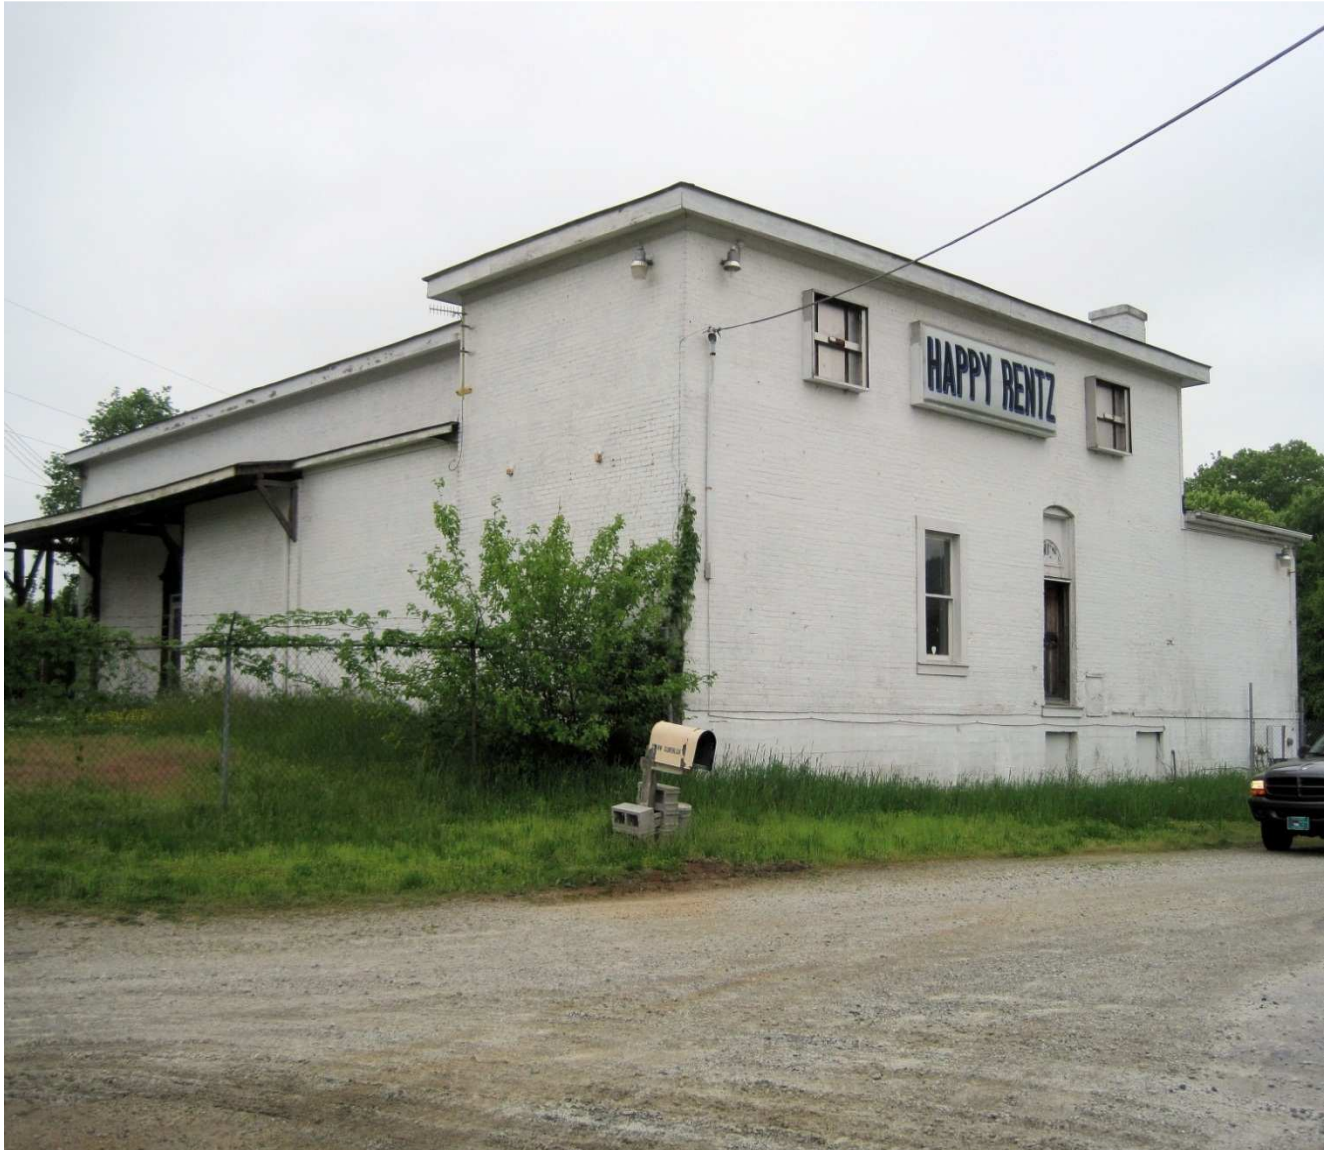
| 1) | Property Name Christos Global Cathedral Happy Rentz 125 NW Cloverleaf Place High Point, NC 27260 | Property Owner: Gail H. Hodgin 548 Hodgin Valley Road Pleasant Garden, NC 27313 |

This active church is located in the western quadrant of the US 29/US70/I-85 BUS and US 311 (S. Main Street) interchange. Happy Rentz previously operated at this location. The structure, originally built in 1920 has been modified several times and occupied by numerous businesses. There is the potential that USTs are present on this property. This parcel does not appear on the UST Section Registry nor are any ground water incidents associated with this location. **This site is anticipated to present low geoenvironmental impacts to the project.**

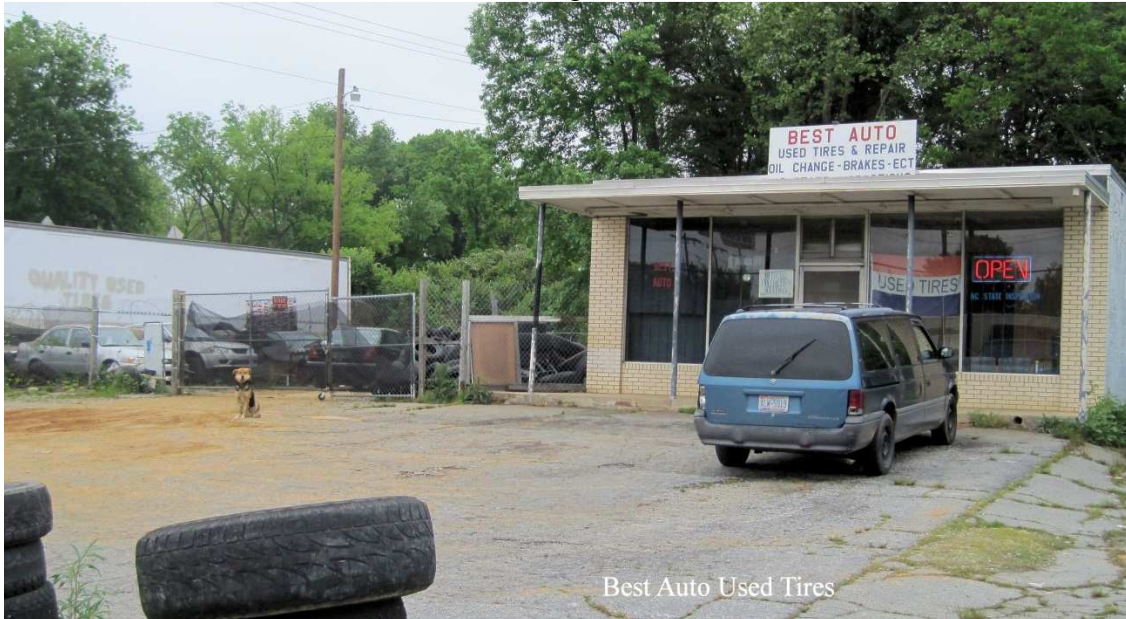
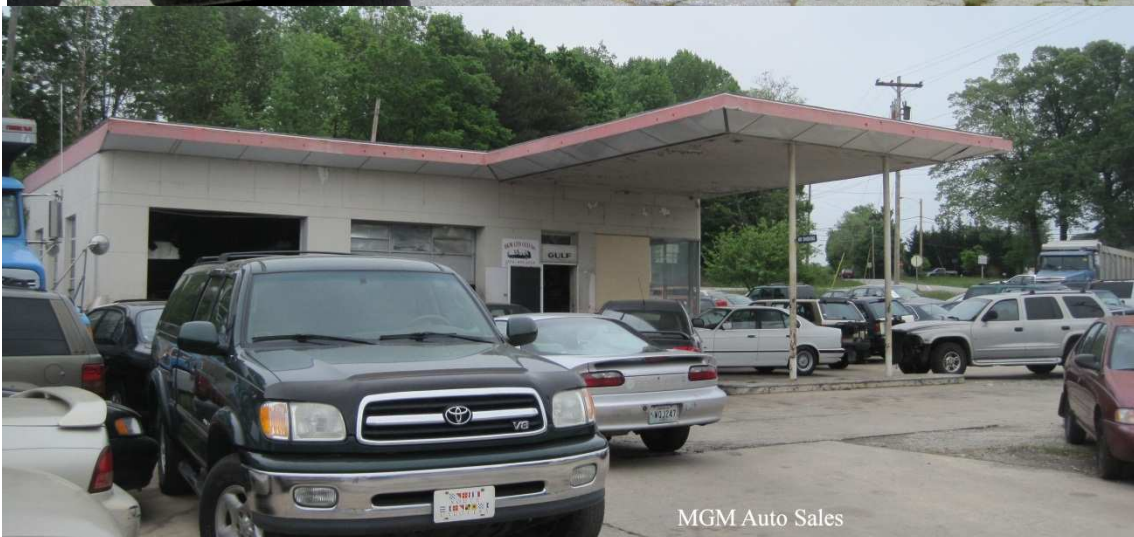
2) **Property Name**
Best Auto Used Tires
MGM Auto Sales, Inc.
2107-2111 S. Main Street
High Point, NC 27260
Facility ID #: 0-010470
Incident #: 06333

These active businesses are located in the eastern quadrant of the US 29/US70/I-85 BUS and US 311 (S. Main Street) interchange. Hyder's Fork Lift Repair previously operated from the Best Auto Tire location. The fenced in area to the northwest of the building contains tires, junk vehicles and automotive parts. To the southeast of this business is MGM Auto Sales. MGM operates out of a former gas station (Furniture City Gulf). According to the UST Section Registry four (4) tanks were removed in 1990. Ground Water Incident 06333 was assigned to this facility in 1995. **This site is anticipated to present low geoenvironmental impacts to the project.**

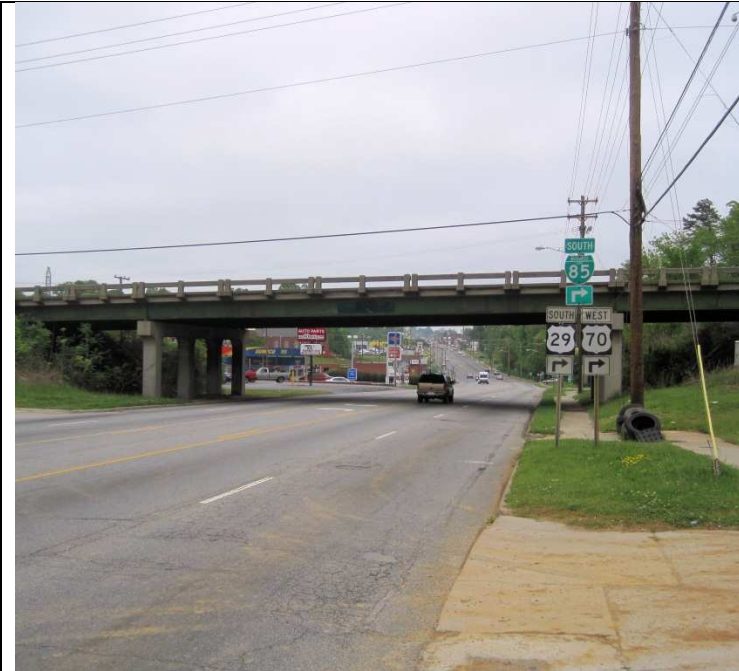
Bridge 147 on US 29/US70/I-85 BUS over US 311 (S. Main Street). View to the northwest.

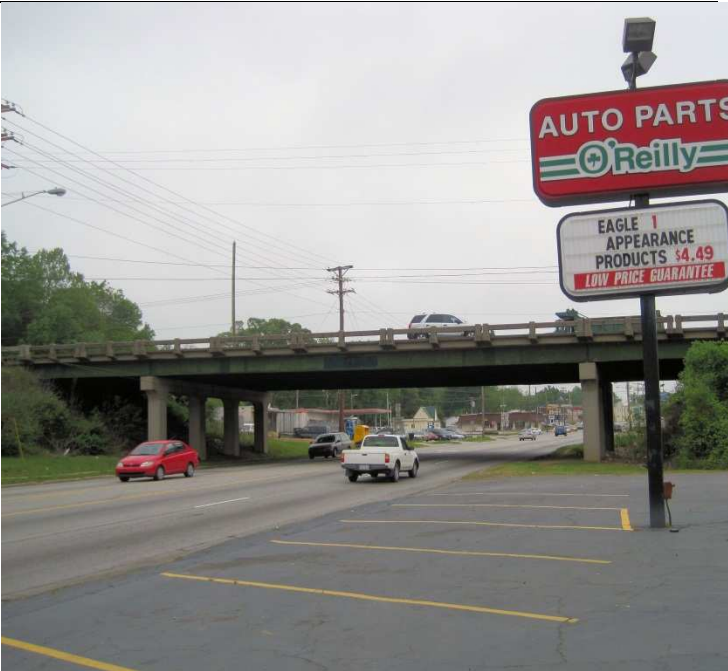
Bridge 147 on US 29/US70/I-85 BUS over US 311 (S. Main Street). View to the southeast.

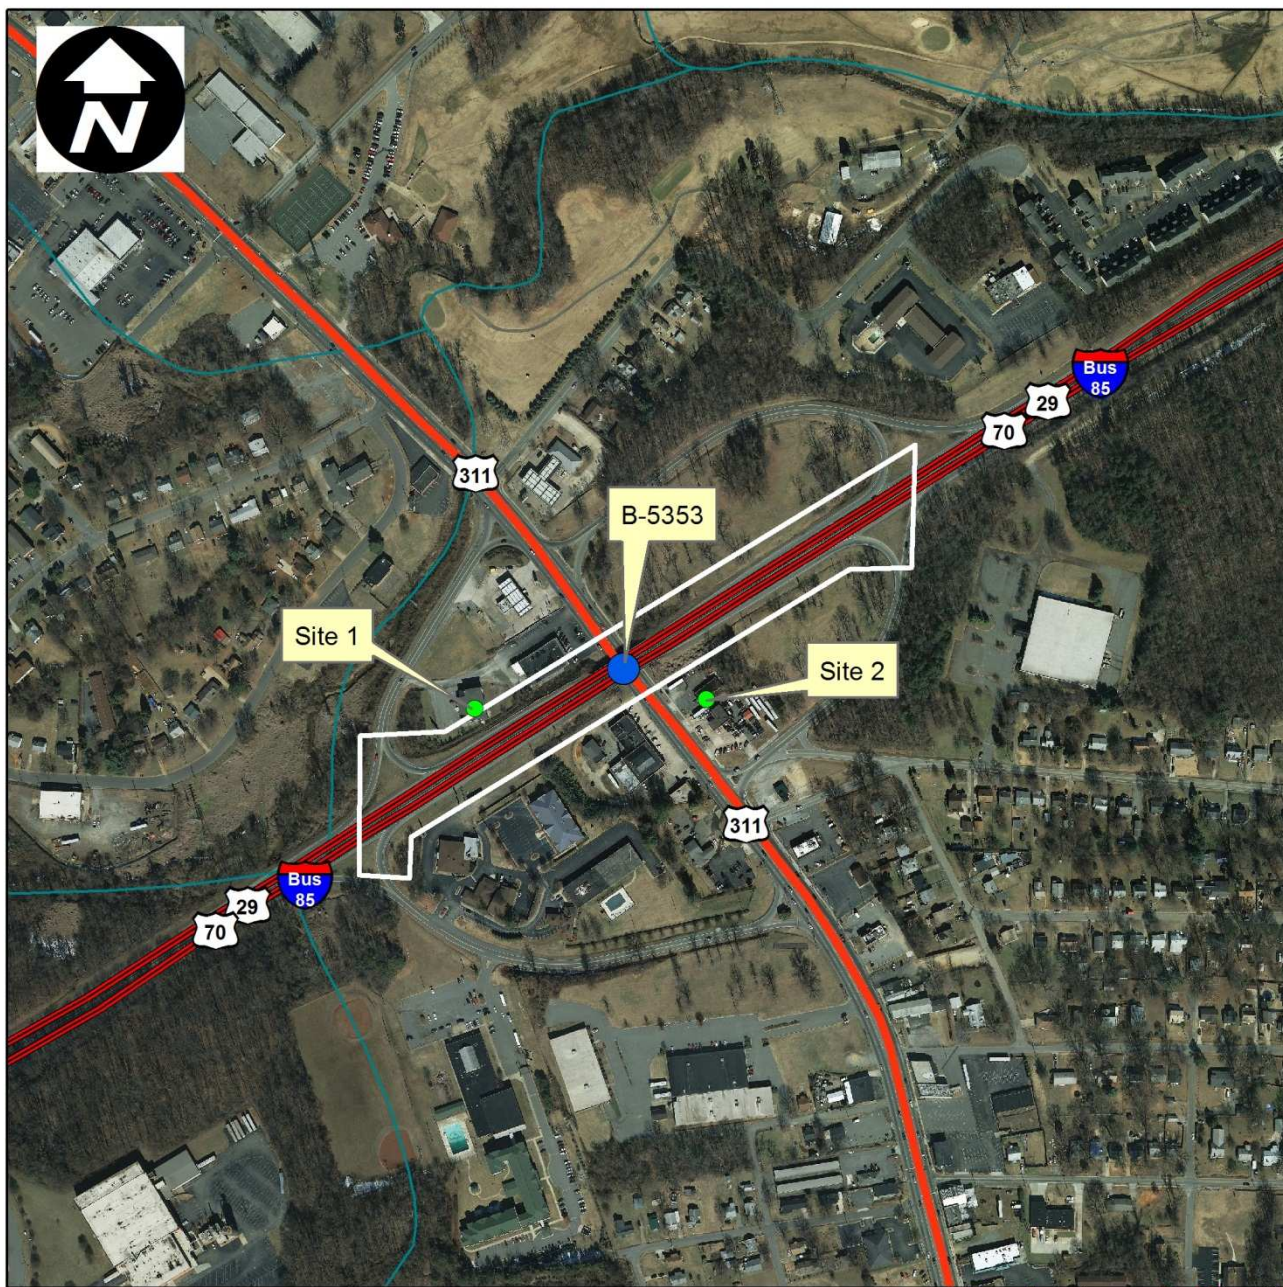
Appendix A
Location of USTs, Landfills, & Other Potentially Contaminated Sites

Project 46067.1.1 (TIP # B-5353)
 Bridge # 147 on US 29/70/I-85 Bus over US 311
 Guilford County
