PROJECT NO. **15BPR.49**
WAKE COUNTY
 BRIDGE NO. **910028**

STATE OF NORTH CAROLINA
 DEPARTMENT OF TRANSPORTATION
 RALEIGH

SUBSTRUCTURE REPAIRS

**BENT 4
 SPAN E FACE**

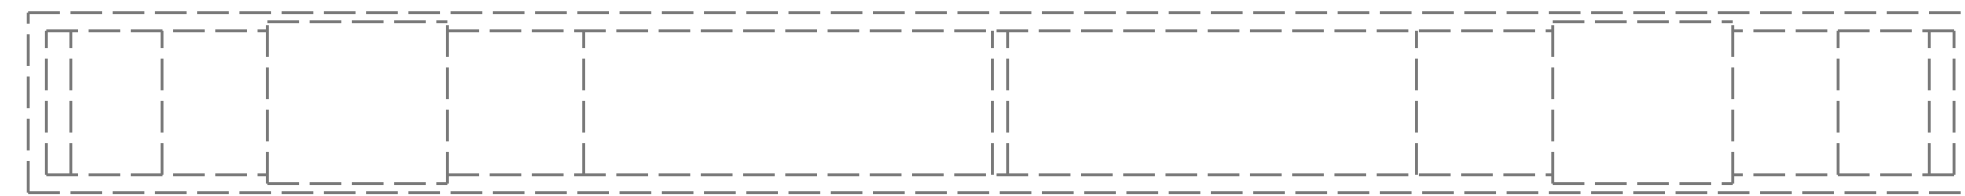
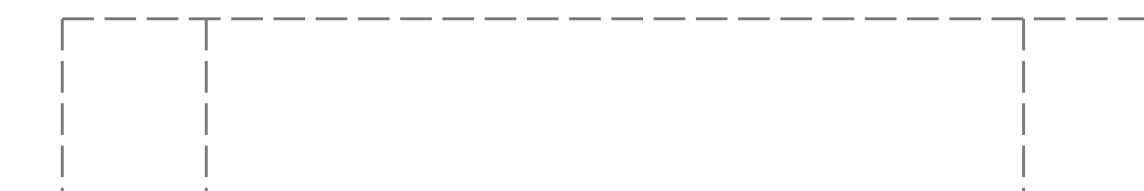
BOTTOM OF CAP

BOTTOM OF STRUT

END VIEW

ELEVATION

SHOTCRETE REPAIR AREA
-

CONCRETE REPAIR AREA
-

VALUES IN CHART REPRESENT ESTIMATED REPAIR TOTALS AFTER REMOVAL OF UNSOUND CONCRETE, MIN. OF 1" BEHIND REBAR AND MIN. 1" CLEAR TO SAWCUT. SEE REPAIR DETAILS.

CONCRETE REPAIRS MAYBE SUBSTITUTED IN LIEU OF SHOTCRETE REPAIRS WITH THE APPROVAL OF THE ENGINEER.

FOR "SHOTCRETE REPAIRS", SEE SPECIAL PROVISIONS.
