15BPR.49 PROJECT NO.__ **WAKE** COUNTY 910240 BRIDGE NO. ___

STATE OF NORTH CAROLINA DEPARTMENT OF TRANSPORTATION

SUBSTRUCTURE REPAIRS END BENT 1

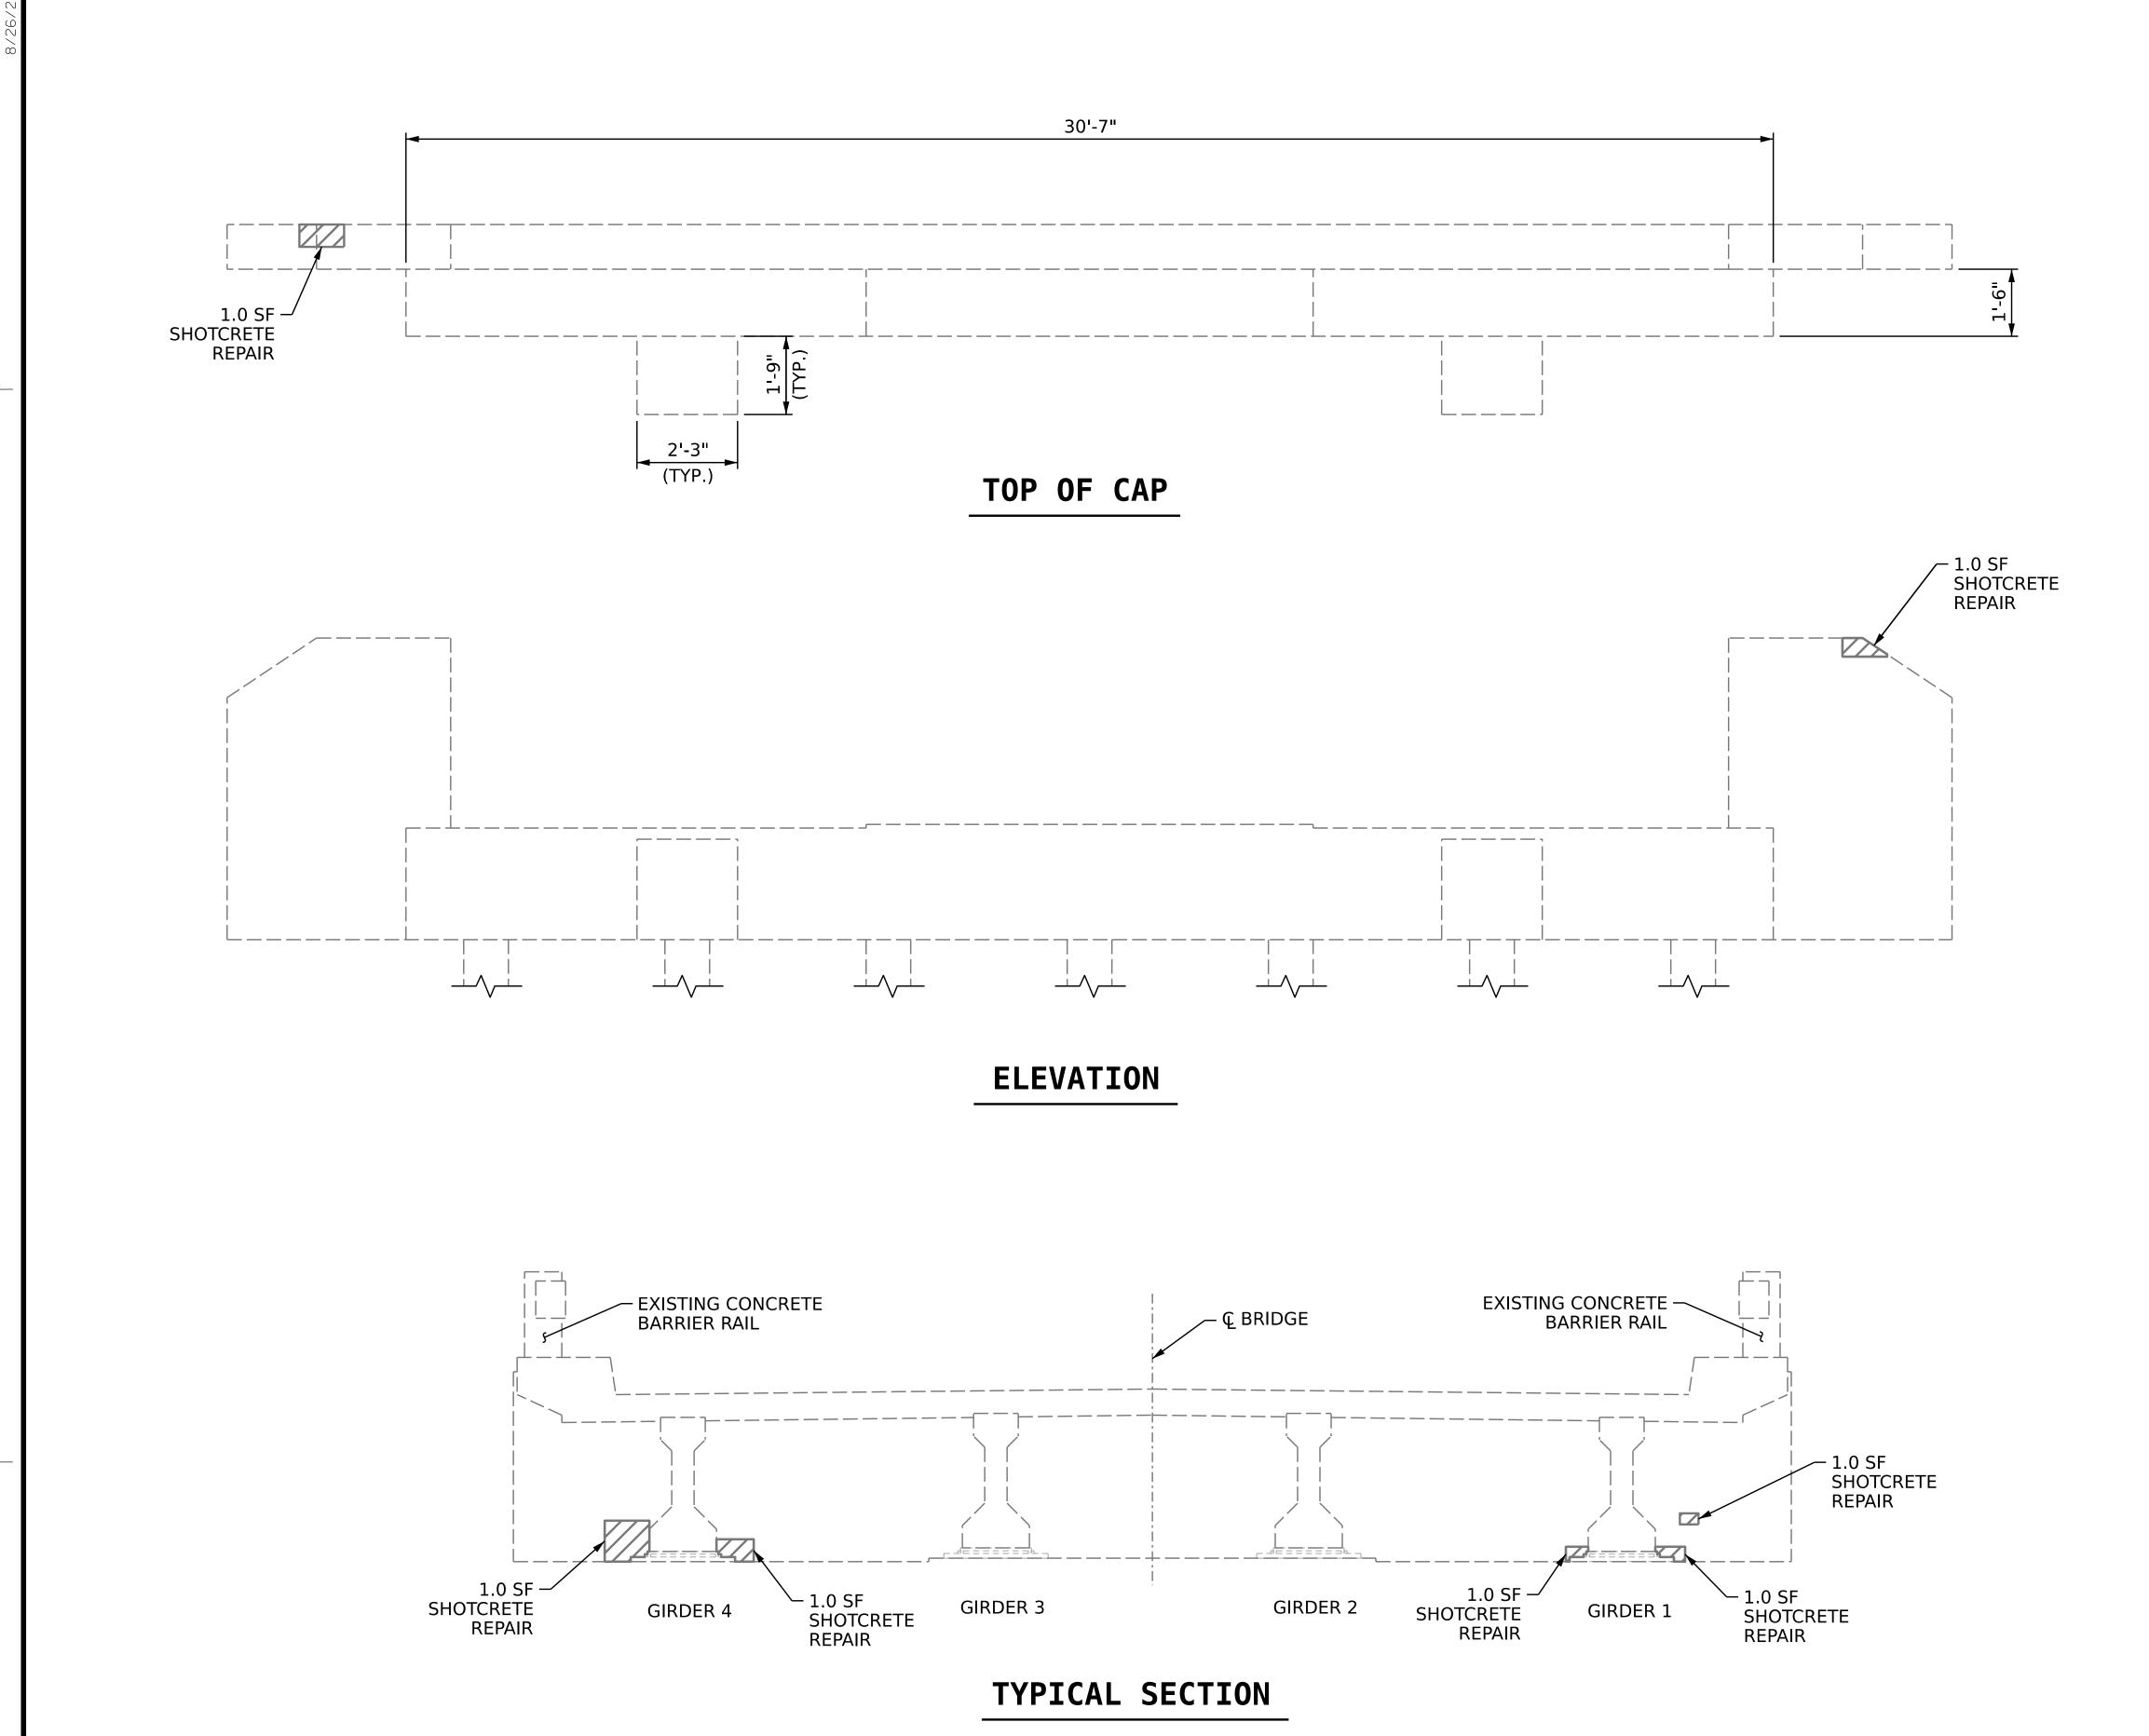
CLEAN AND REMOVE DEBRIS FROM THE TOP OF THE CAP AND APPLY EPOXY PROTECTIVE COATING. EPOXY COATING SHALL BE APPLIED TO THE TOP SURFACE OF THE CAP. THE CONTRACTOR SHALL NOT COAT THE AREA OF THE CAP BENEATH THE MASONRY PLATES. FOR EPOXY COATING, SEE SPECIAL PROVISIONS.

SHOTCRETE REPAIR AREA

CONCRETE REPAIR AREA

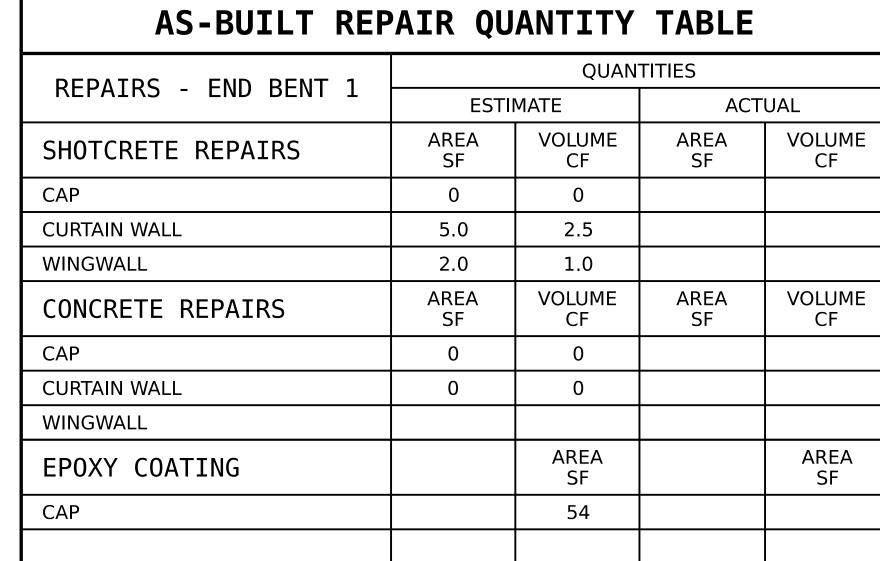
VALUES IN CHART REPRESENT ESTIMATED REPAIR TOTALS AFTER REMOVAL OF UNSOUND CONCRETE, MIN. OF 1" BEHIND REBAR AND MIN. 1" CLEAR TO SAWCUT. SEE REPAIR DETAILS.

CONCRETE REPAIRS MAYBE SUBSTITUTED IN LIEU OF SHOTCRETE REPAIRS WITH THE APPROVAL OF THE ENGINEER.

FOR "SHOTCRETE REPAIRS", SEE SPECIAL PROVISIONS.
