PROJECT NO. **15BPR.49**
WAKE COUNTY
 BRIDGE NO. **910240**

SHEET 10 OF 12

STATE OF NORTH CAROLINA
 DEPARTMENT OF TRANSPORTATION
 RALEIGH
SUBSTRUCTURE REPAIRS
BENT 5

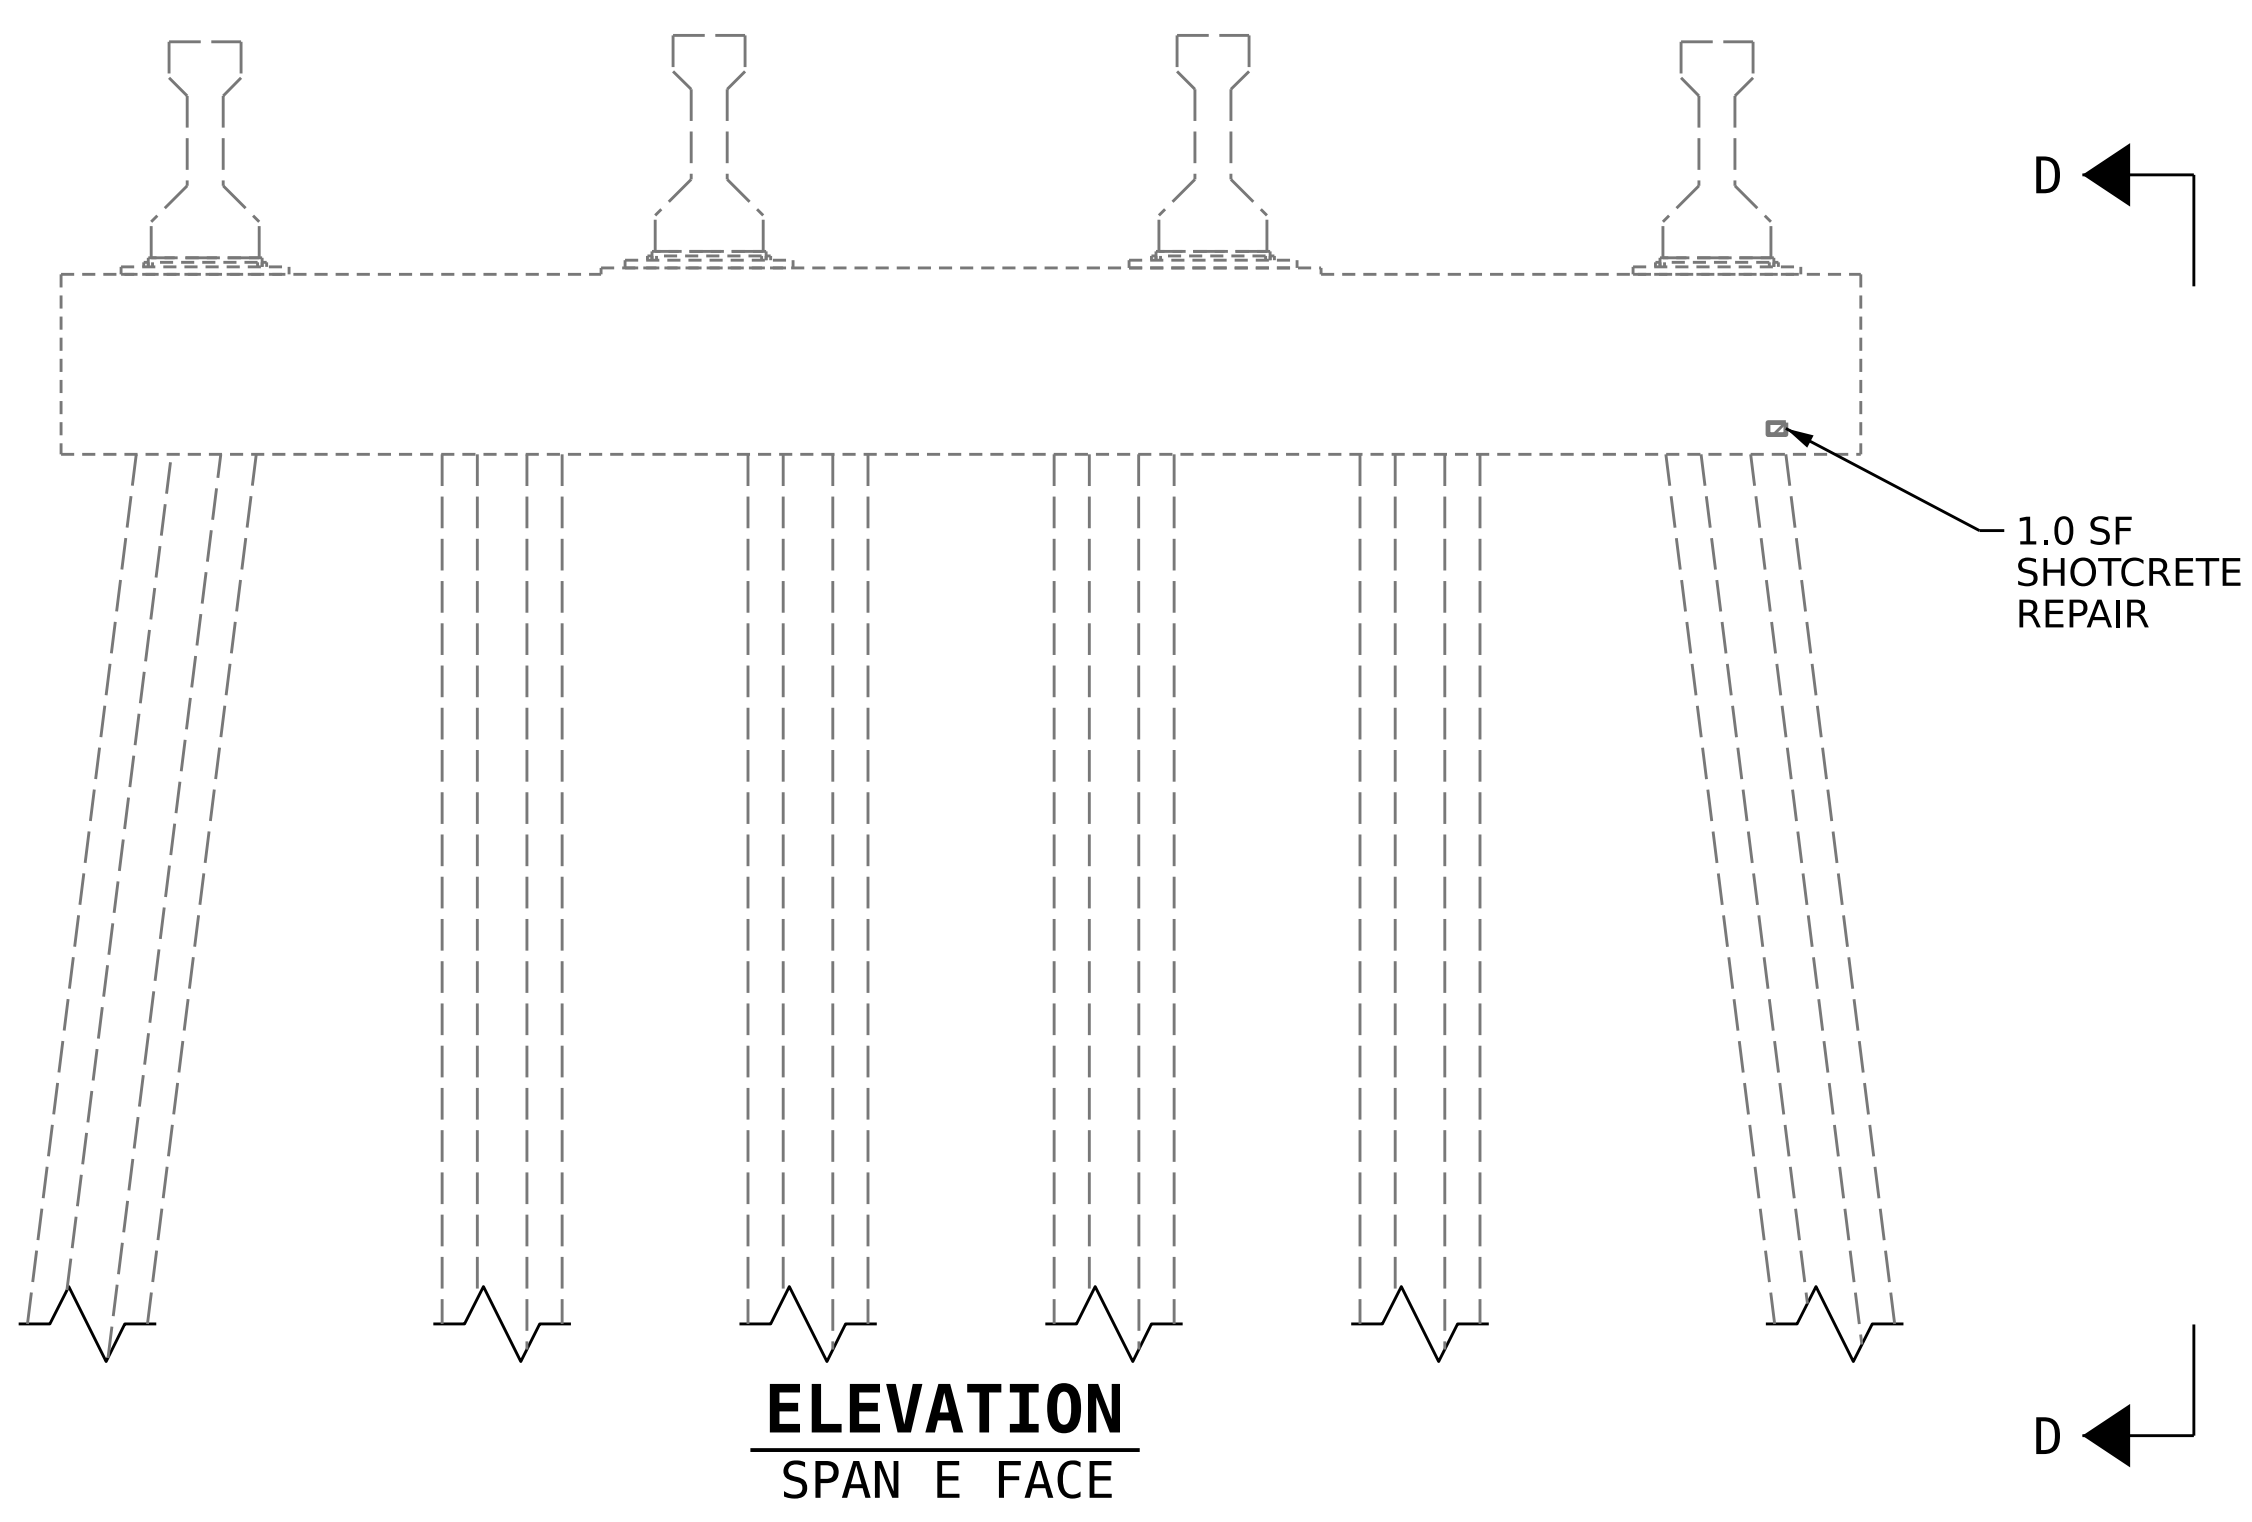
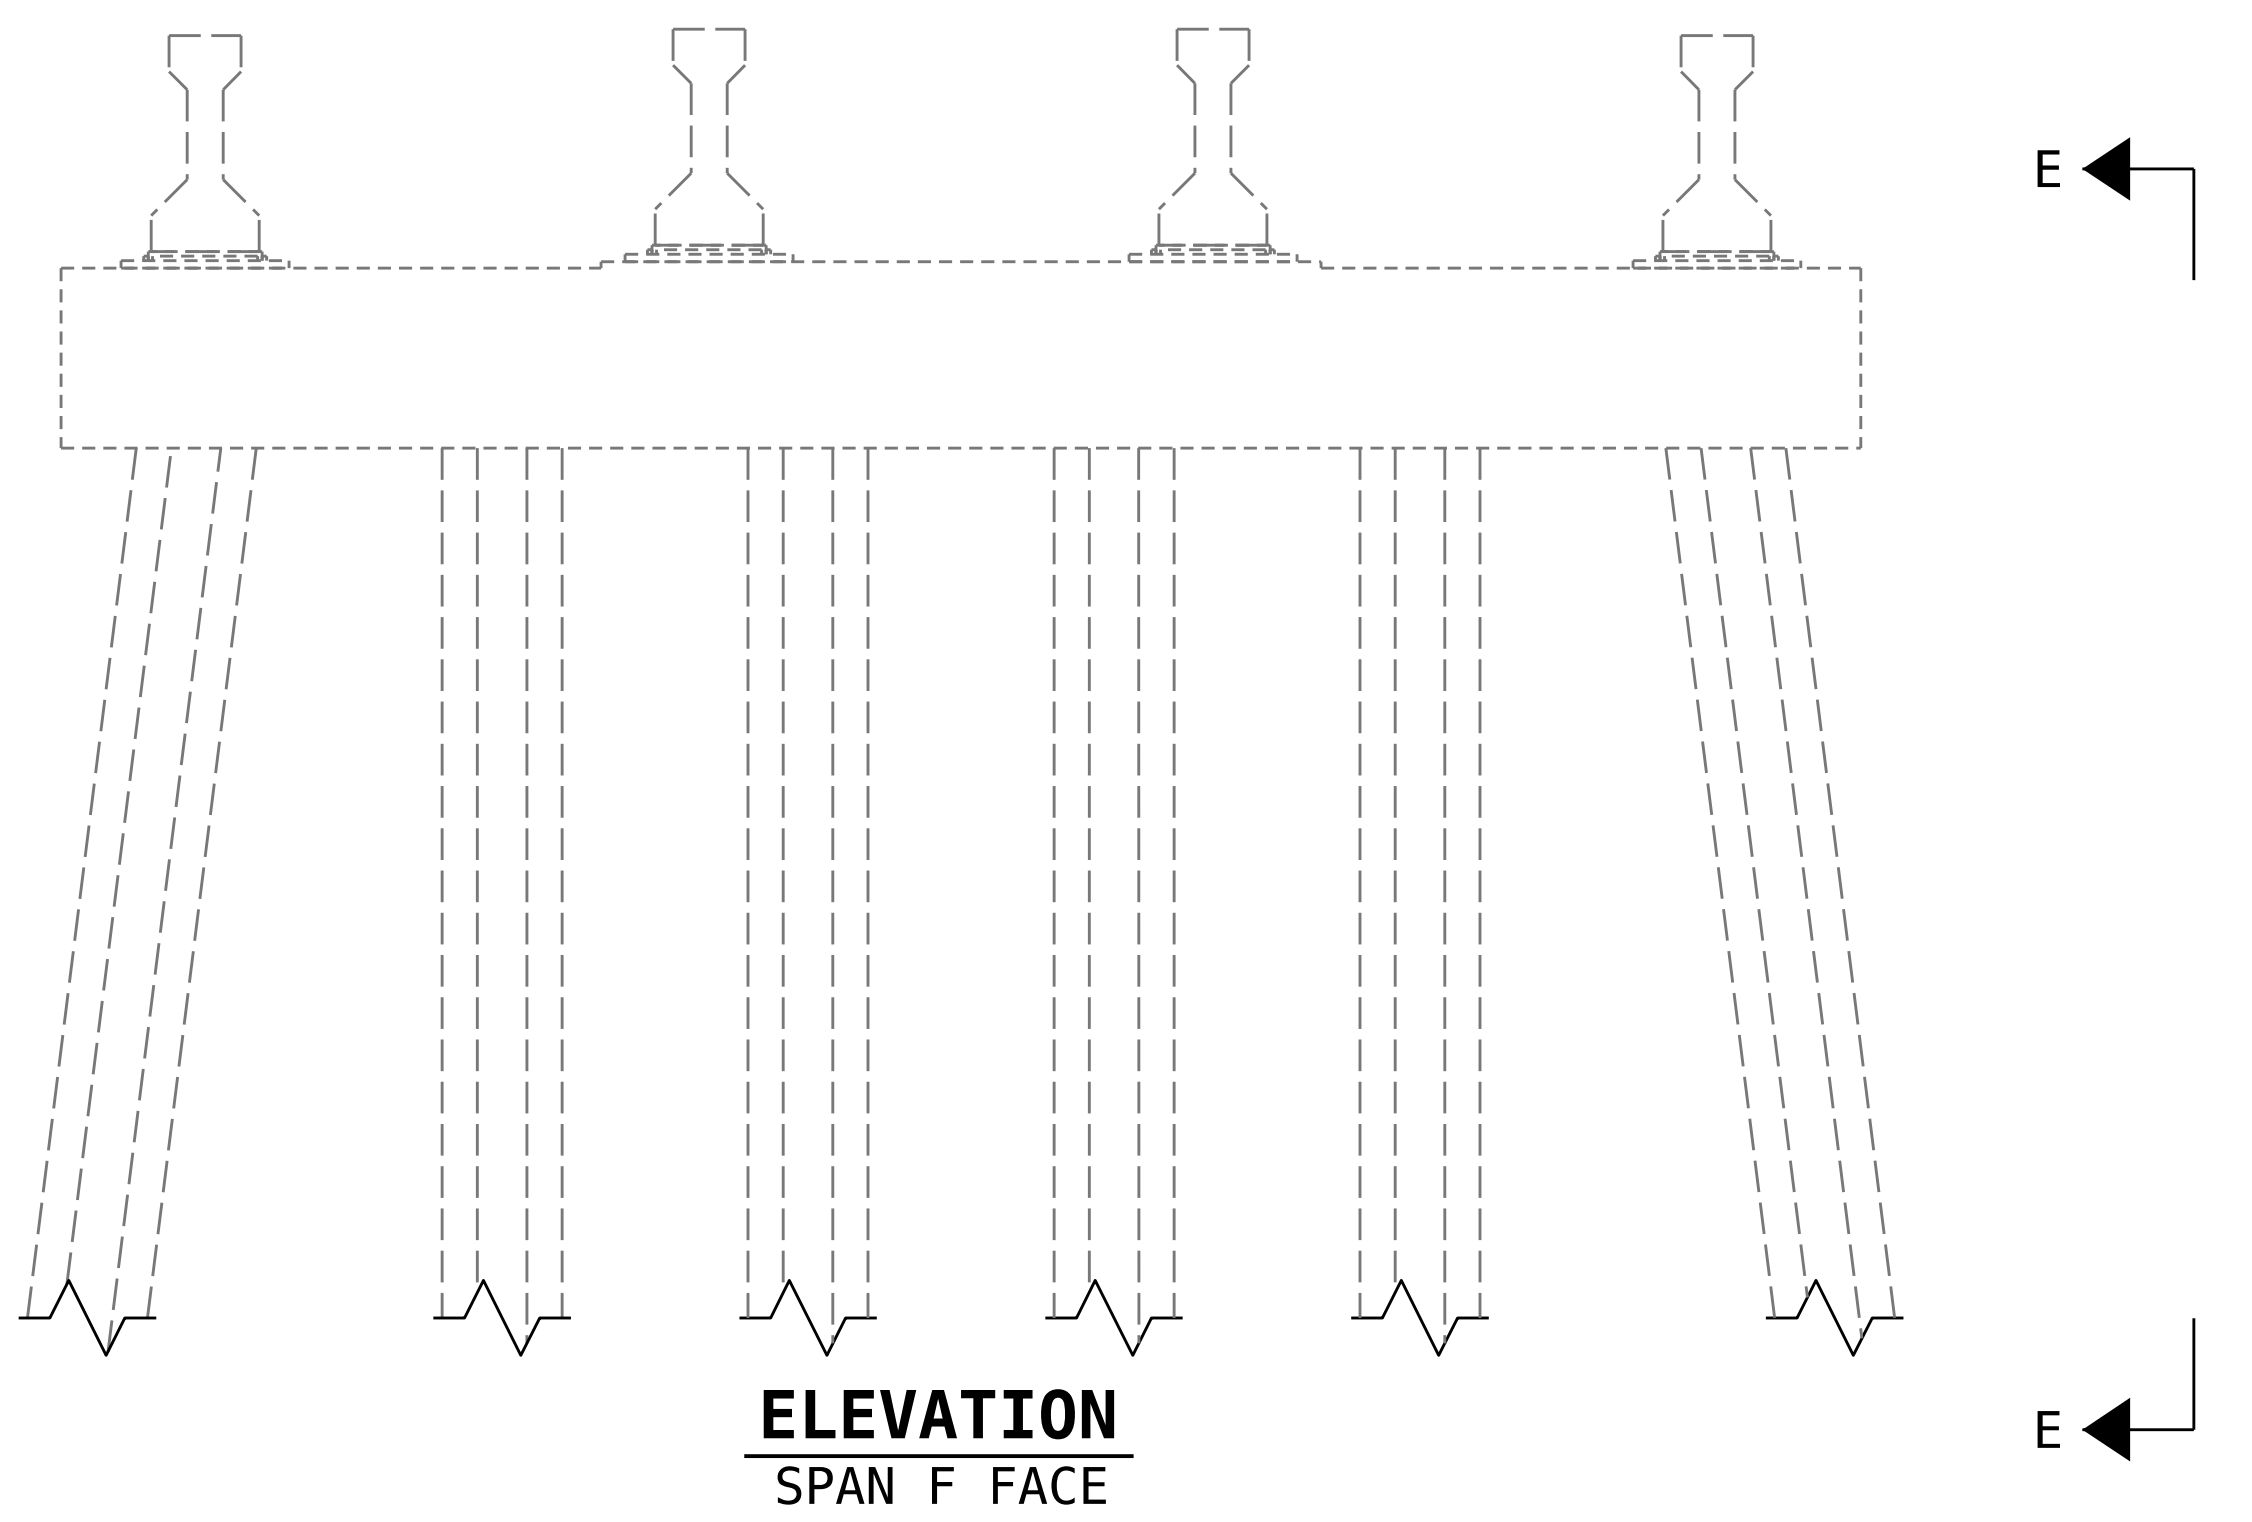
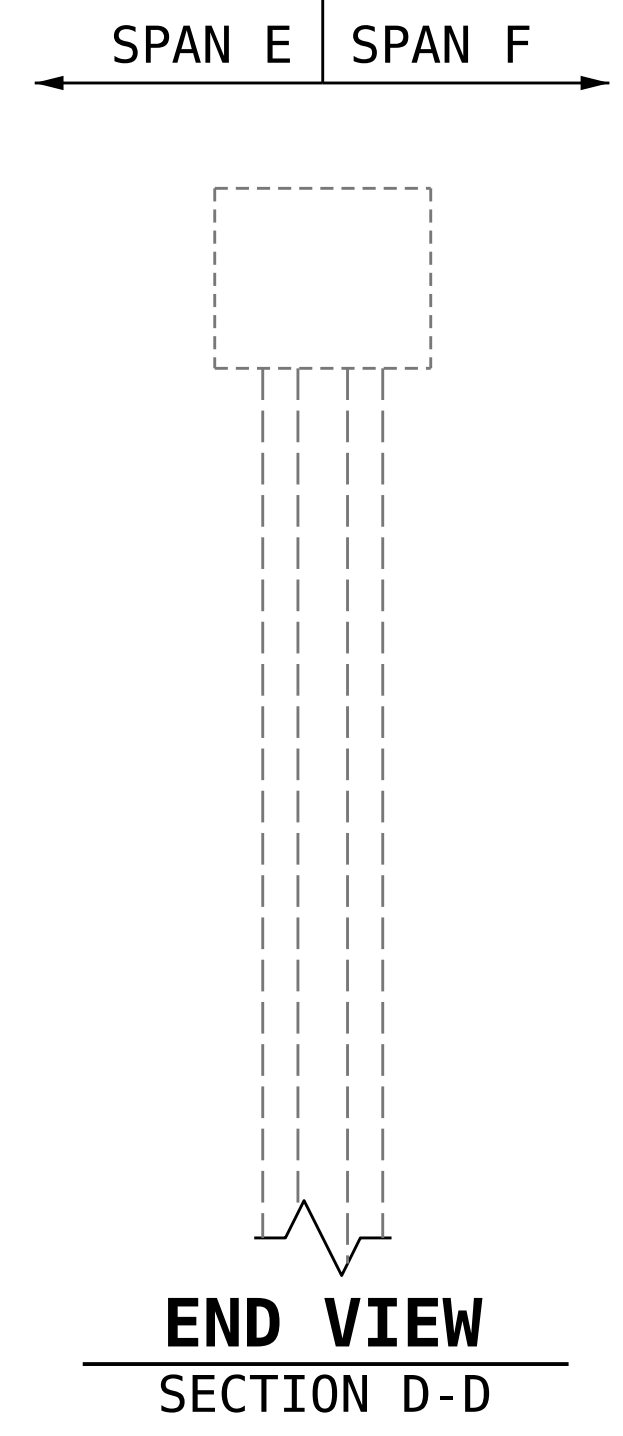
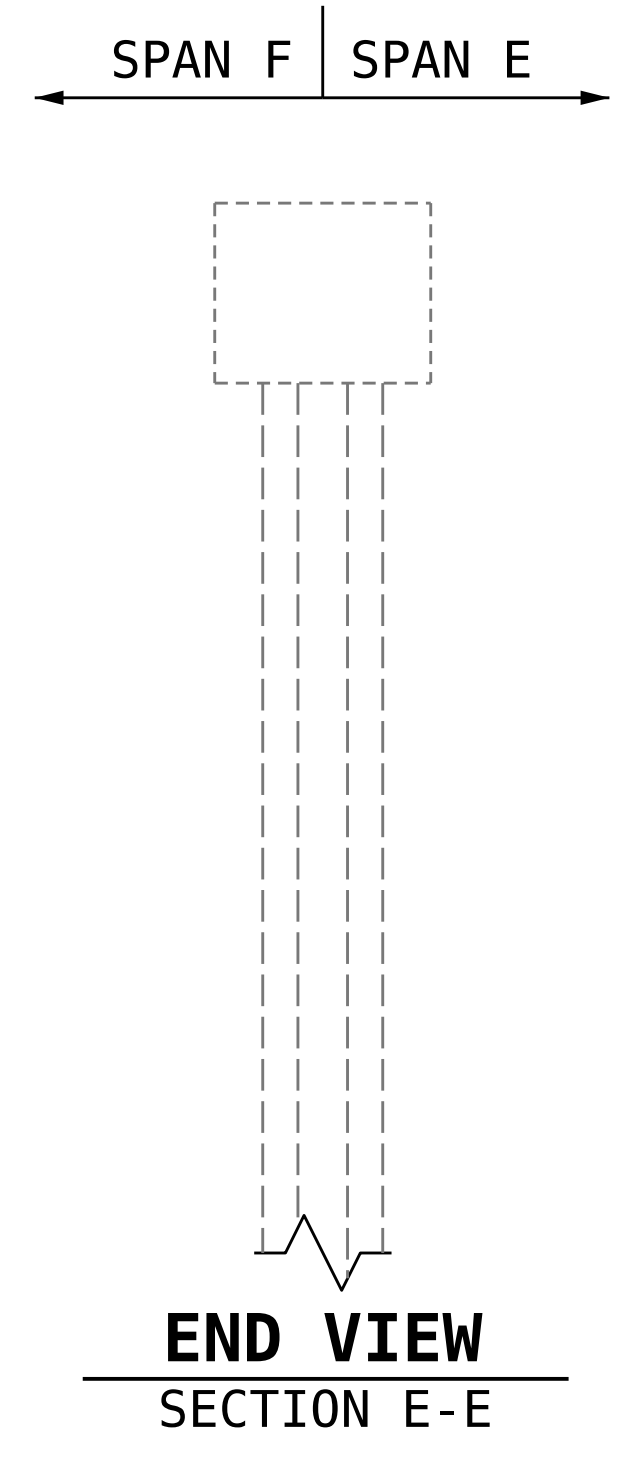
VALUES IN CHART REPRESENT ESTIMATED REPAIR TOTALS AFTER REMOVAL OF UNSOUND CONCRETE, MIN. OF 1" BEHIND REBAR AND MIN. 1" CLEAR TO SAWCUT. SEE REPAIR DETAILS.

CLEAN AND REMOVE DEBRIS FROM THE TOP OF THE CAP AND APPLY EPOXY PROTECTIVE COATING. EPOXY COATING SHALL BE APPLIED TO THE TOP SURFACE OF THE CAP. THE CONTRACTOR SHALL NOT COAT THE AREA OF THE CAP BENEATH THE MASONRY PLATES. FOR EPOXY COATING, SEE SPECIAL PROVISIONS.

CONCRETE REPAIRS MAYBE SUBSTITUTED IN LIEU OF SHOTCRETE REPAIRS WITH THE APPROVAL OF THE ENGINEER.
