PROJECT NO. 15BPR.56
BEAUFORT COUNTY
 BRIDGE NO. 060027

STATE OF NORTH CAROLINA
 DEPARTMENT OF TRANSPORTATION
 RALEIGH
SUPERSTRUCTURE
DECK SURFACE REPAIR

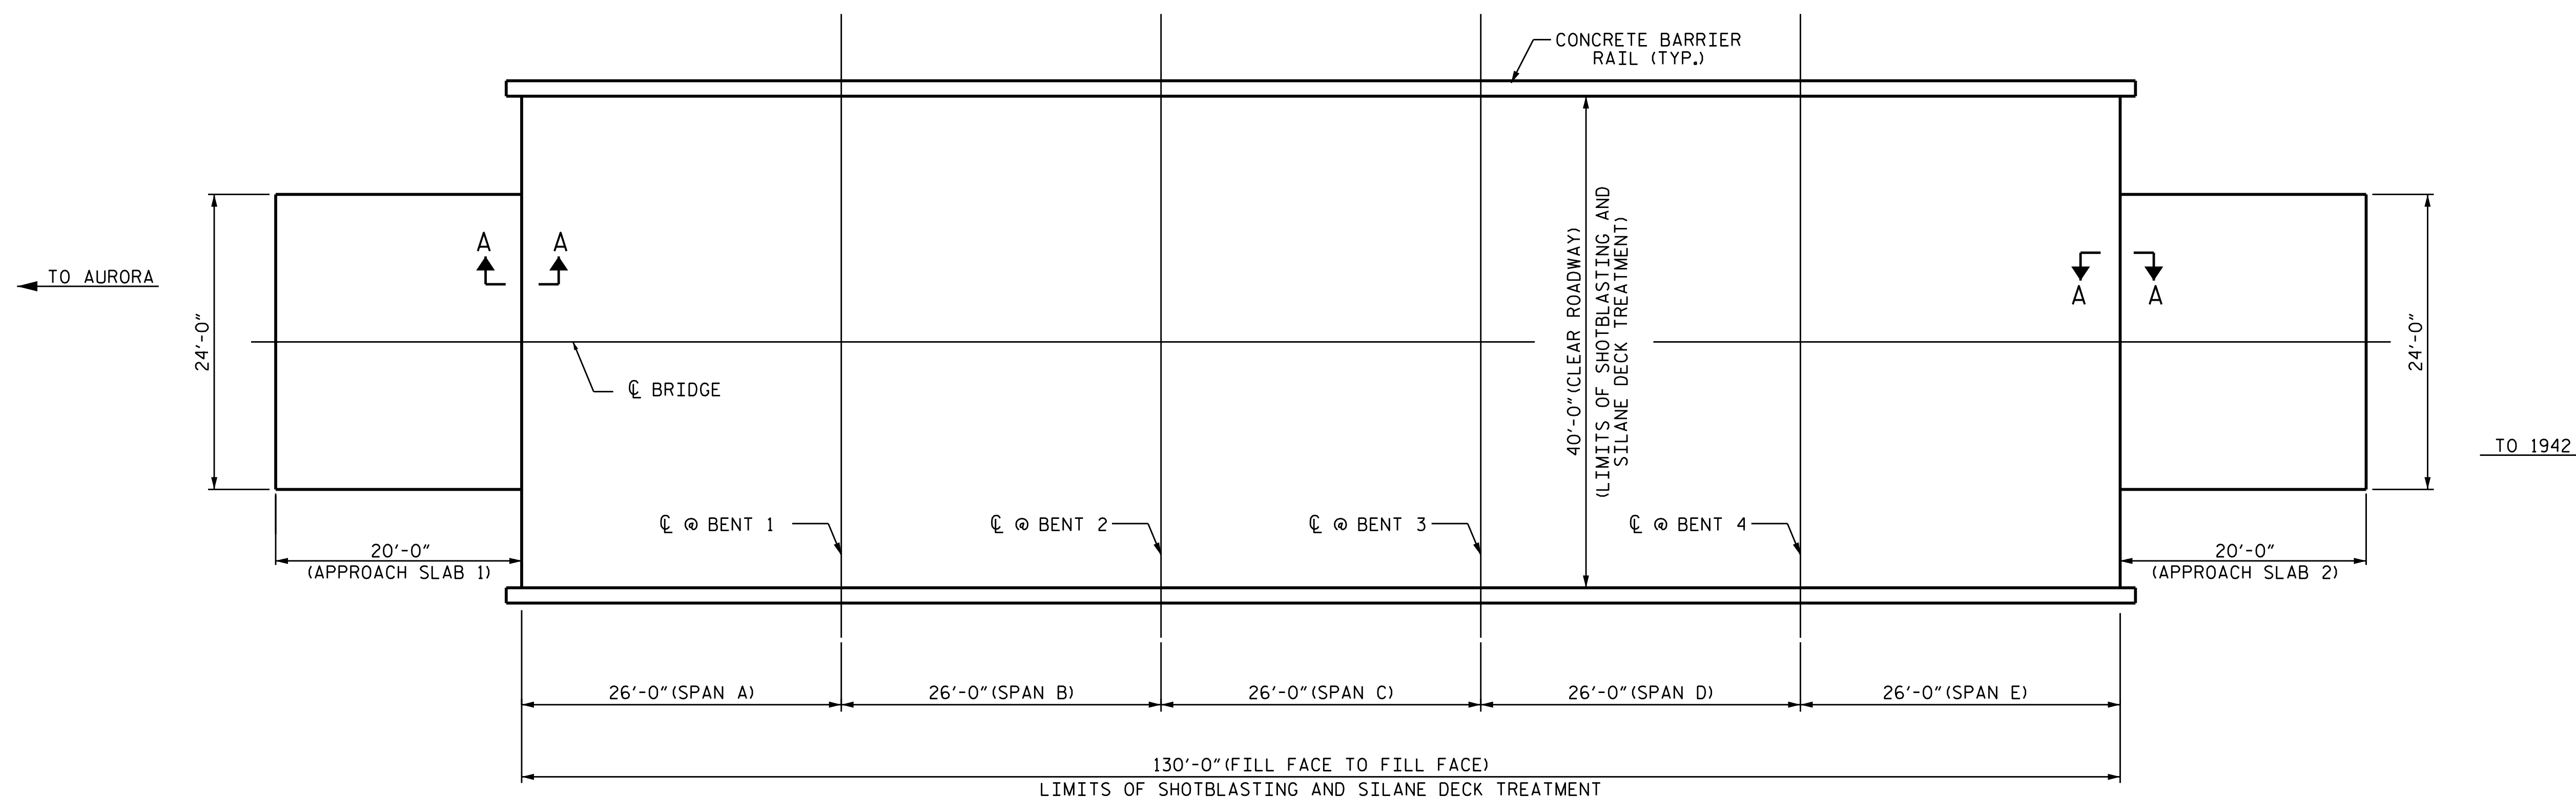
PLAN
(SPANS A THRU E AND APPROACH SLABS)

FOR SECTION A-A, SEE "JOINT REPAIR DETAILS" SHEET.

NO REPAIRS ARE PROPOSED FOR THE APPROACH SLABS.
