AS-BUILT REPAIR QUANTITY TABLE

DECK SURFACE REPAIRS - SPANS 4 THROUGH 7

PROJECT NO. 15BPR.56
BEAUFORT COUNTY
 BRIDGE NO. 060077

SUPERSTRUCTURE
 PLAN OF SPANS

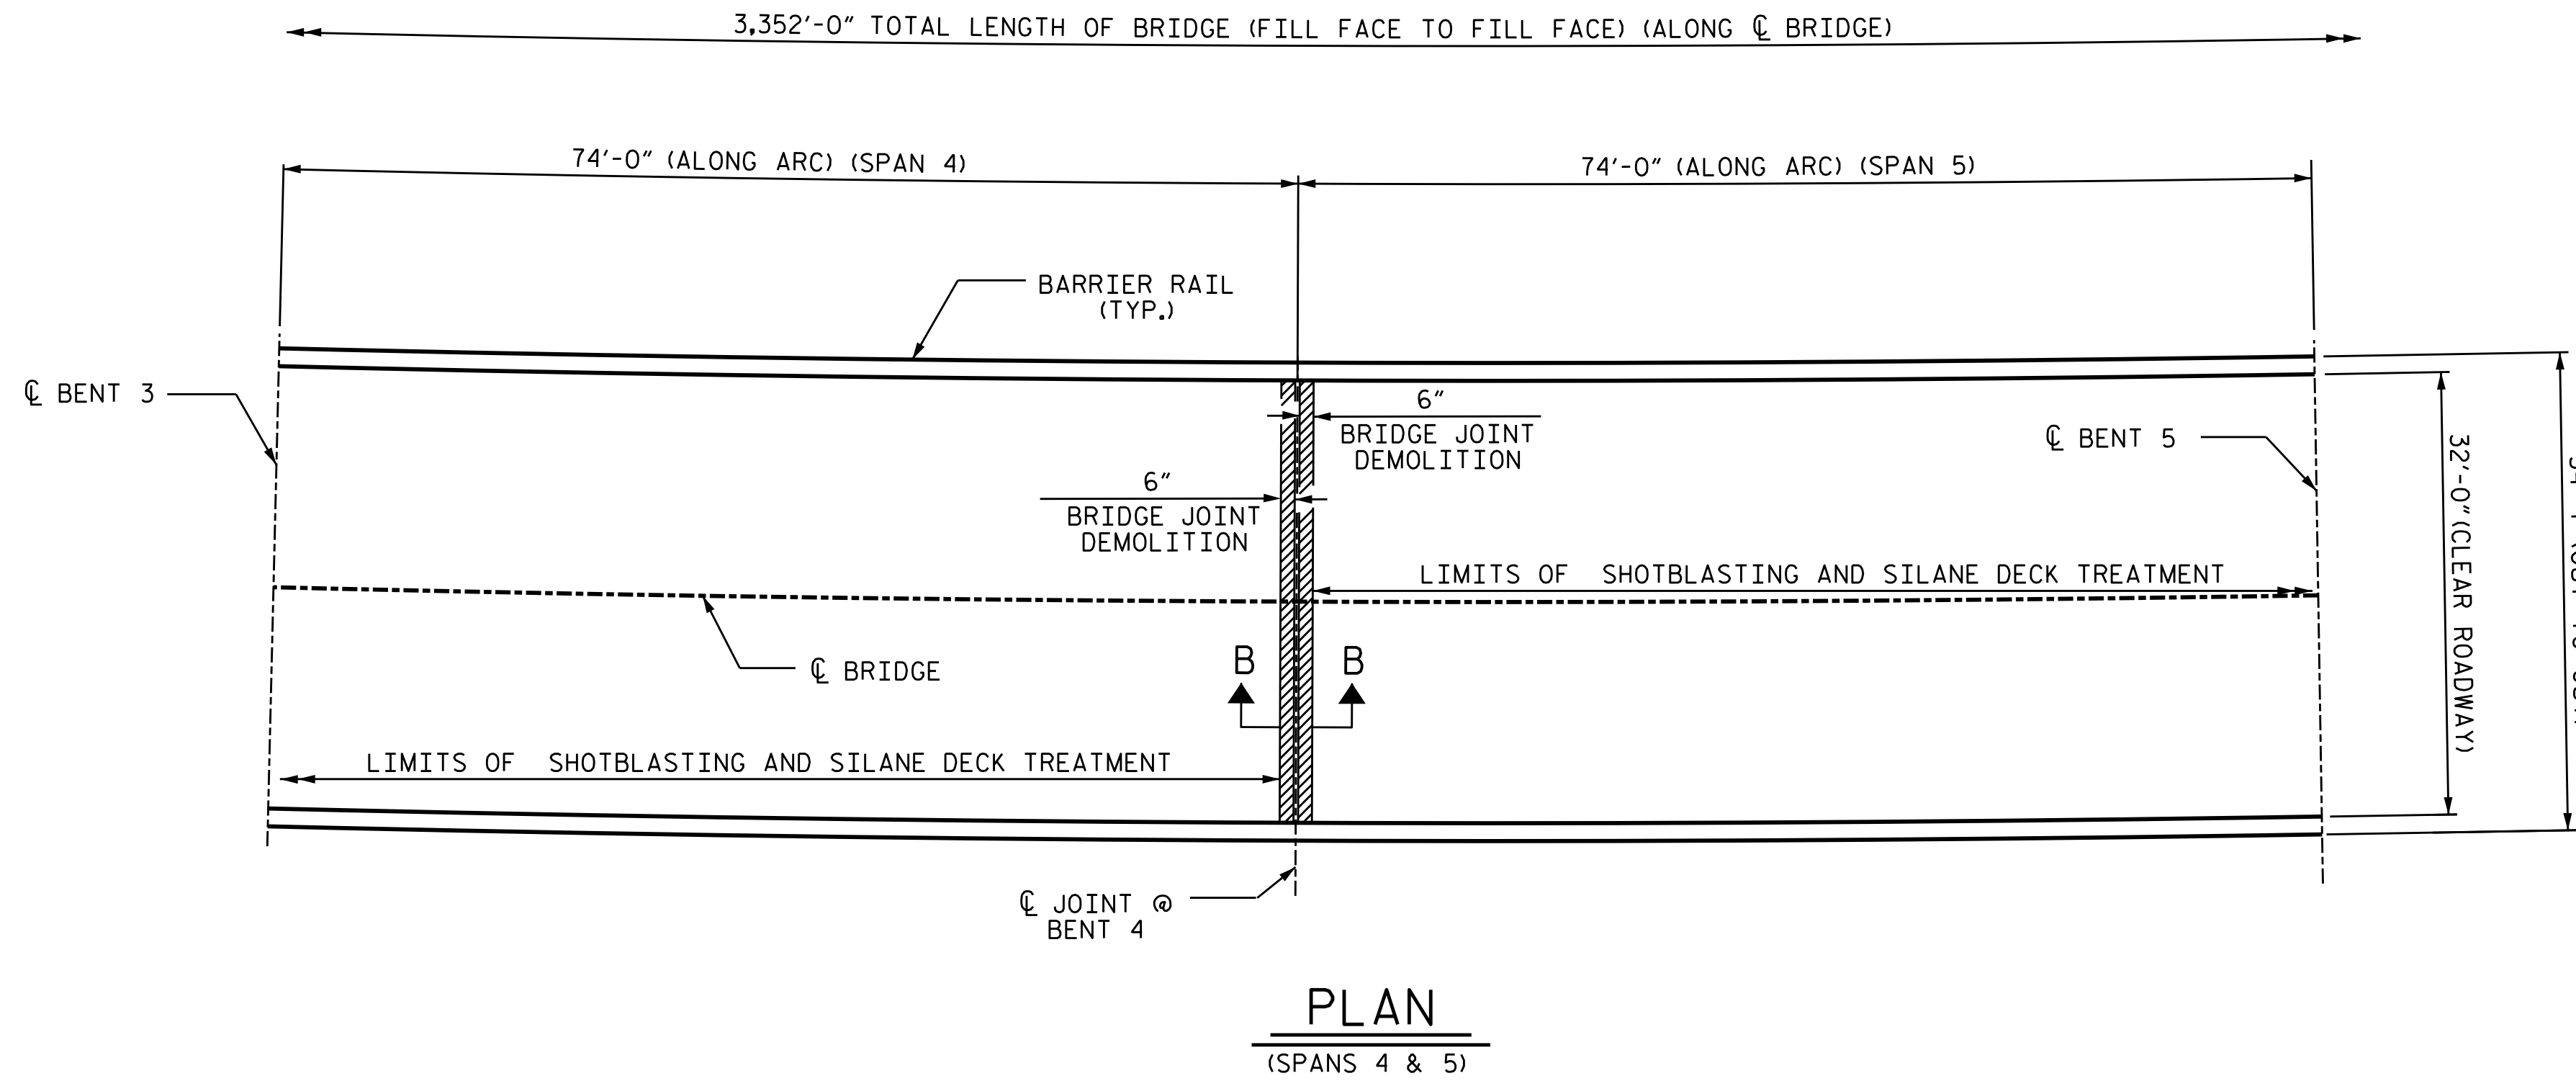
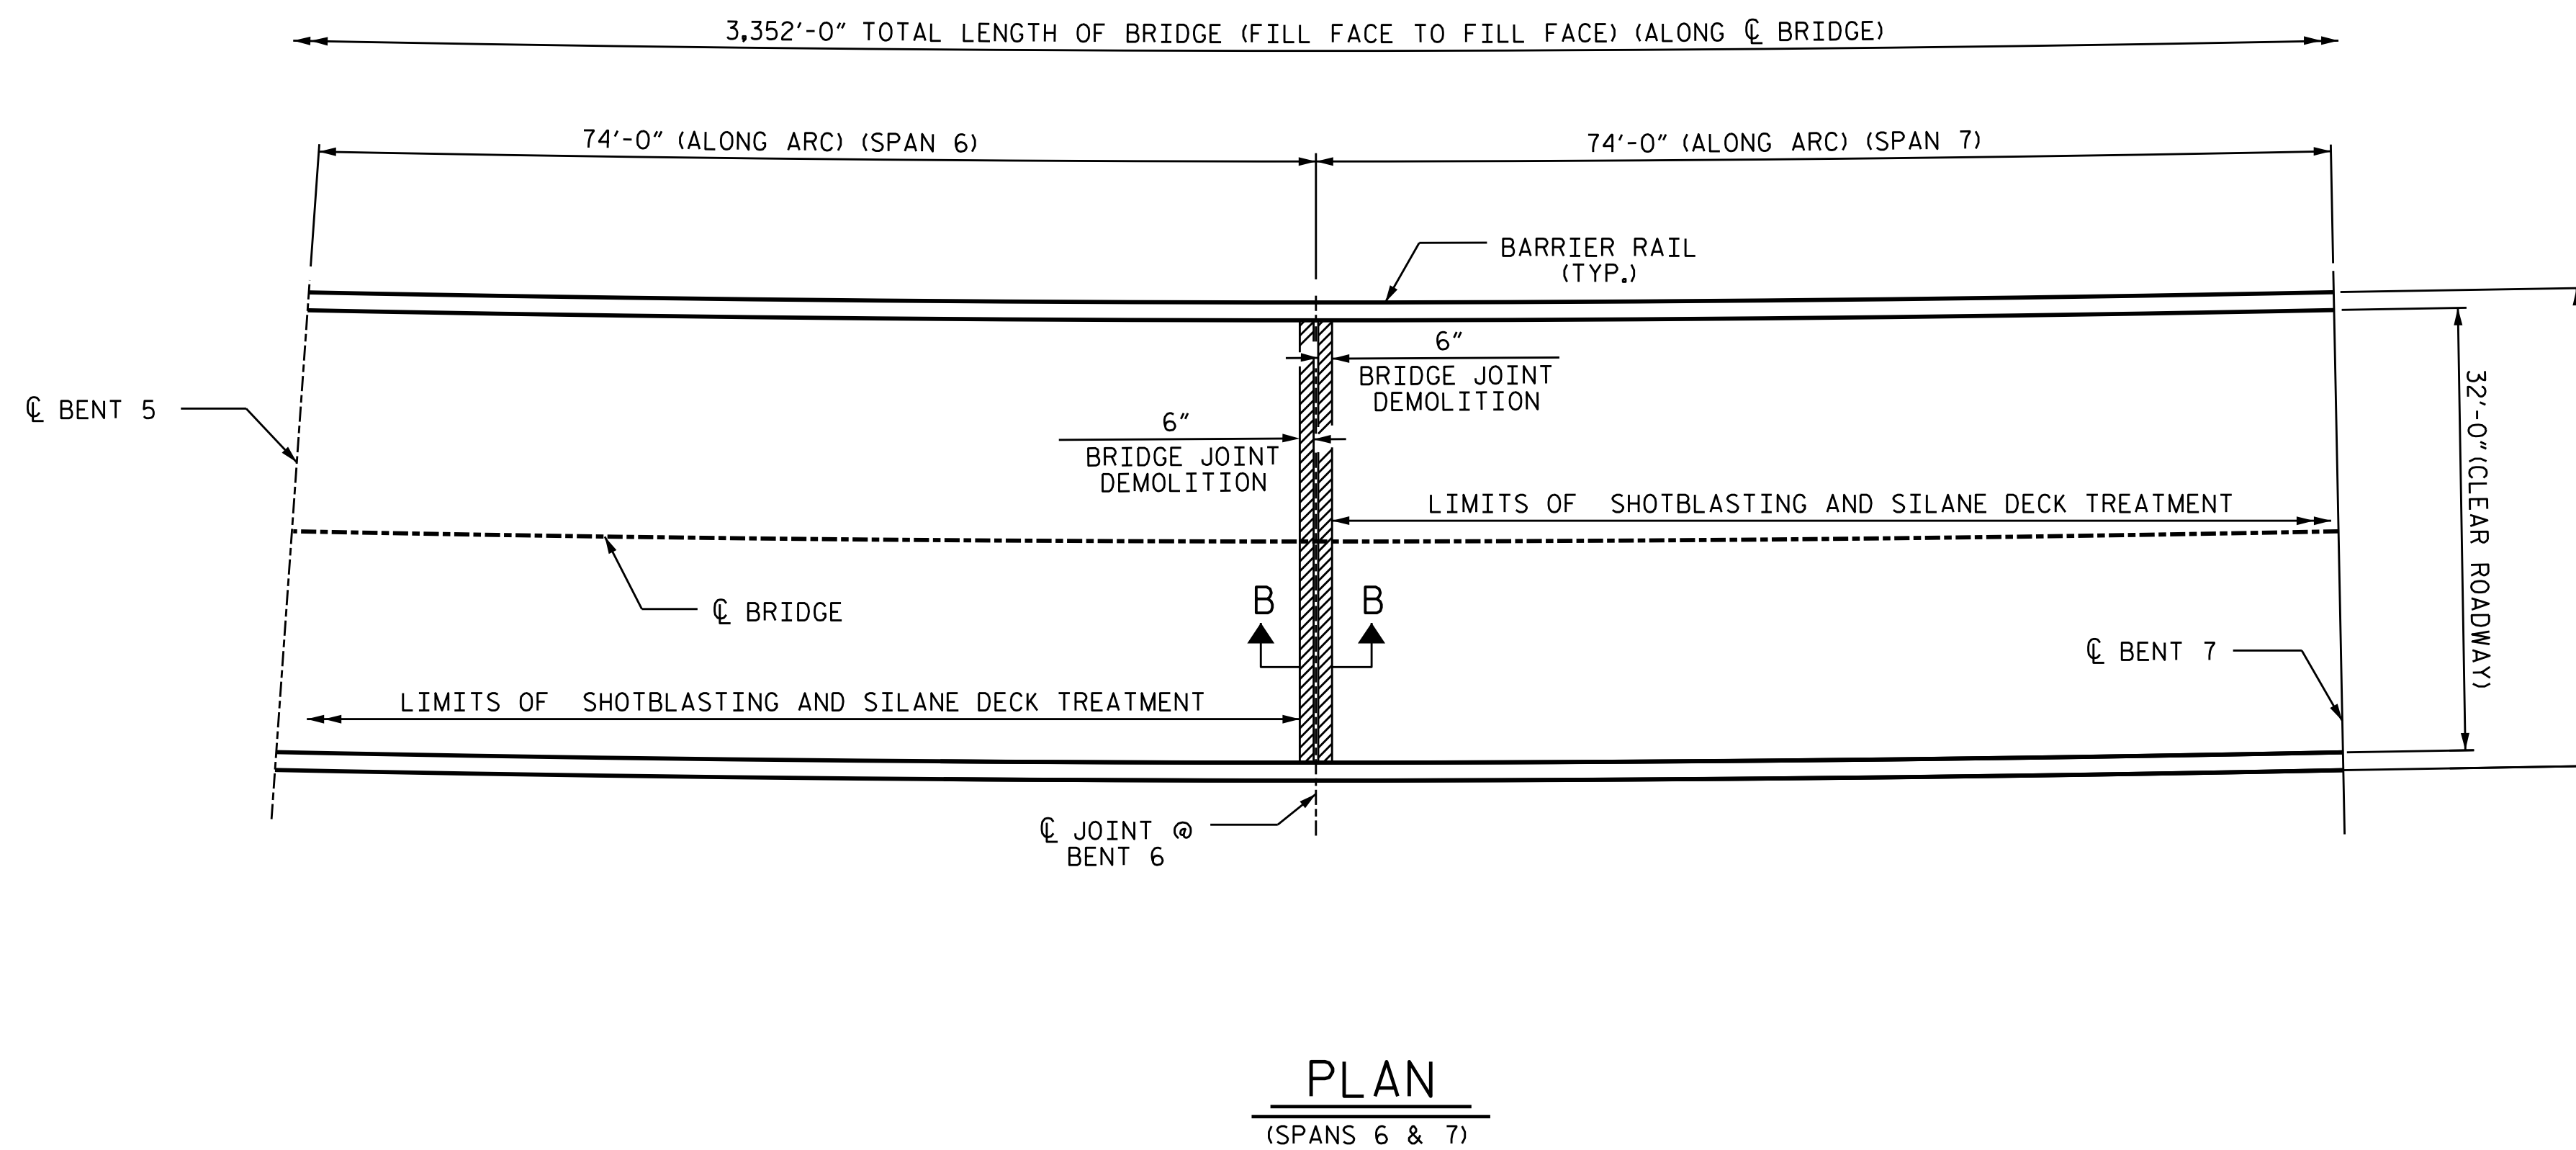
- SHOTBLASTING AND SILANE DECK TREATMENT AREA
- ERI - EPOXY RESIN INJECTION
- BRIDGE JOINT DEMOLITION

ESTIMATE	ACTUAL
SHOTBLASTING BRIDGE DECK	1,045.3 SQ. YDS.	
SILANE DECK TREATMENT	1,045.3 SQ. YDS.	
CONCRETE DECK REPAIR FOR SILANE DECK TREATMENT	0.0 SQ. FT.

ESTIMATE	ACTUAL
EPOXY RESIN INJECTION	0.0 LIN. FT.

ESTIMATE	ACTUAL
BRIDGE JOINT DEMOLITION	64.0 SQ. FT.
