SEAL 7 26445 PROJECT NO. 15BPR.56

BRIDGE NO. 060077

SUPERSTRUCTURE

PLAN OF SPANS

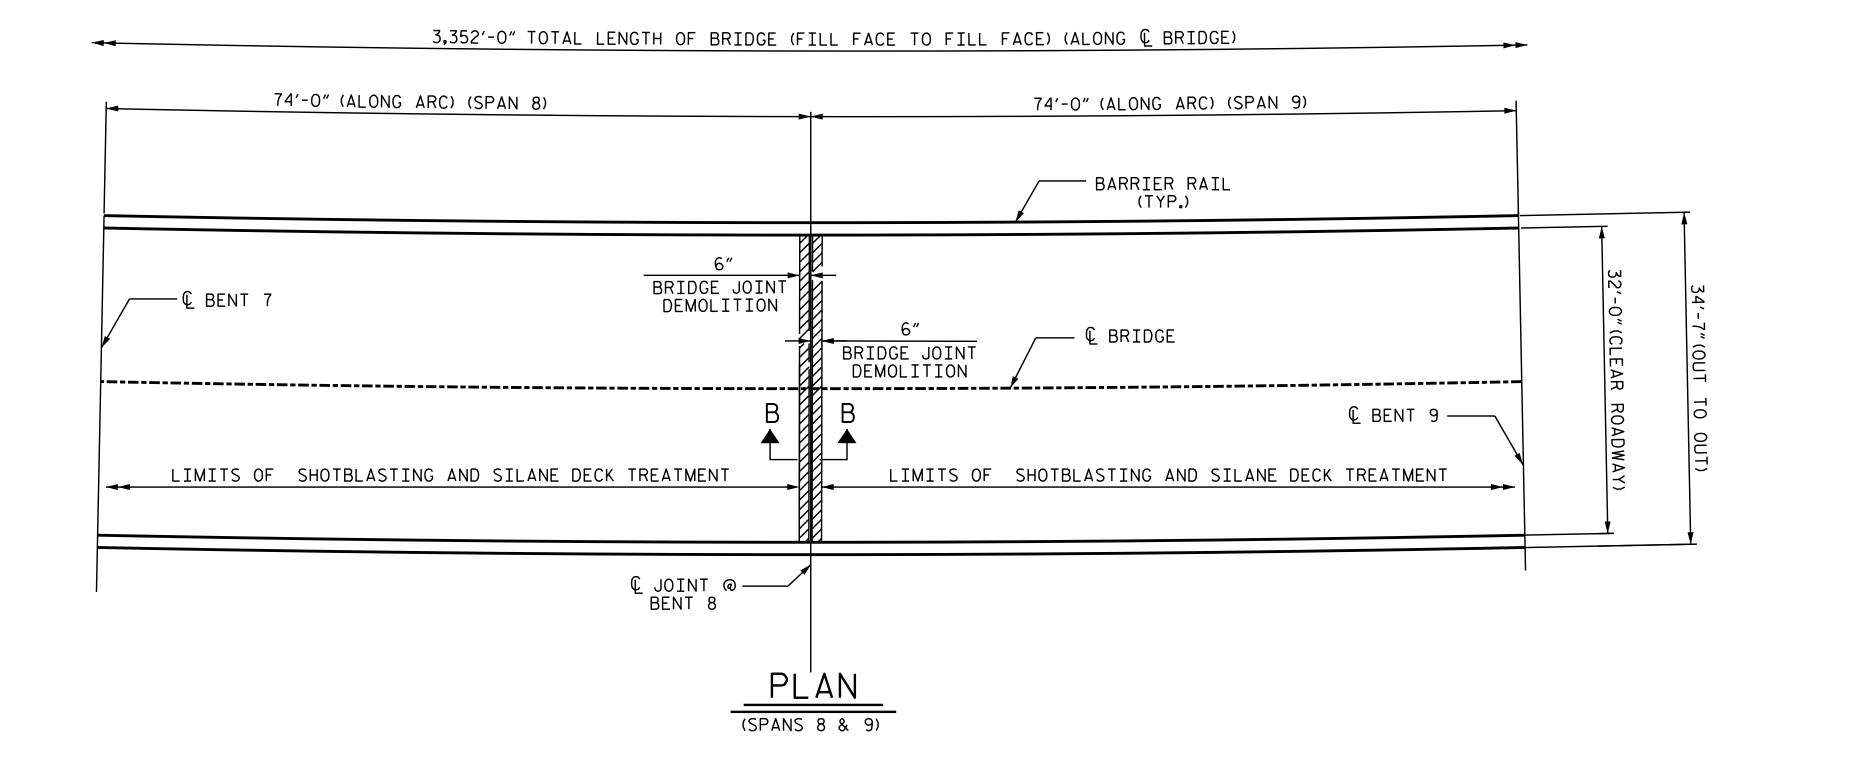
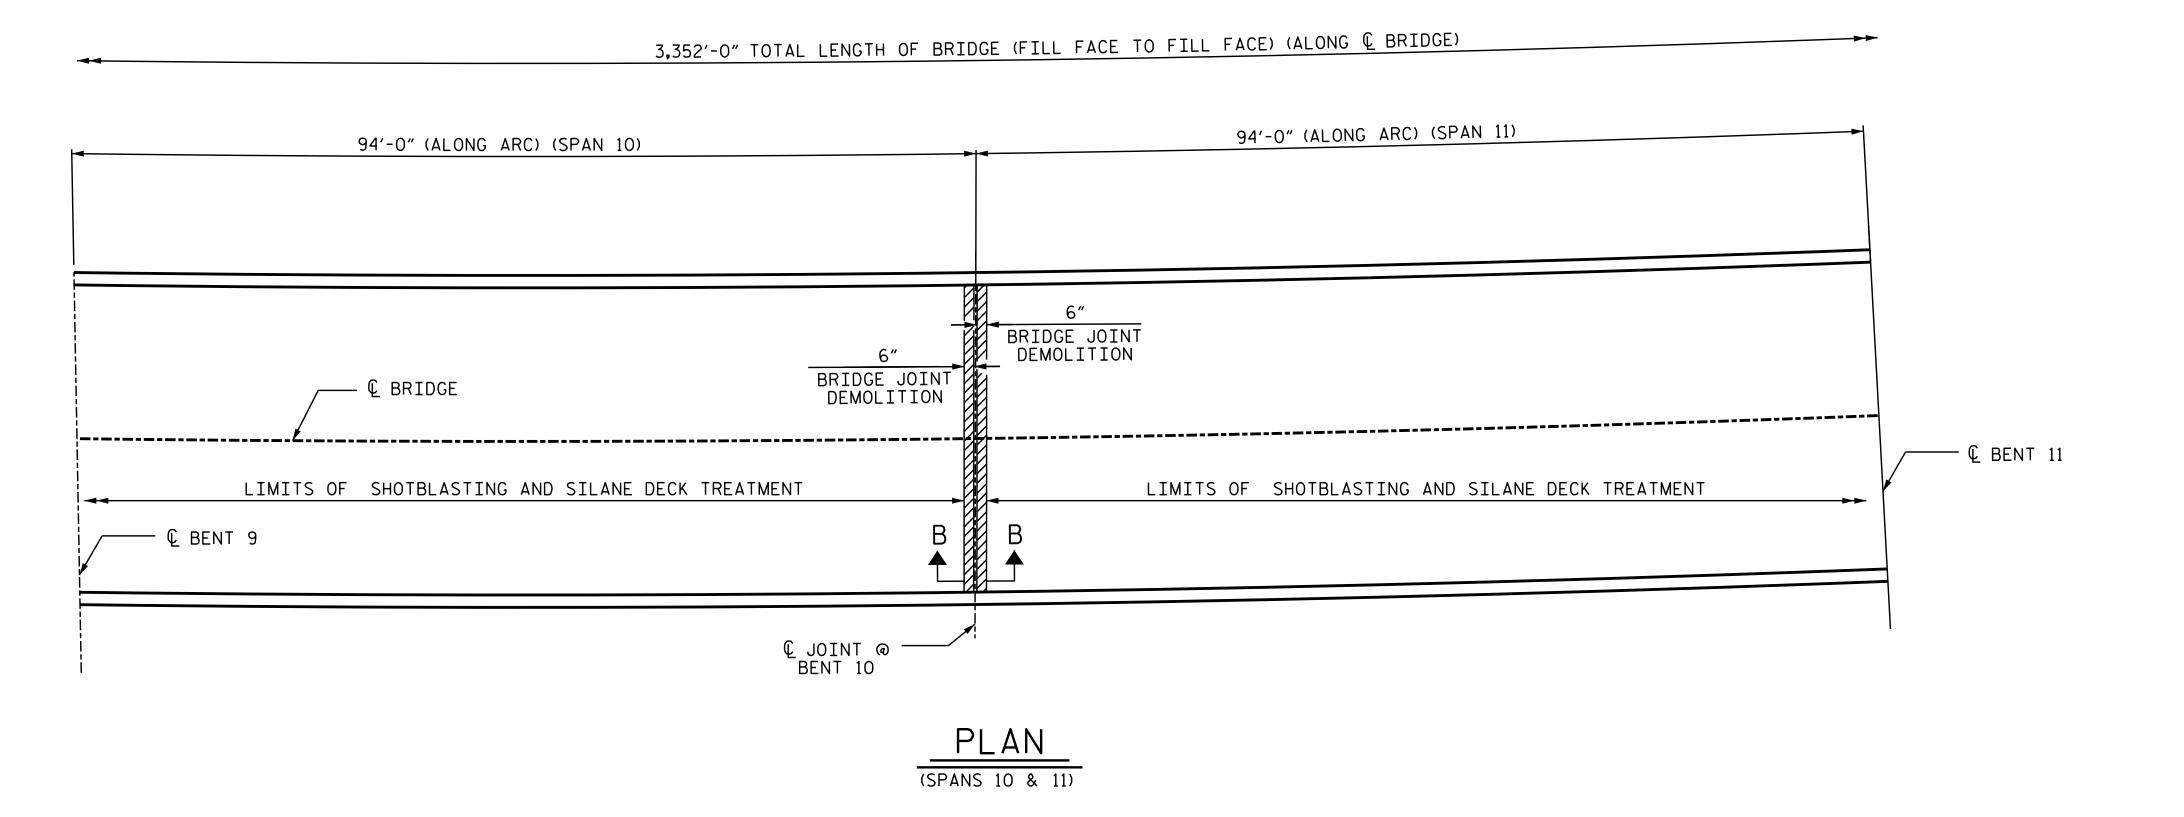
AS-BUILT REPAIR QUANTITY TABLE DECK SURFACE REPAIRS - SPANS 8 THROUGH 11 ESTIMATE ACTUAL 1,187.6 SQ. YDS. SHOTBLASTING BRIDGE DECK SILANE DECK TREATMENT 1,187.6 SQ. YDS. CONCRETE DECK REPAIR FOR SILANE DECK TREATMENT 0.0 SQ.FT. BARRIER RAIL REPAIRS ESTIMATE ACTUAL EPOXY RESIN INJECTION O.O LIN.FT. JOINT REPAIR ESTIMATE ACTUAL BRIDGE JOINT DEMOLITION 64.0 SQ.FT.

SHOTBLASTING AND SILANE DECK TREATMENT AREA

ERI - EPOXY RESIN INJECTION

BRIDGE JOINT DEMOLITION

FOR SILANE DECK TREATMENT, SEE SPECIAL PROVISIONS.

FOR CONCRETE DECK REPAIR FOR SILANE DECK TREATMENT, SEE SPECIAL PROVISIONS.

FOR SECTION B-B, SEE "JOINT REPAIR DETAILS" SHEET.

FOR EPOXY RESIN INJECTION, SEE SPECIAL PROVISIONS.

FOR BRIDGE JOINT DEMOLITION, SEE SPECIAL PROVISIONS.
