DECK SURFACE REPAIRS - SPANS 20 THROUGH 23

PROJECT NO. 15BPR.56
BEAUFORT COUNTY
 BRIDGE NO. 060077

STATE OF NORTH CAROLINA
 DEPARTMENT OF TRANSPORTATION
 RALEIGH
**SUPERSTRUCTURE
 PLAN OF SPANS**

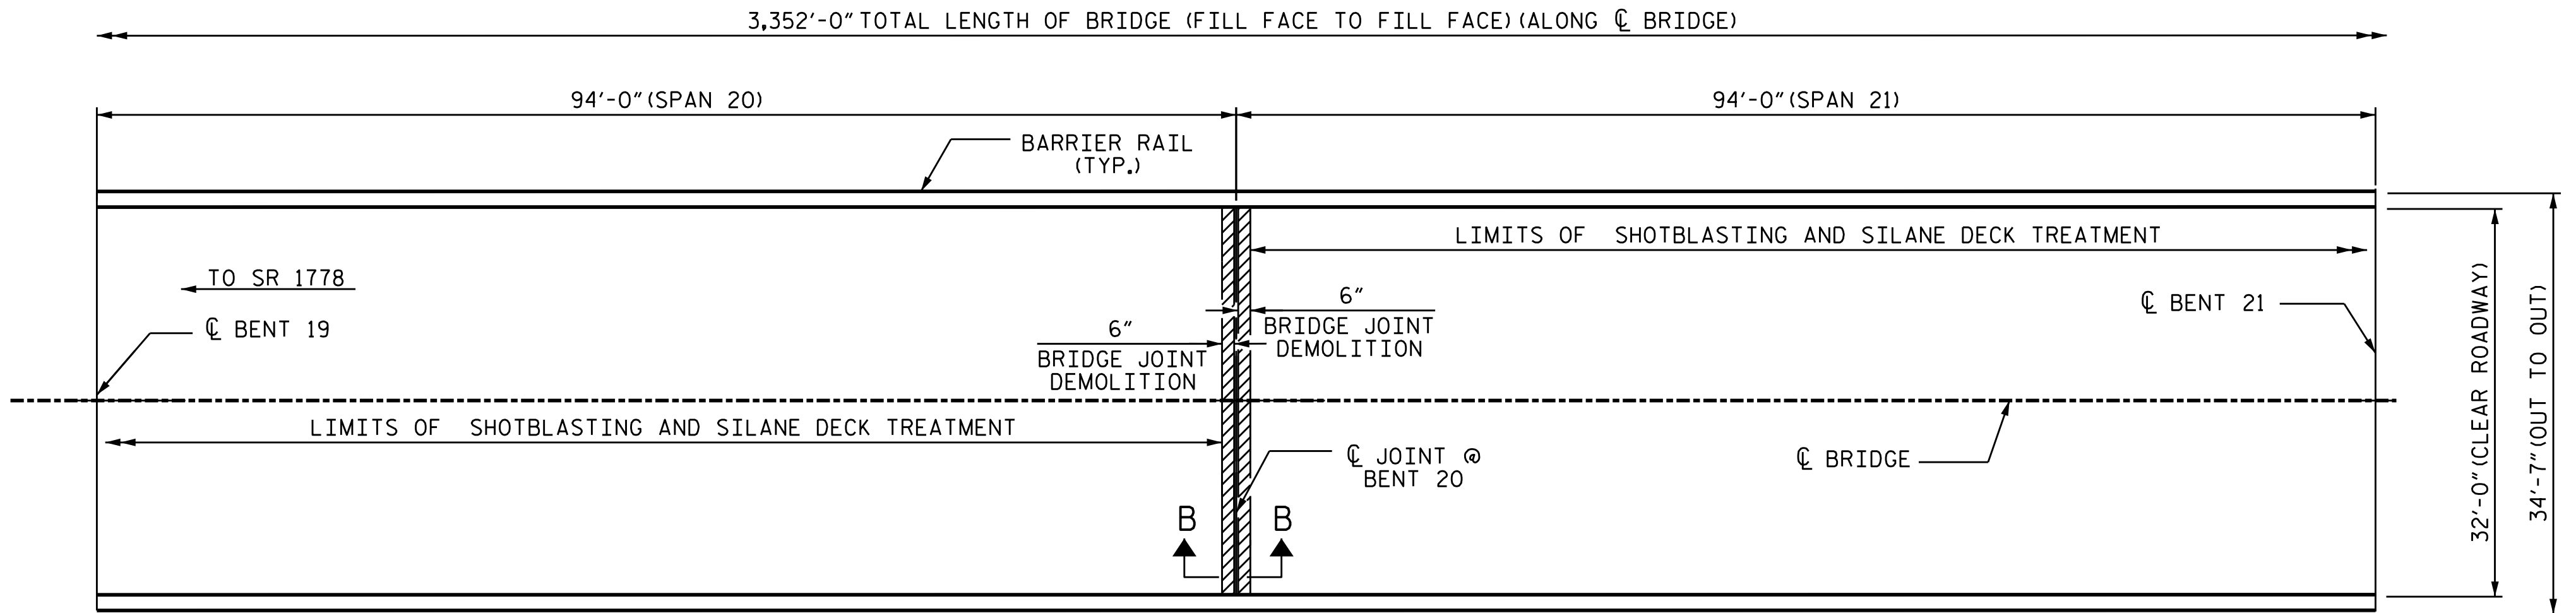
PLAN
(SPANS 20 & 21)

- SHOTBLASTING AND SILANE DECK TREATMENT AREA
- ERI - EPOXY RESIN INJECTION
- BRIDGE JOINT DEMOLITION
