PROJECT NO. 15BPR.56
BEAUFORT COUNTY
 BRIDGE NO. 060077
 SHEET 7 OF 10

STATE OF NORTH CAROLINA
 DEPARTMENT OF TRANSPORTATION
 RALEIGH

**SUPERSTRUCTURE
 PLAN OF SPANS**

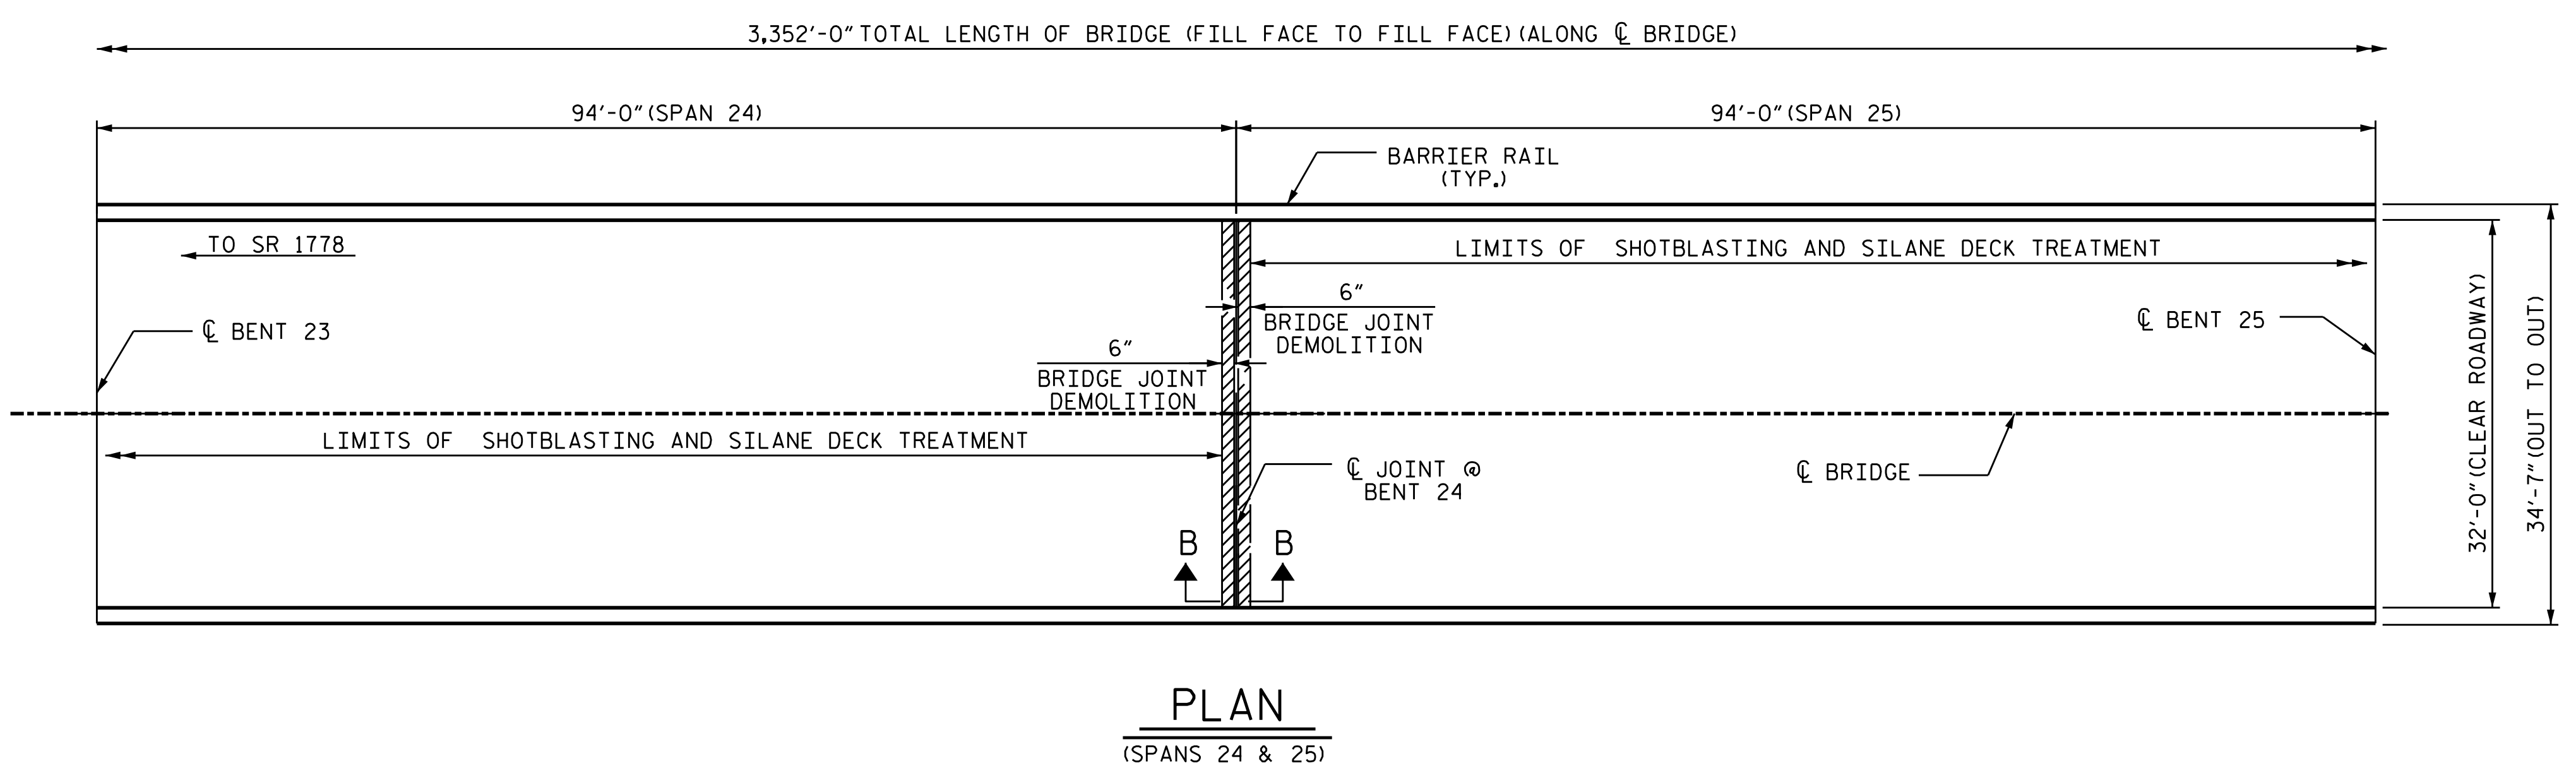
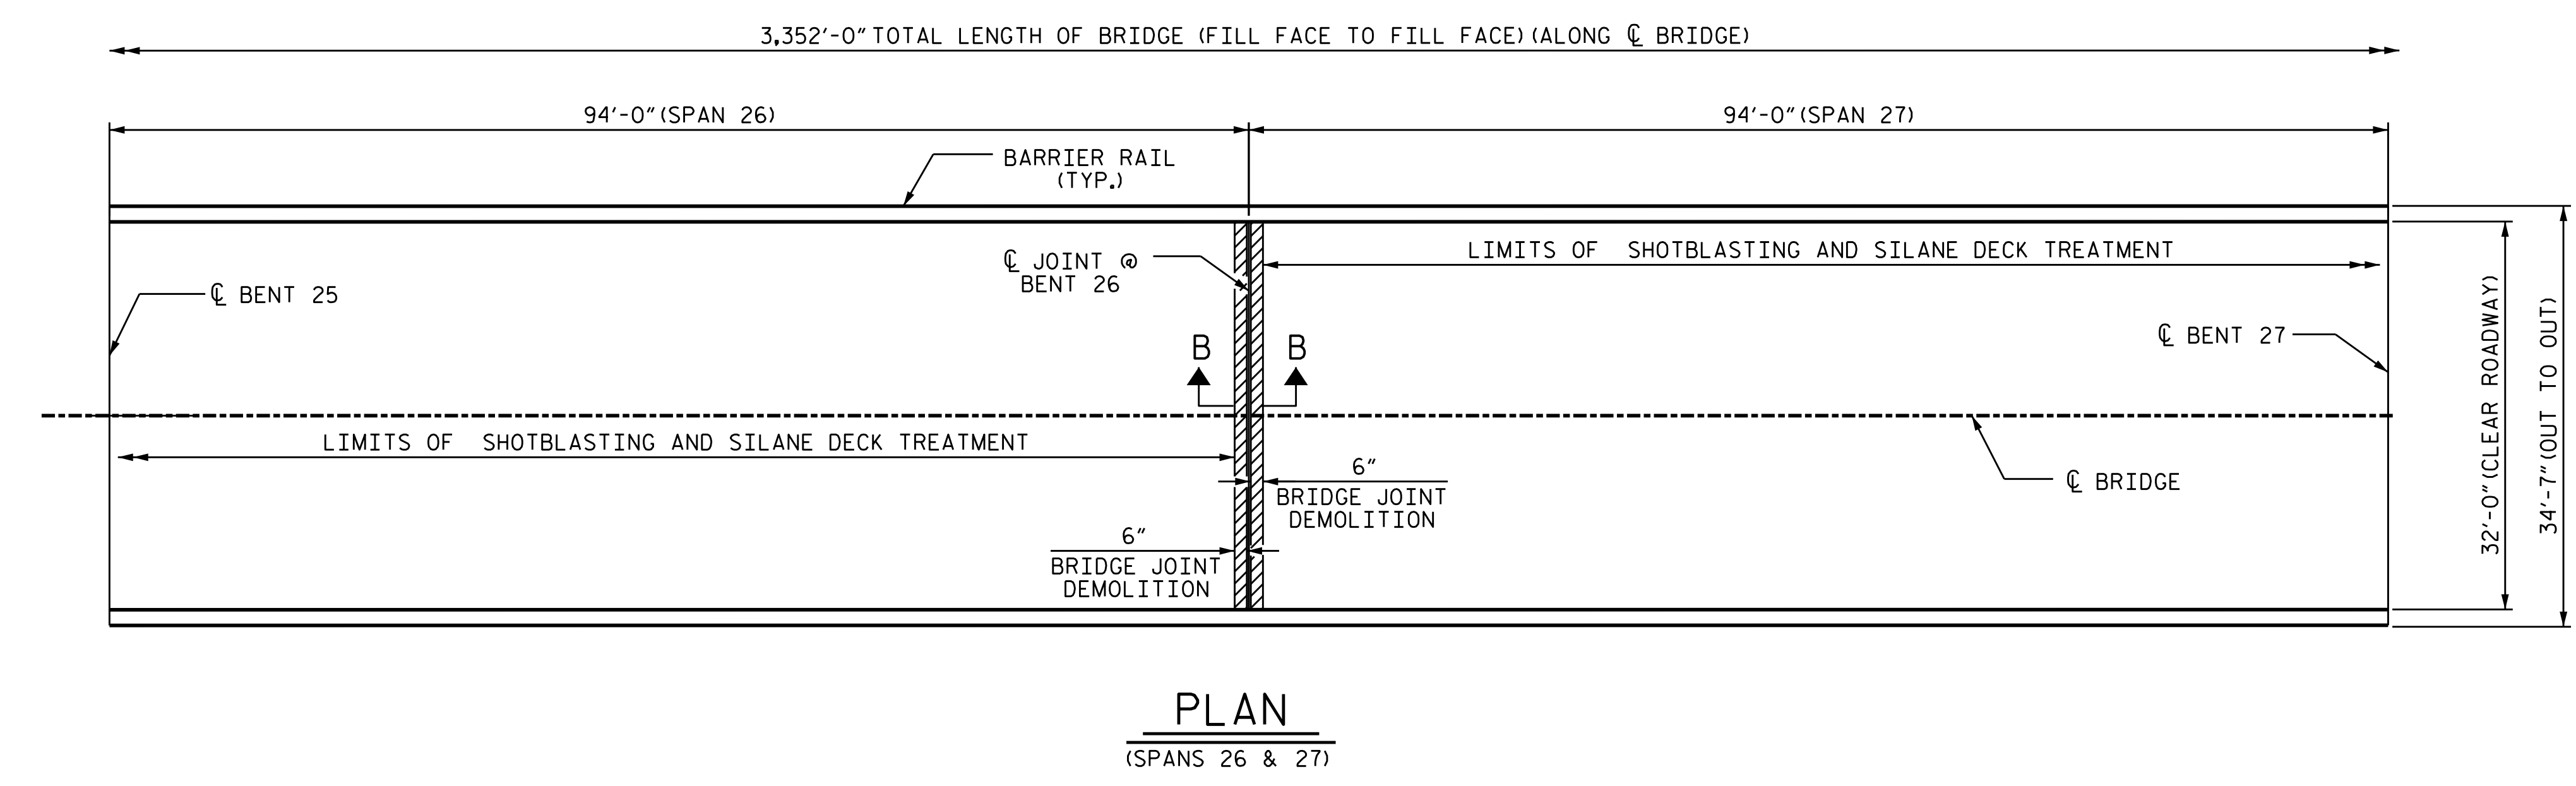
SHOTBLASTING AND SILANE DECK TREATMENT AREA
-

ERI - EPOXY RESIN INJECTION
-

BRIDGE JOINT DEMOLITION
