AS-BUILT REPAIR QUANTITY TABLE

DECK SURFACE REPAIRS - SPANS 28 THROUGH 31

PROJECT NO. 15BPR.56
BEAUFORT COUNTY
 BRIDGE NO. 060077

STATE OF NORTH CAROLINA
 DEPARTMENT OF TRANSPORTATION
 RALEIGH
 SUPERSTRUCTURE
 PLAN OF SPANS

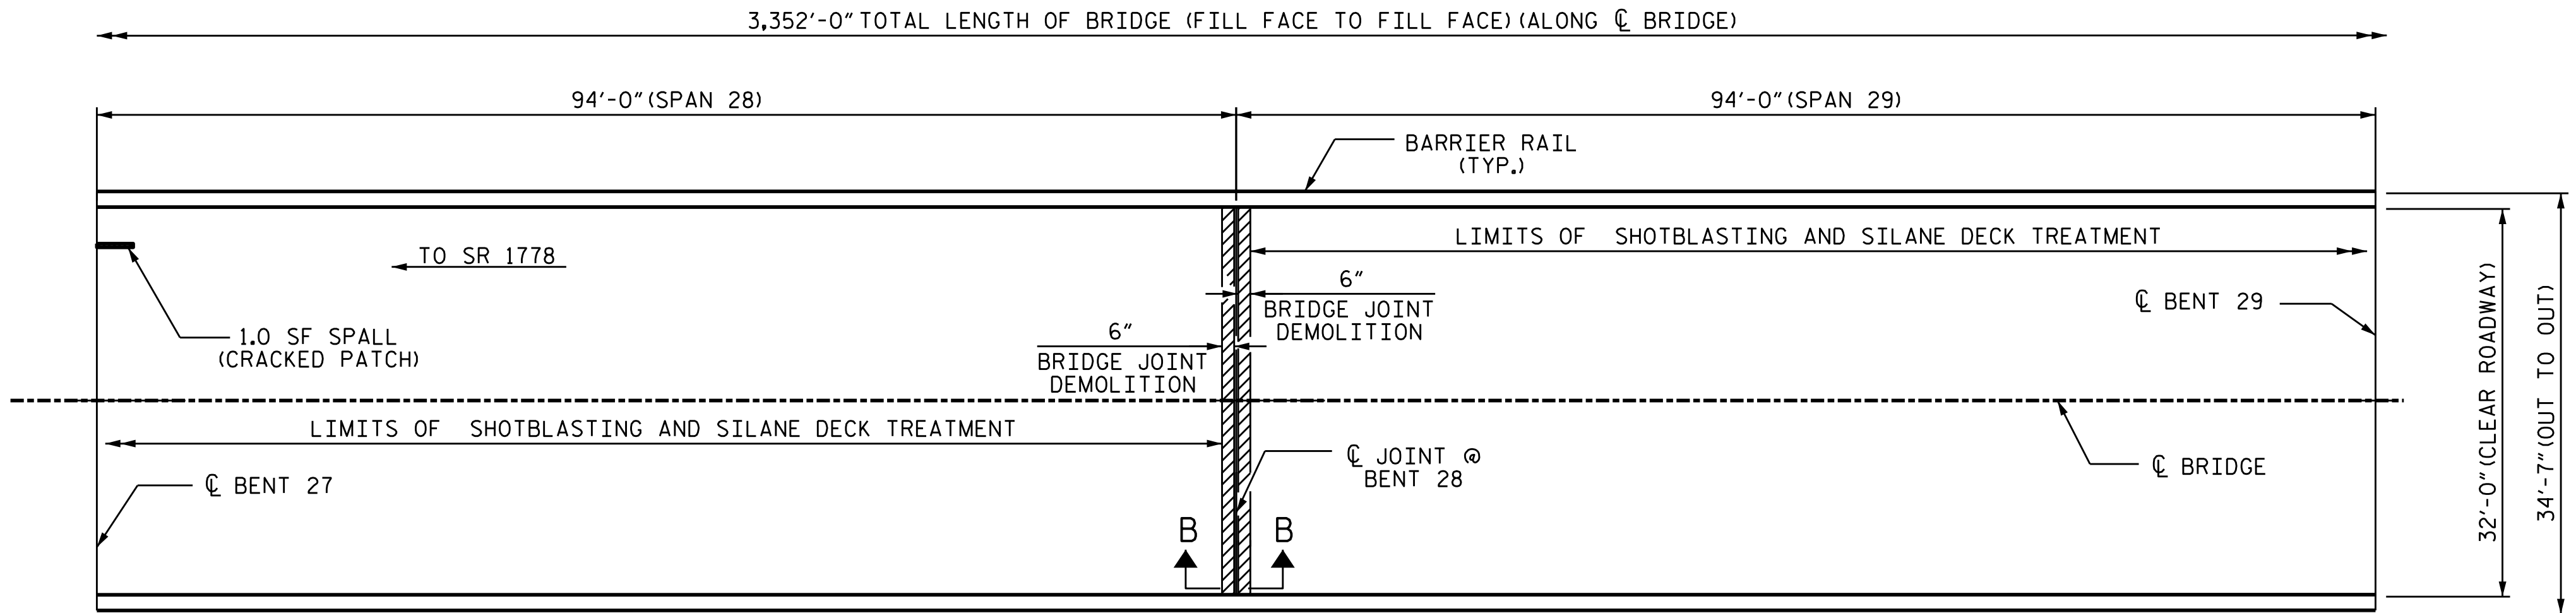
PLAN
(SPANS 28 & 29)

- SHOTBLASTING AND SILANE DECK TREATMENT AREA
- ERI - EPOXY RESIN INJECTION
- BRIDGE JOINT DEMOLITION
