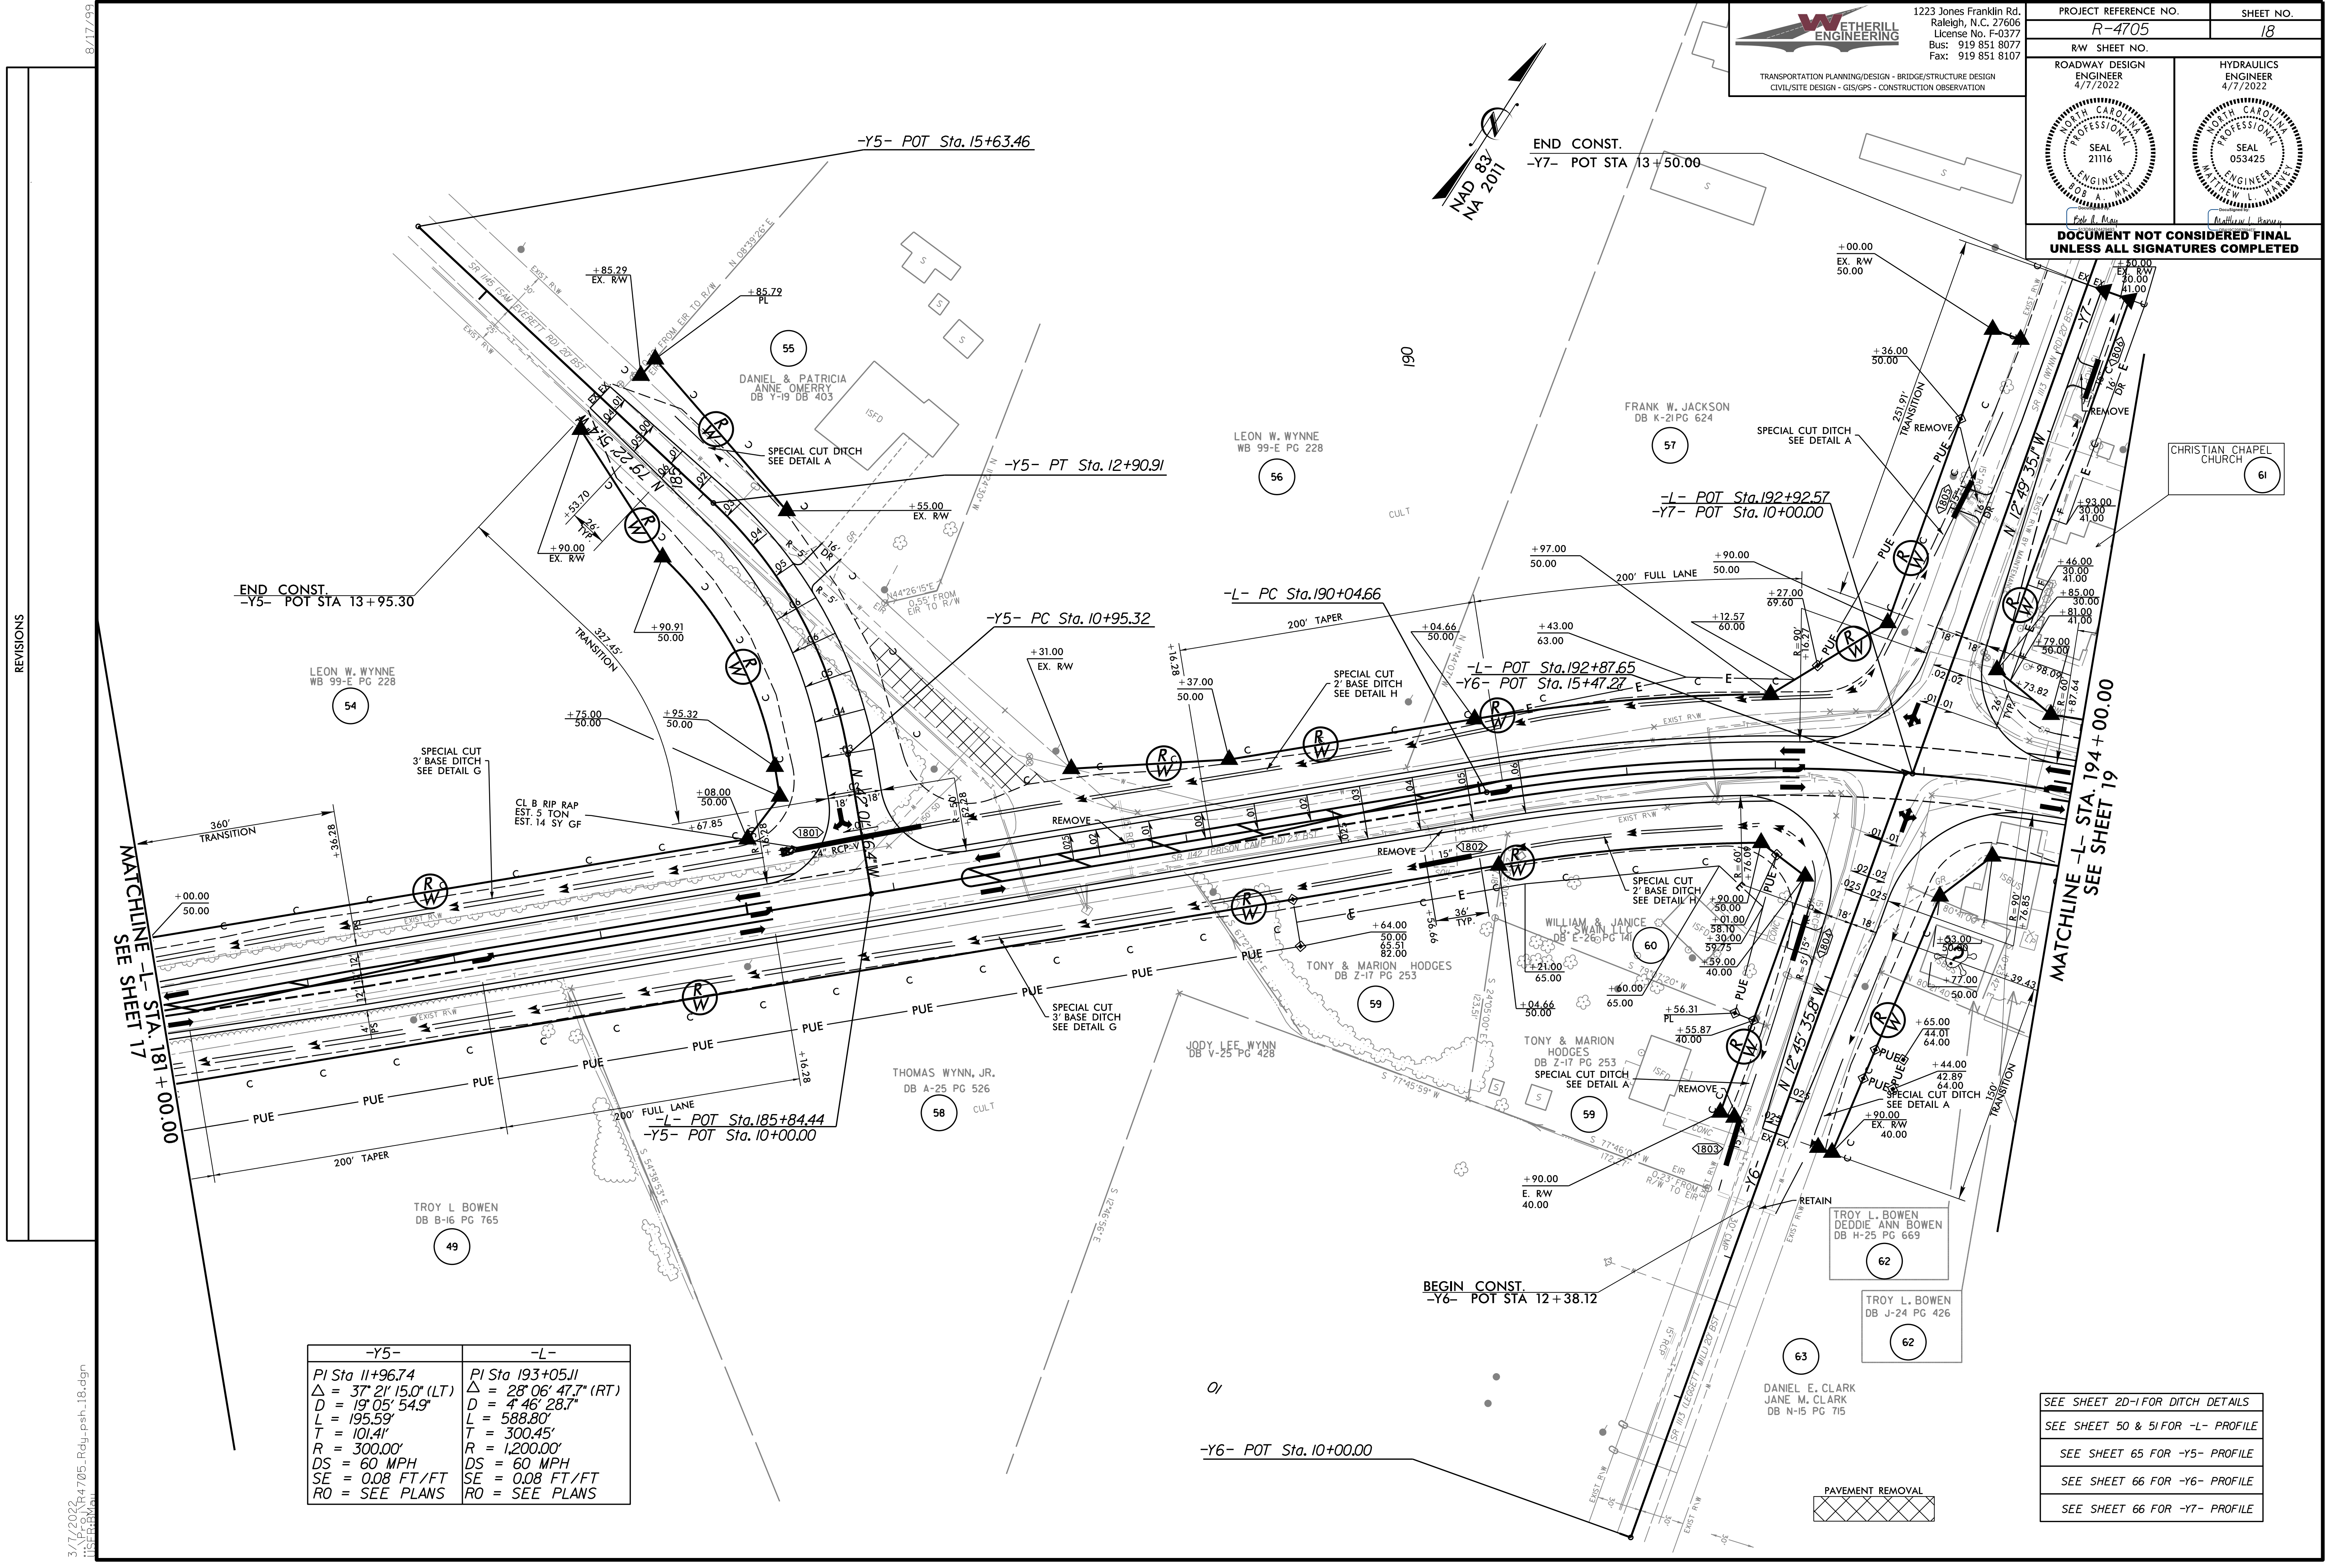
| -Y5- | -L- |
| PI Sta 11+96.74 | PI Sta 193+05.11 |
| $\Delta = 37^\circ 21' 15.0''$ (LT) | $\Delta = 28^\circ 06' 47.7''$ (RT) |
| $D = 19^\circ 05' 54.9''$ | $D = 4^\circ 46' 28.7''$ |
| $L = 195.59'$ | $L = 588.80'$ |
| $T = 101.41'$ | $T = 300.45'$ |
| $R = 300.00'$ | $R = 1,200.00'$ |
| $DS = 60$ MPH | $DS = 60$ MPH |
| $SE = 0.08$ FT/FT | $SE = 0.08$ FT/FT |
| $RO =$ SEE PLANS | $RO =$ SEE PLANS |
