PROJECT NO. I-5997
WAKE COUNTY
 BRIDGE NO. 910263 & 910264

PEDESTRIAN SAFETY FENCE REPAIR DETAILS

REVISIONS						SHEET NO.
NO.	BY:	DATE:	NO.	BY:	DATE:	S-41
1			3			TOTAL SHEETS
2			4			81

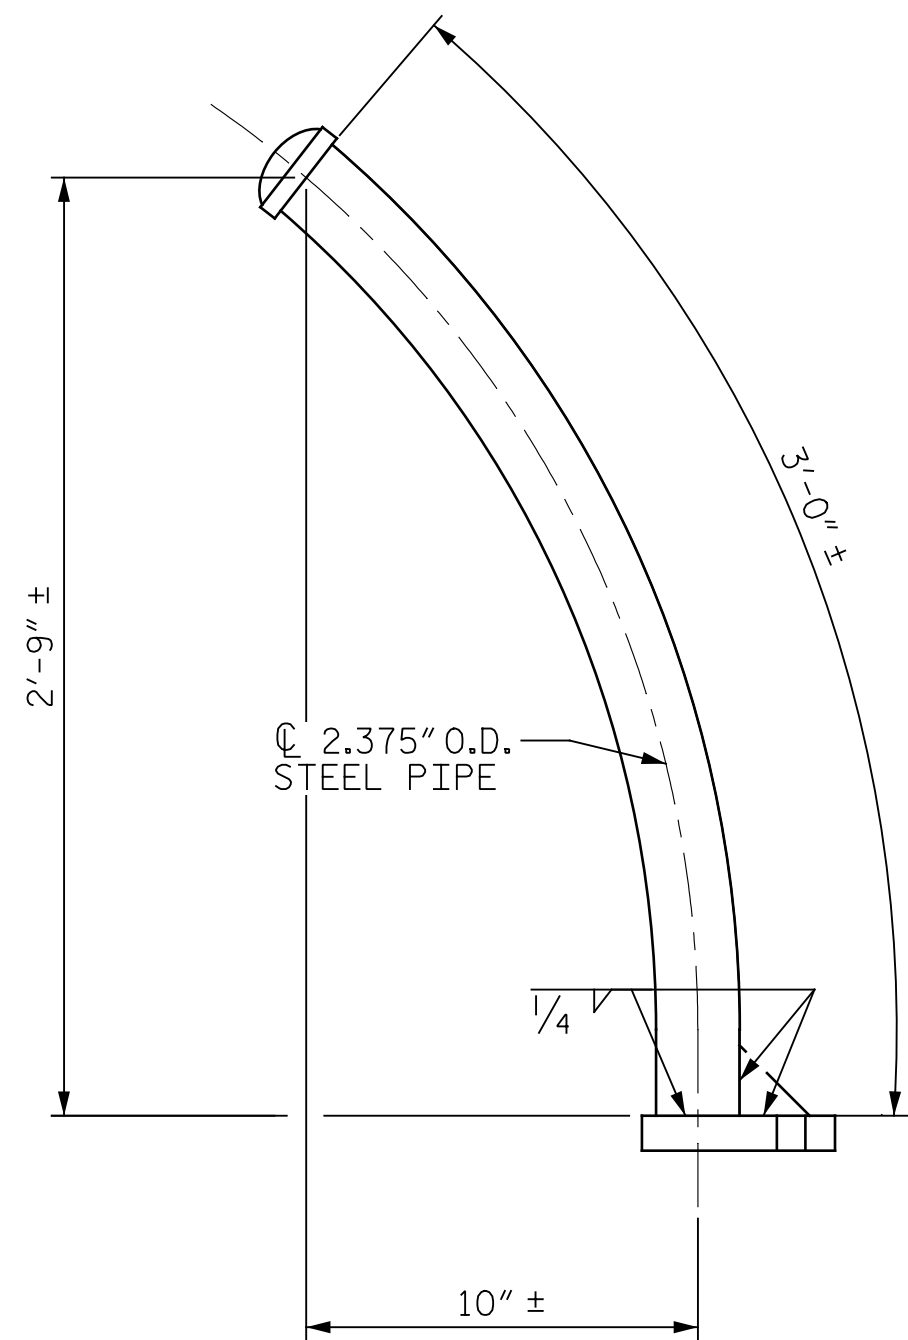
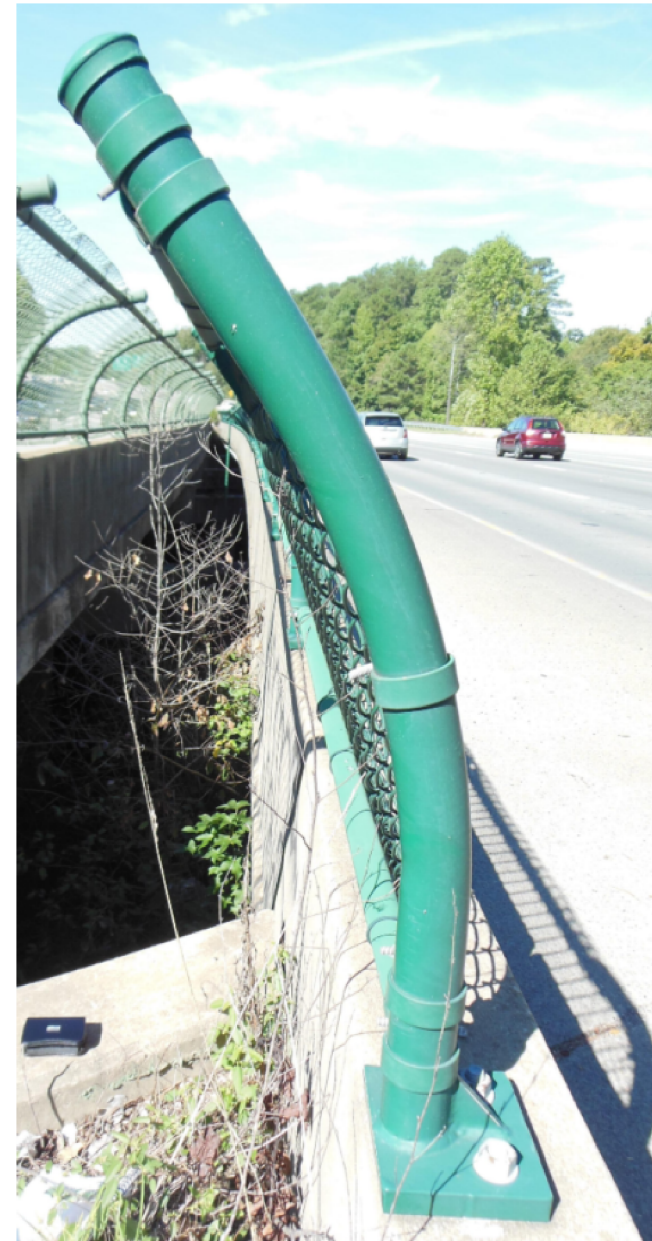
PIPE POST DETAIL

6'-2" ± x 1.660" O.D. STEEL PIPE BRACE RAILS

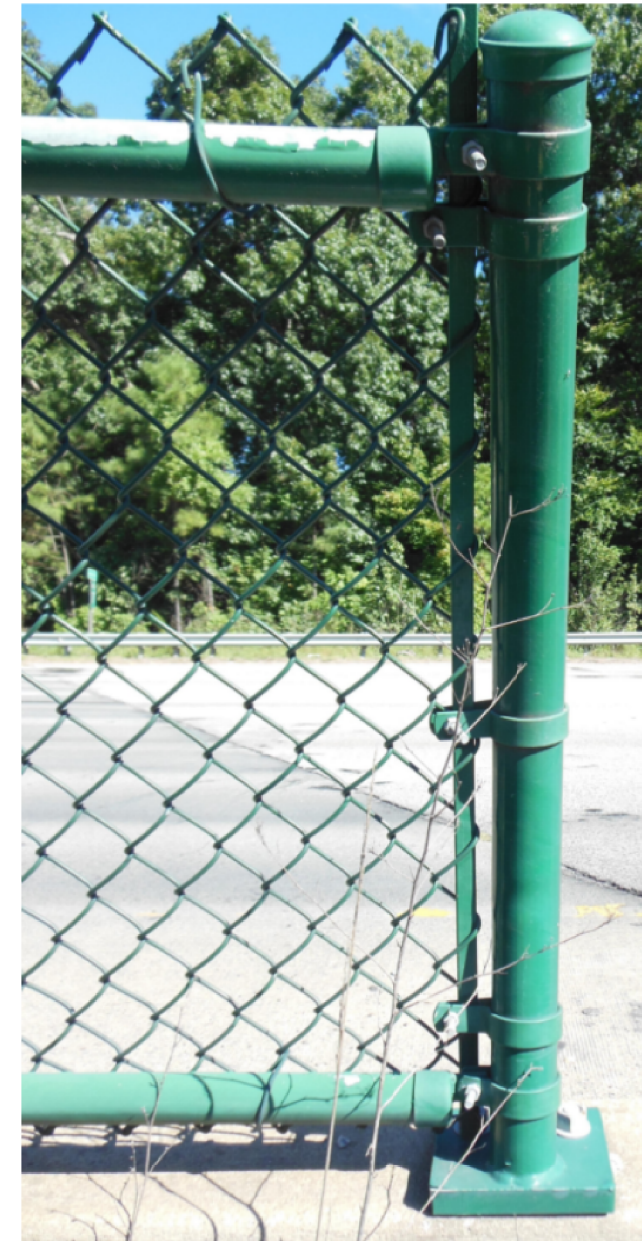
METHOD OF TYING FENCE TO PIPE POSTS AND BRACE RAILS

#6 GA. TIE WIRE @ 24" CTS. TO TIE FABRIC TO BRACE RAIL (TYP.)

WIRE CLIPS/TIES USED TO ATTACH FABRIC TO PIPE POST @ 12" CTS. (TYP.)
