AS-BUILT REPAIR QUANTITY TABLE

PROJECT NO. HB-0017
DARE COUNTY
BRIDGE NO. 270009

BENT 9 & BENT 10

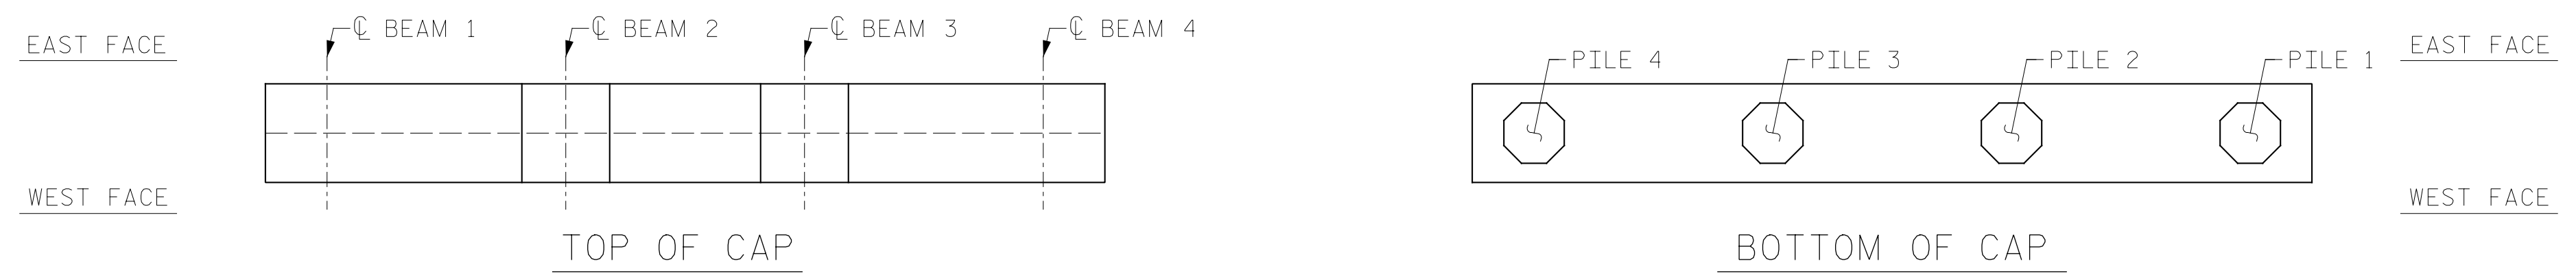
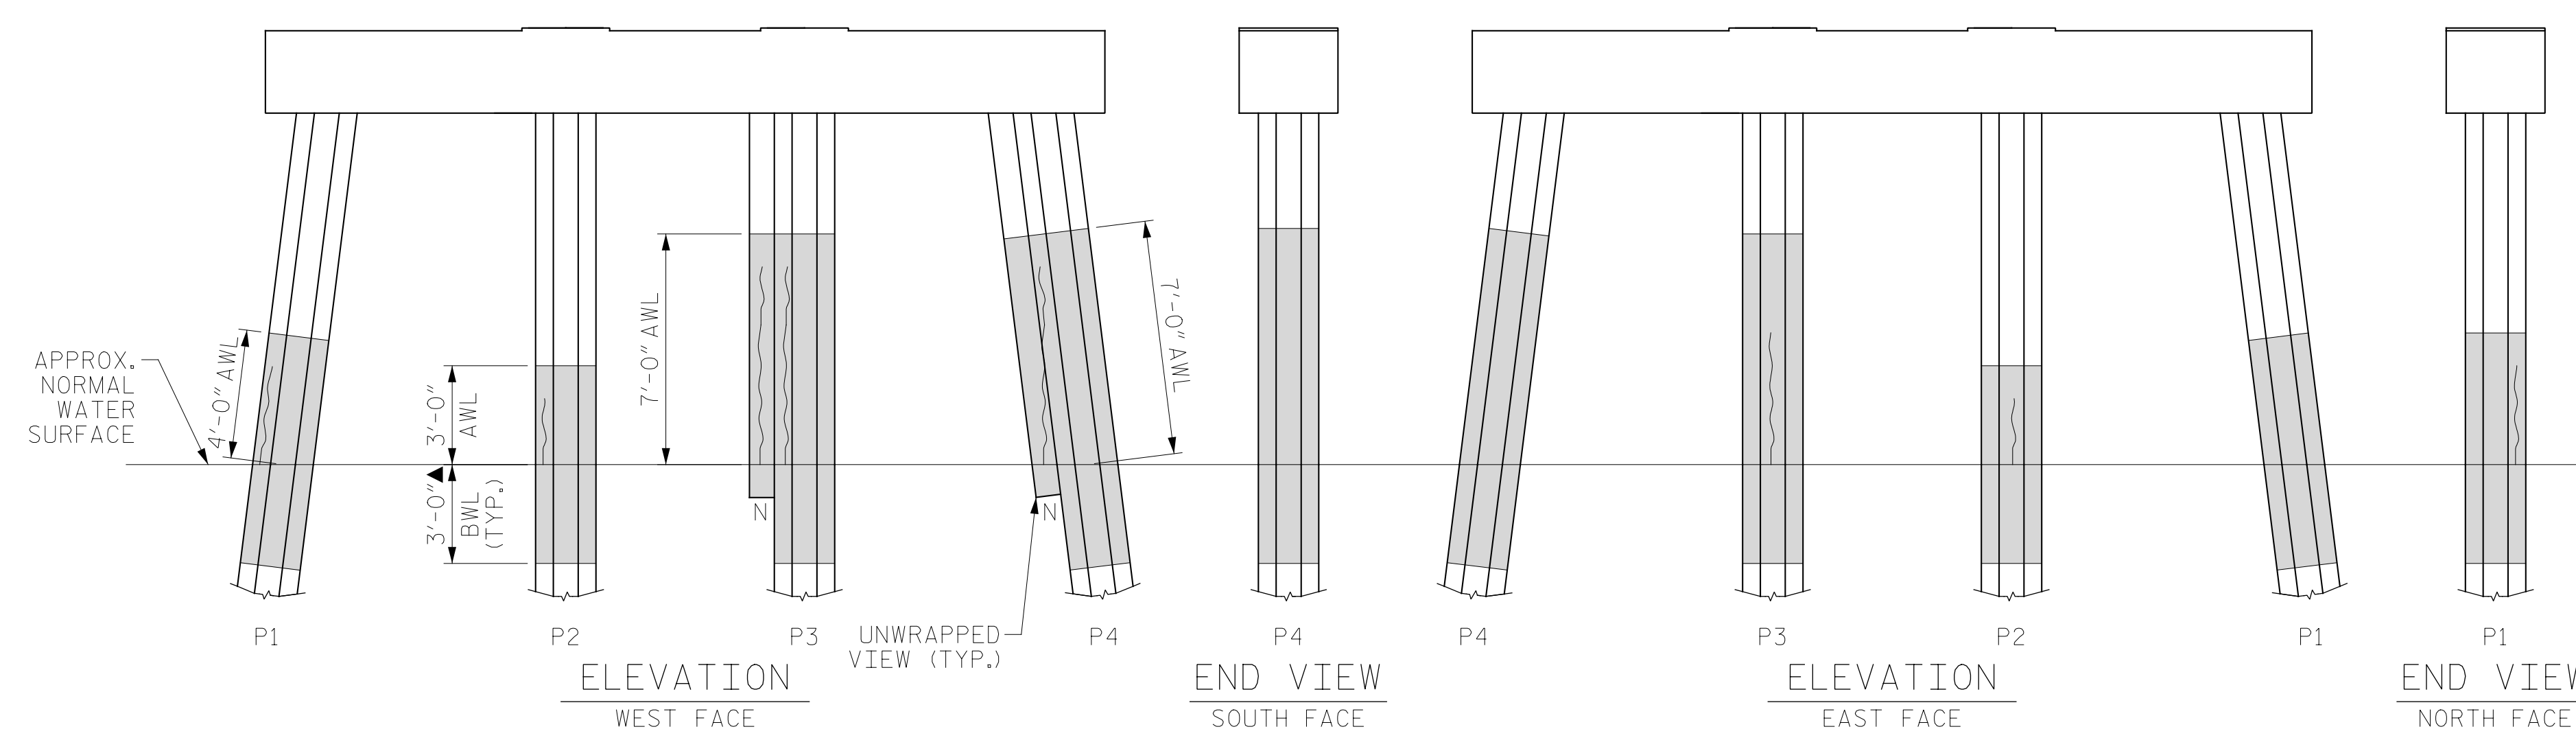
BENT 9

CAP REPAIRS		ESTIMATE			
SHOTCRETE REPAIRS	- SF	- CF	SF	CF	
EPOXY RESIN INJECTION	- LF				LF
PILE REPAIRS		ESTIMATE			
PILE CONCRETE RESTORATION	- SF	- CF	SF	CF	
FRP PROTECTIVE SYSTEM AWL	116.0 SF				
FRP PROTECTIVE SYSTEM BWL	66.0 SF

(AWL = ABOVE WATERLINE)
(BWL = BELOW WATERLINE)
(**QUANTITY INCLUDES ADJACENT REPAIRS)

FOR CAP REPAIRS: VALUES IN CHART REPRESENT ESTIMATED REPAIR TOTALS AFTER REMOVAL OF UNSOUND CONCRETE, MIN. OF 1" BEHIND REBAR AND MIN. 2" CL. TO SAWCUT. SEE REPAIR DETAILS.

FOR SHOTCRETE REPAIRS, SEE SPECIAL PROVISIONS.
FOR CONCRETE REPAIR DETAILS, SEE "TYPICAL CAP, COLUMN & UNDERDECK REPAIR DETAILS" & "PILE CONCRETE RESTORATION DETAILS" SHEETS.
FOR PILE CONCRETE RESTORATION, SEE SPECIAL PROVISIONS.
FOR FRP PROTECTIVE SYSTEM, SEE SPECIAL PROVISIONS.
FOR FRP PROTECTIVE SYSTEM DETAILS AND UNDERWATER MORTAR REPAIRS, SEE "PILE FRP PROTECTIVE SYSTEM DETAILS" SHEET.

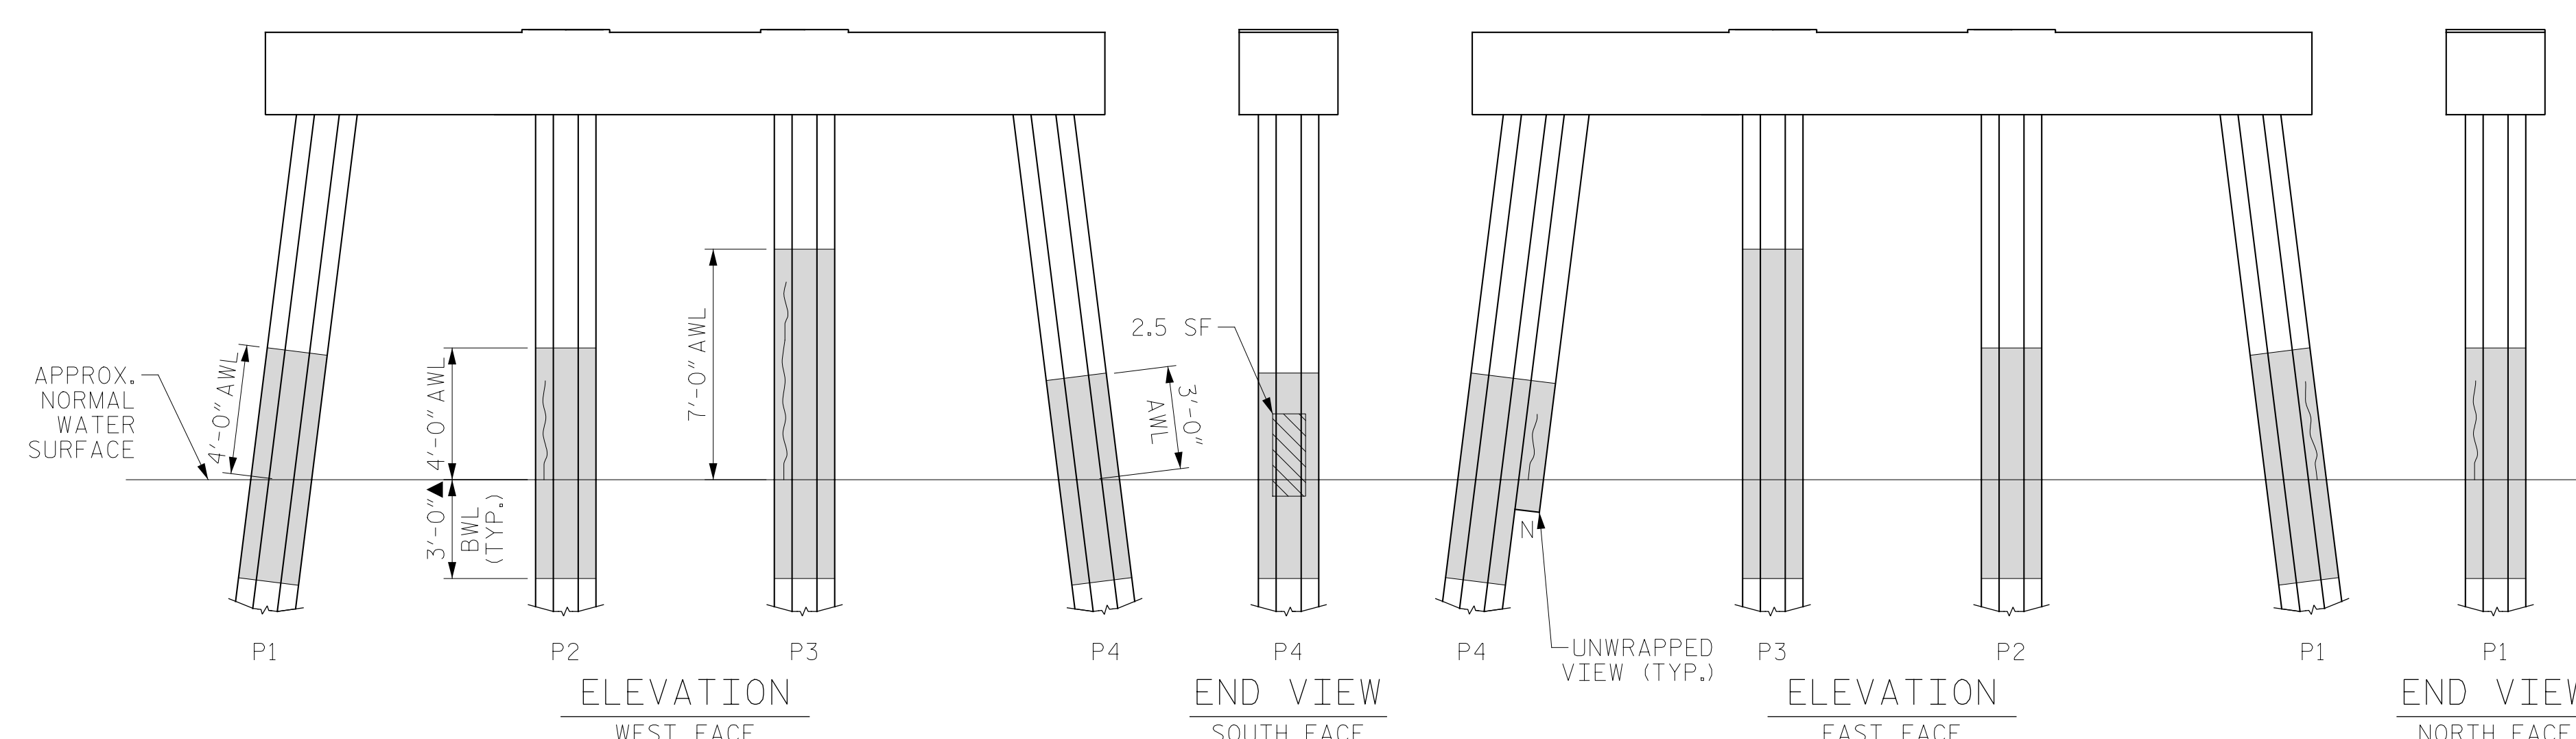
BENT 10

CAP REPAIRS		ESTIMATE			
SHOTCRETE REPAIRS	- SF	- CF	SF	CF	
EPOXY RESIN INJECTION	- LF				LF
PILE REPAIRS		ESTIMATE			
PILE CONCRETE RESTORATION	2.5 SF	1.0 CF	SF	CF	
FRP PROTECTIVE SYSTEM AWL	99.0 SF				
FRP PROTECTIVE SYSTEM BWL	66.0 SF

(AWL = ABOVE WATERLINE)
(BWL = BELOW WATERLINE)
(**QUANTITY INCLUDES ADJACENT REPAIRS)
