AS-BUILT REPAIR QUANTITY TABLE

PROJECT NO. HB-0017
DARE COUNTY
BRIDGE NO. 270009

BENT 25 & BENT 26

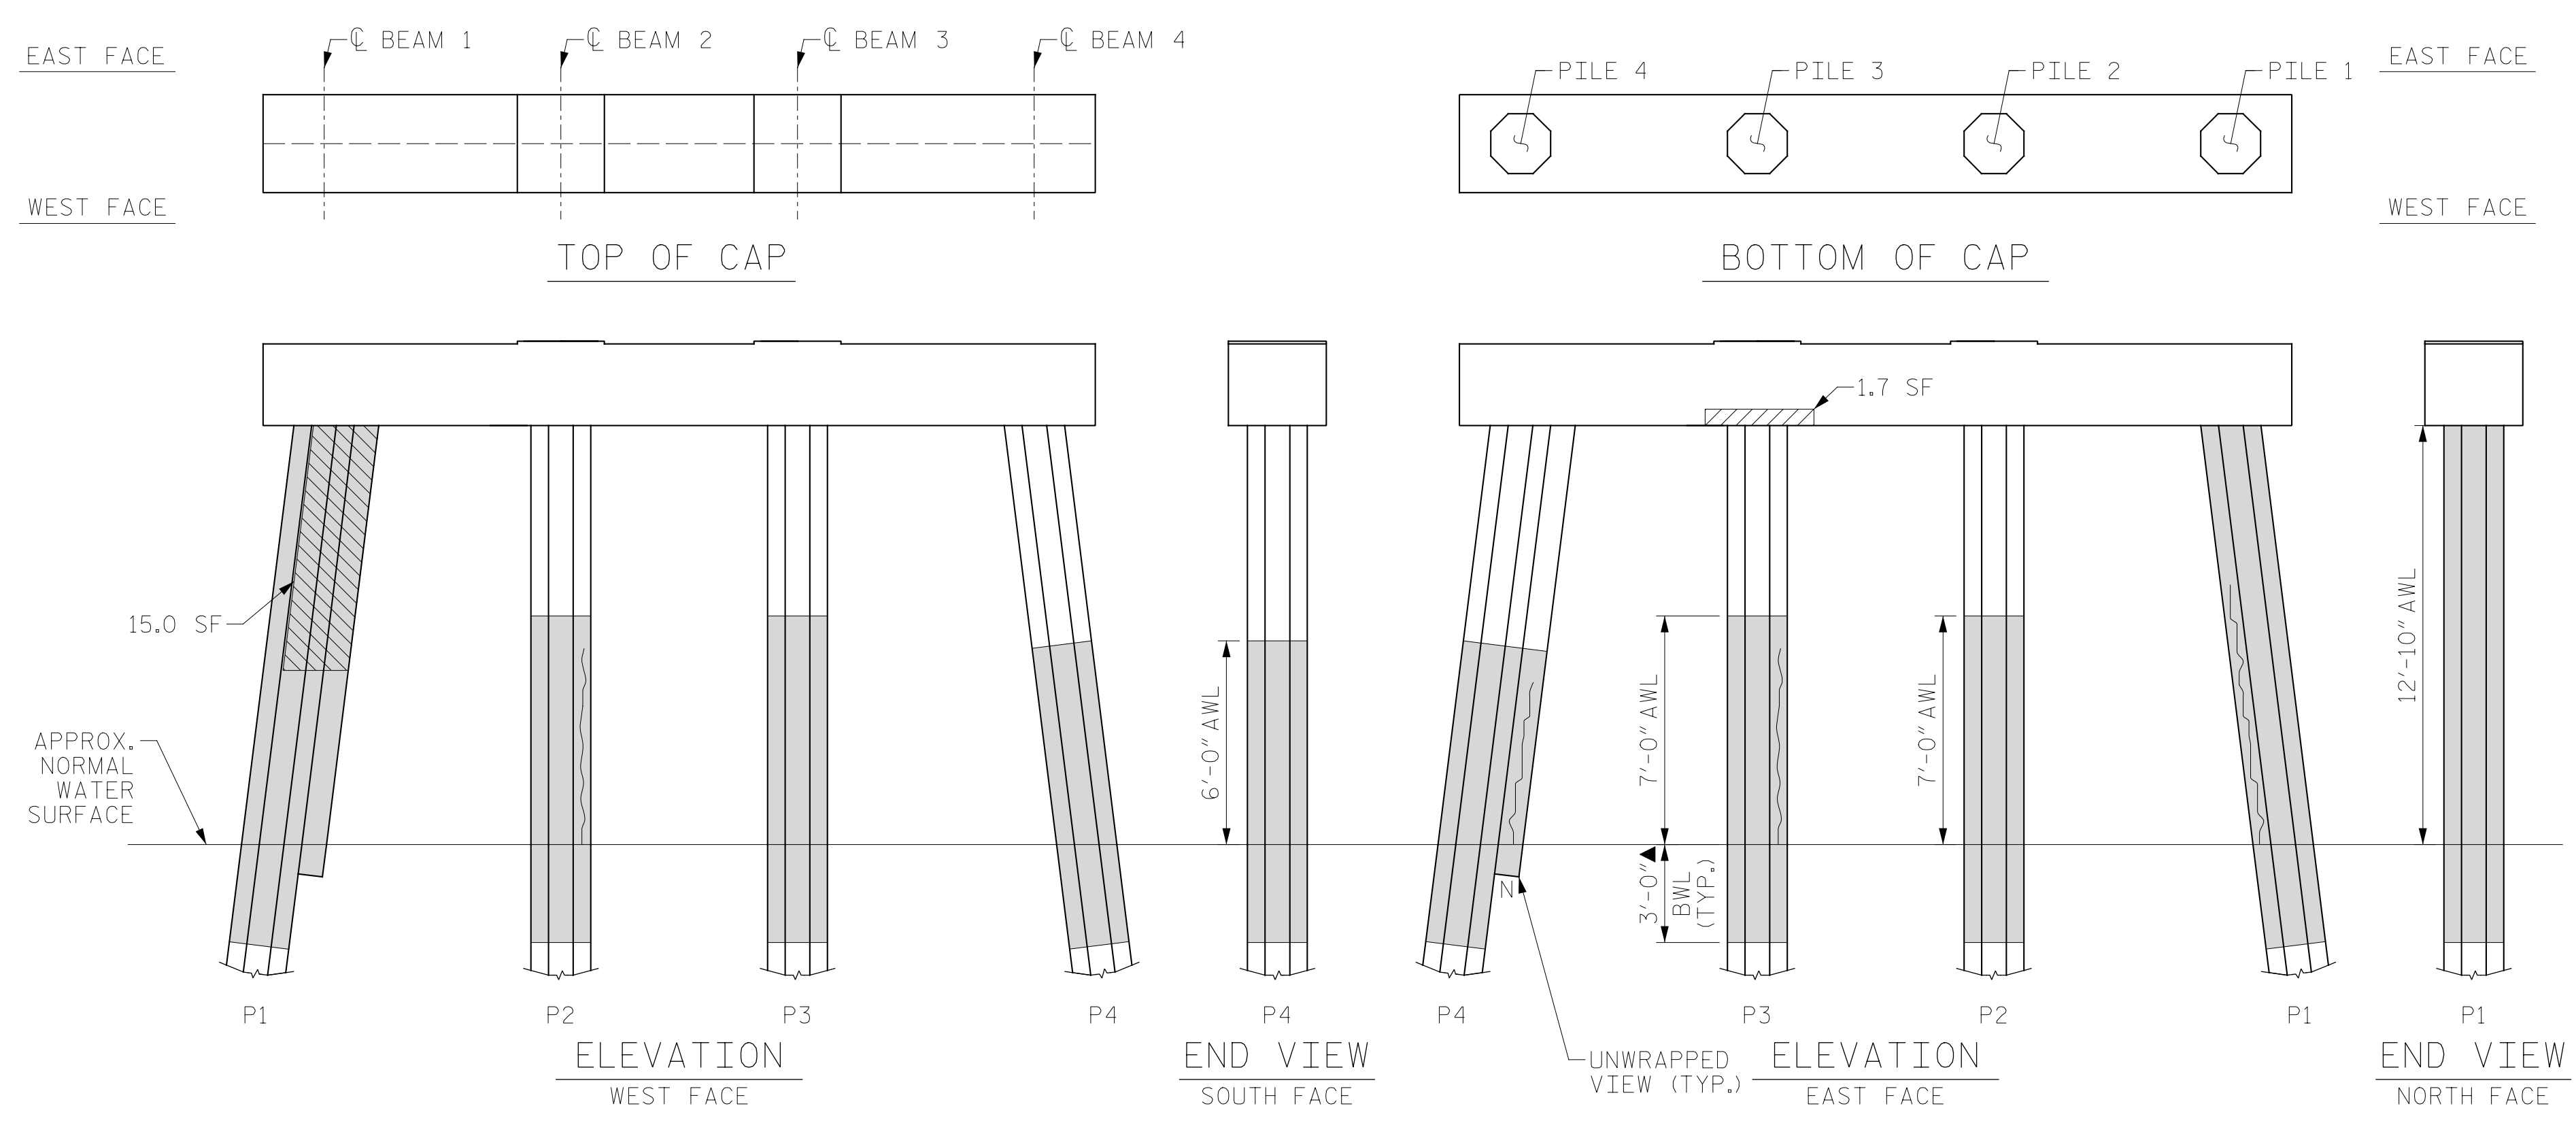
BENT 25

(AWL = ABOVE WATERLINE)
(BWL = BELOW WATERLINE)
(*QUANTITY INCLUDES ADJACENT REPAIRS)

CAP REPAIRS		ESTIMATE			
SHOTCRETE REPAIRS	1.7 SF	0.9 CF	SF	CF	
EPOXY RESIN INJECTION	- LF				LF
PILE REPAIRS		ESTIMATE			
PILE CONCRETE RESTORATION	15.0 SF	5.9 CF	SF	CF	
FRP PROTECTIVE SYSTEM AWL	181.0 SF				
FRP PROTECTIVE SYSTEM BWL	66.0 SF

FOR CAP REPAIRS: VALUES IN CHART REPRESENT ESTIMATED REPAIR TOTALS AFTER REMOVAL OF UNSOUND CONCRETE, MIN. OF 1" BEHIND REBAR AND MIN. 2" CL. TO SAWCUT. SEE REPAIR DETAILS.

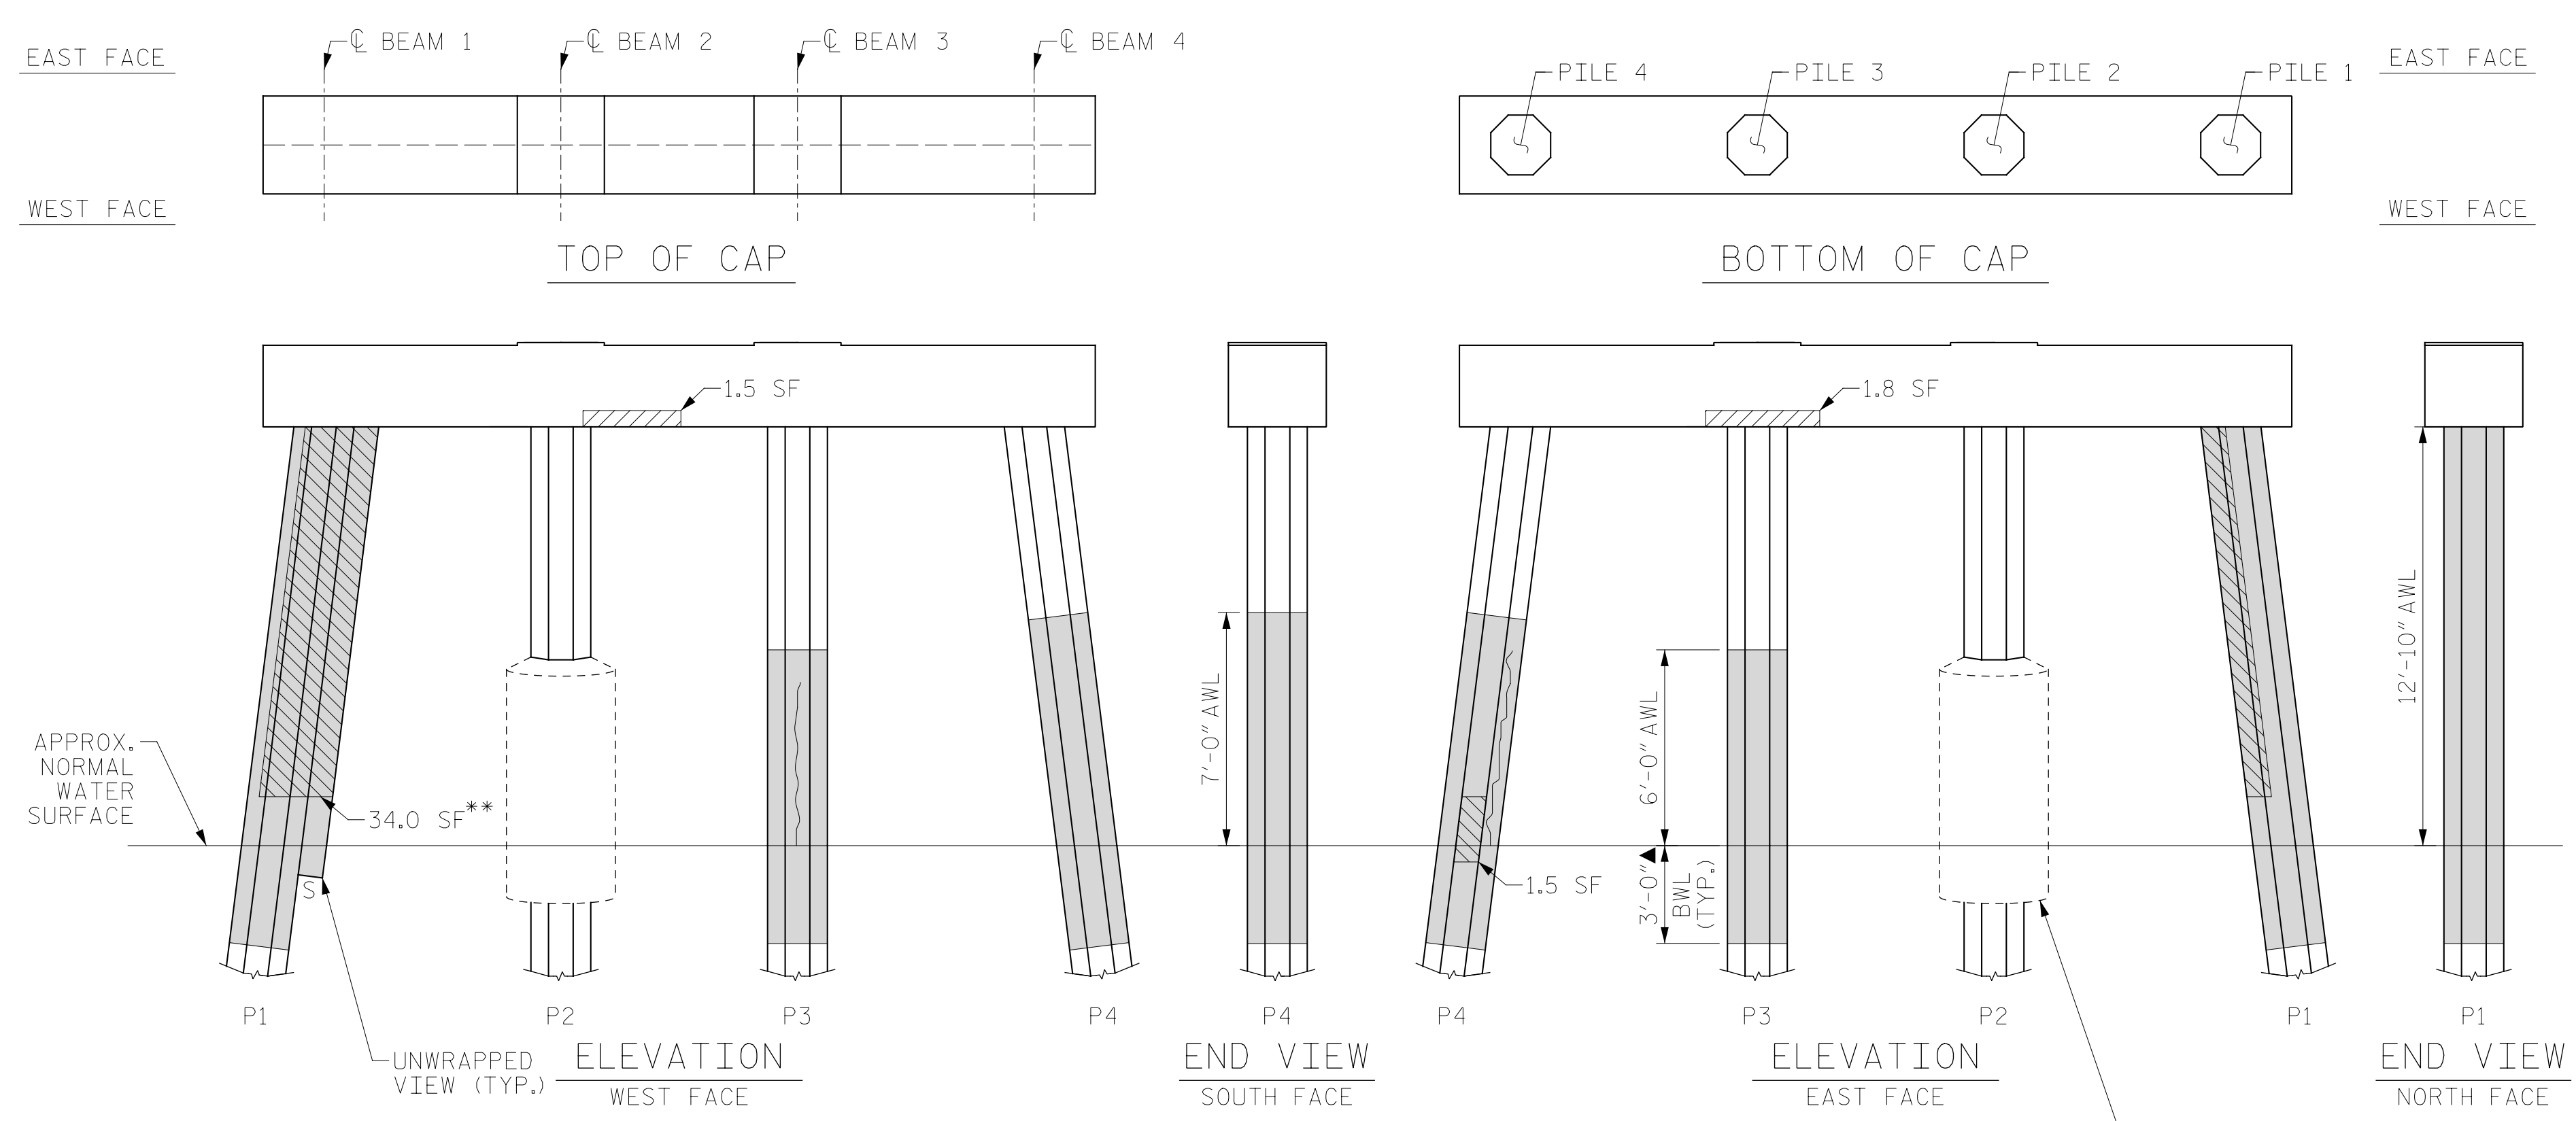
BENT 26

(AWL = ABOVE WATERLINE)
(BWL = BELOW WATERLINE)
(*QUANTITY INCLUDES ADJACENT REPAIRS)

CAP REPAIRS		ESTIMATE			
SHOTCRETE REPAIRS	3.3 SF	1.7 CF	SF	CF	
EPOXY RESIN INJECTION	- LF				LF
PILE REPAIRS		ESTIMATE			
PILE CONCRETE RESTORATION	35.5 SF	14.5 CF	SF	CF	
FRP PROTECTIVE SYSTEM AWL	142.5 SF				
FRP PROTECTIVE SYSTEM BWL	49.5 SF
