AS-BUILT REPAIR QUANTITY TABLE

PROJECT NO. HB-0017
DARE COUNTY
 BRIDGE NO. 270009

BENT 27 & BENT 28

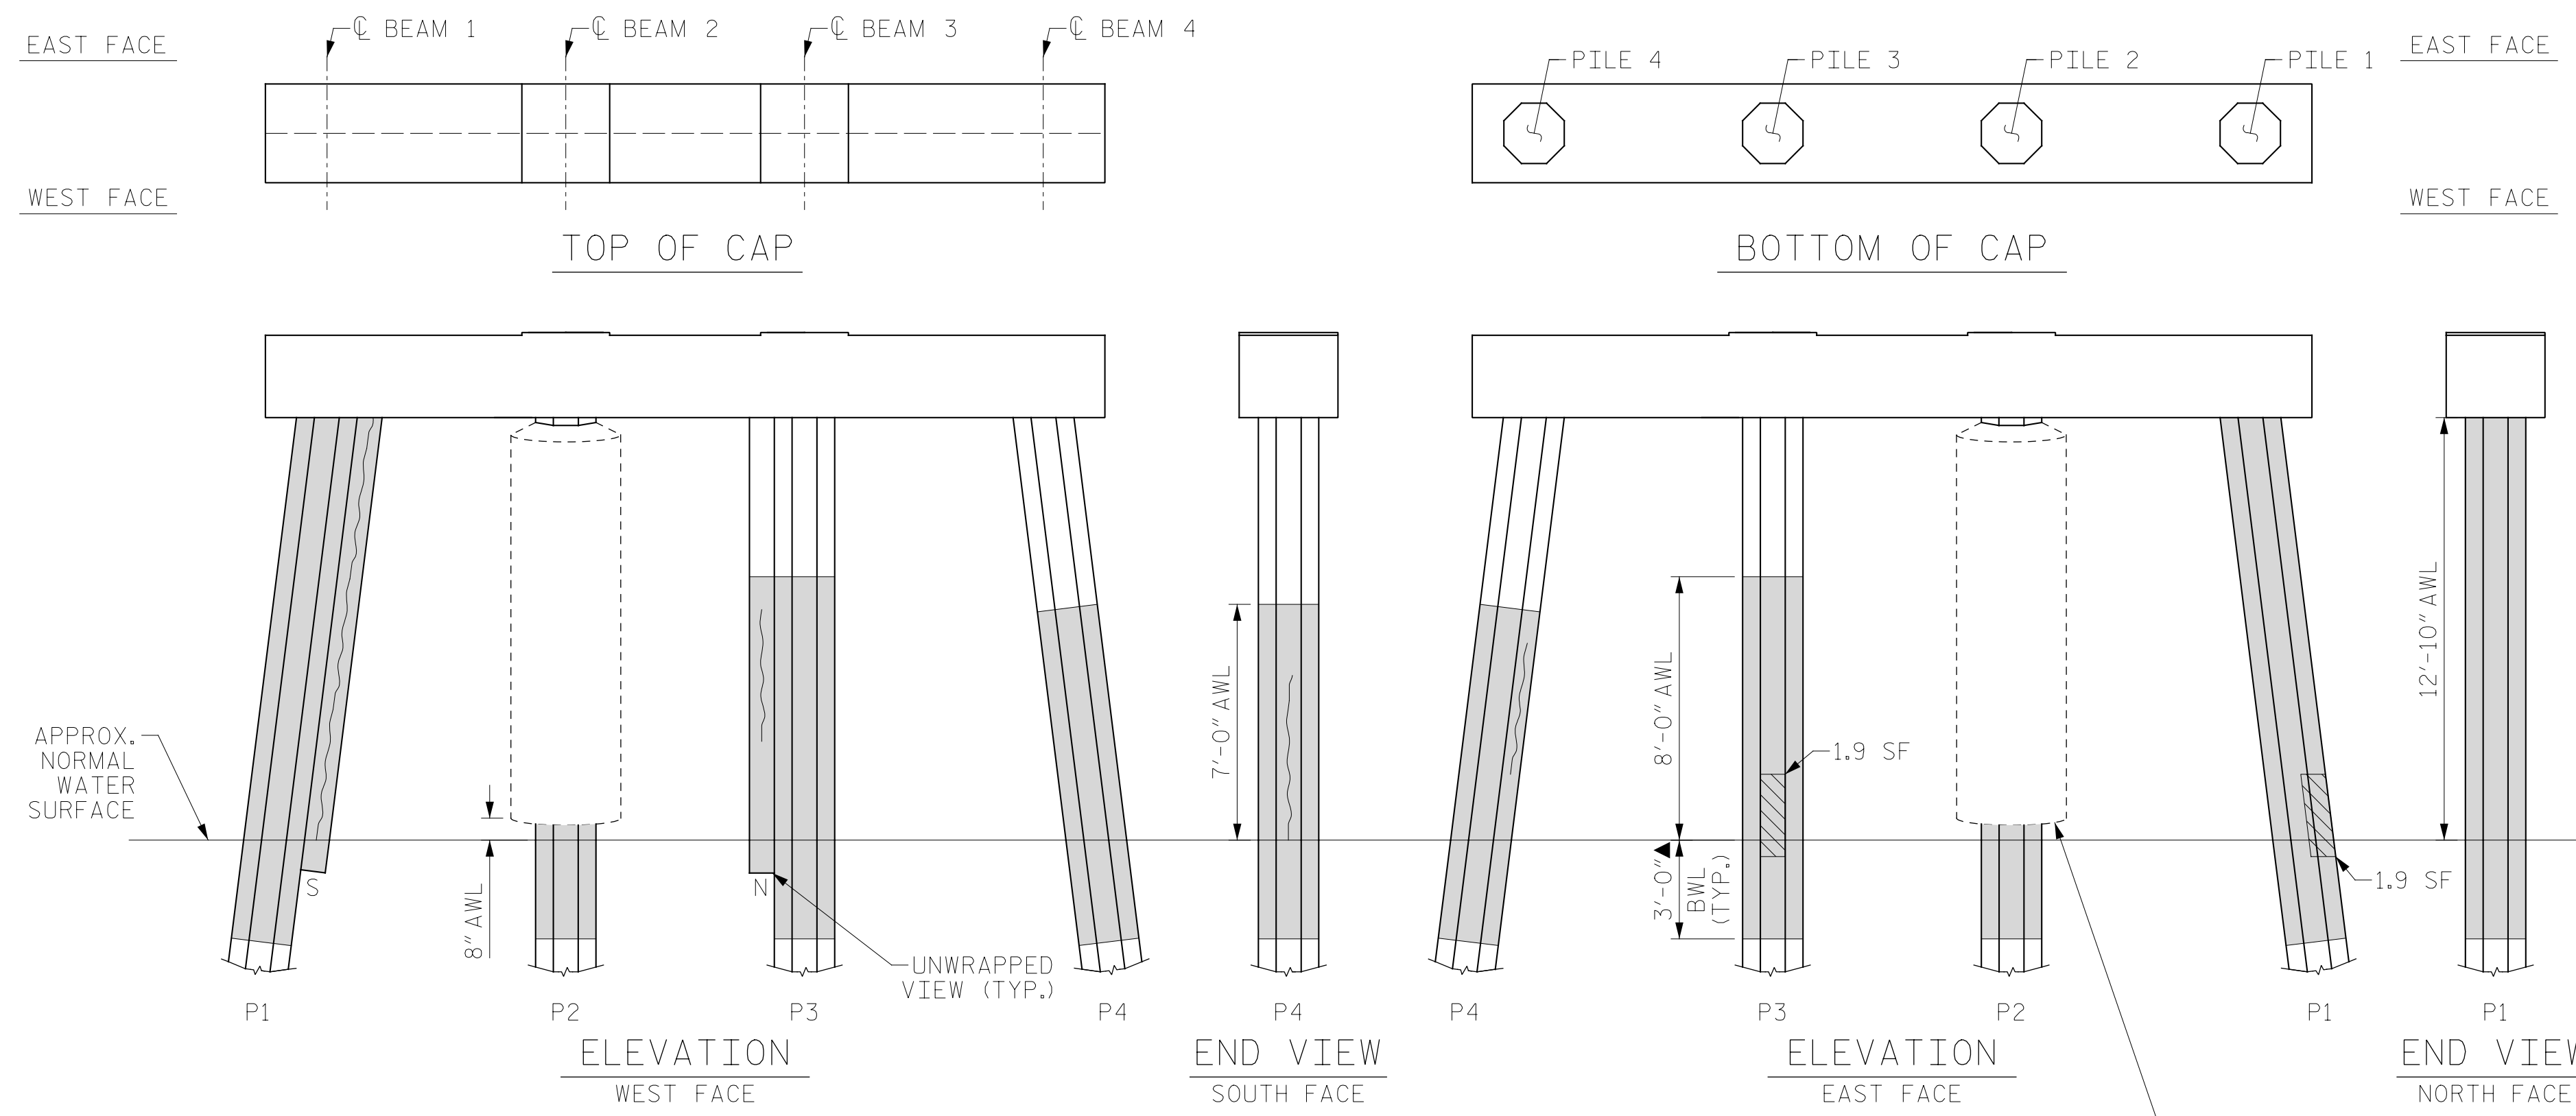
BENT 27

CAP REPAIRS		ESTIMATE			
SHOTCRETE REPAIRS	- SF	- CF	SF	CF	
EPOXY RESIN INJECTION	- LF				LF
PILE REPAIRS		ESTIMATE			
PILE CONCRETE RESTORATION	3.8 SF	2.0 CF	SF	CF	
FRP PROTECTIVE SYSTEM AWL	153.5 SF				
FRP PROTECTIVE SYSTEM BWL	66.0 SF

(AWL = ABOVE WATERLINE)
(BWL = BELOW WATERLINE)
(**QUANTITY INCLUDES ADJACENT REPAIRS)

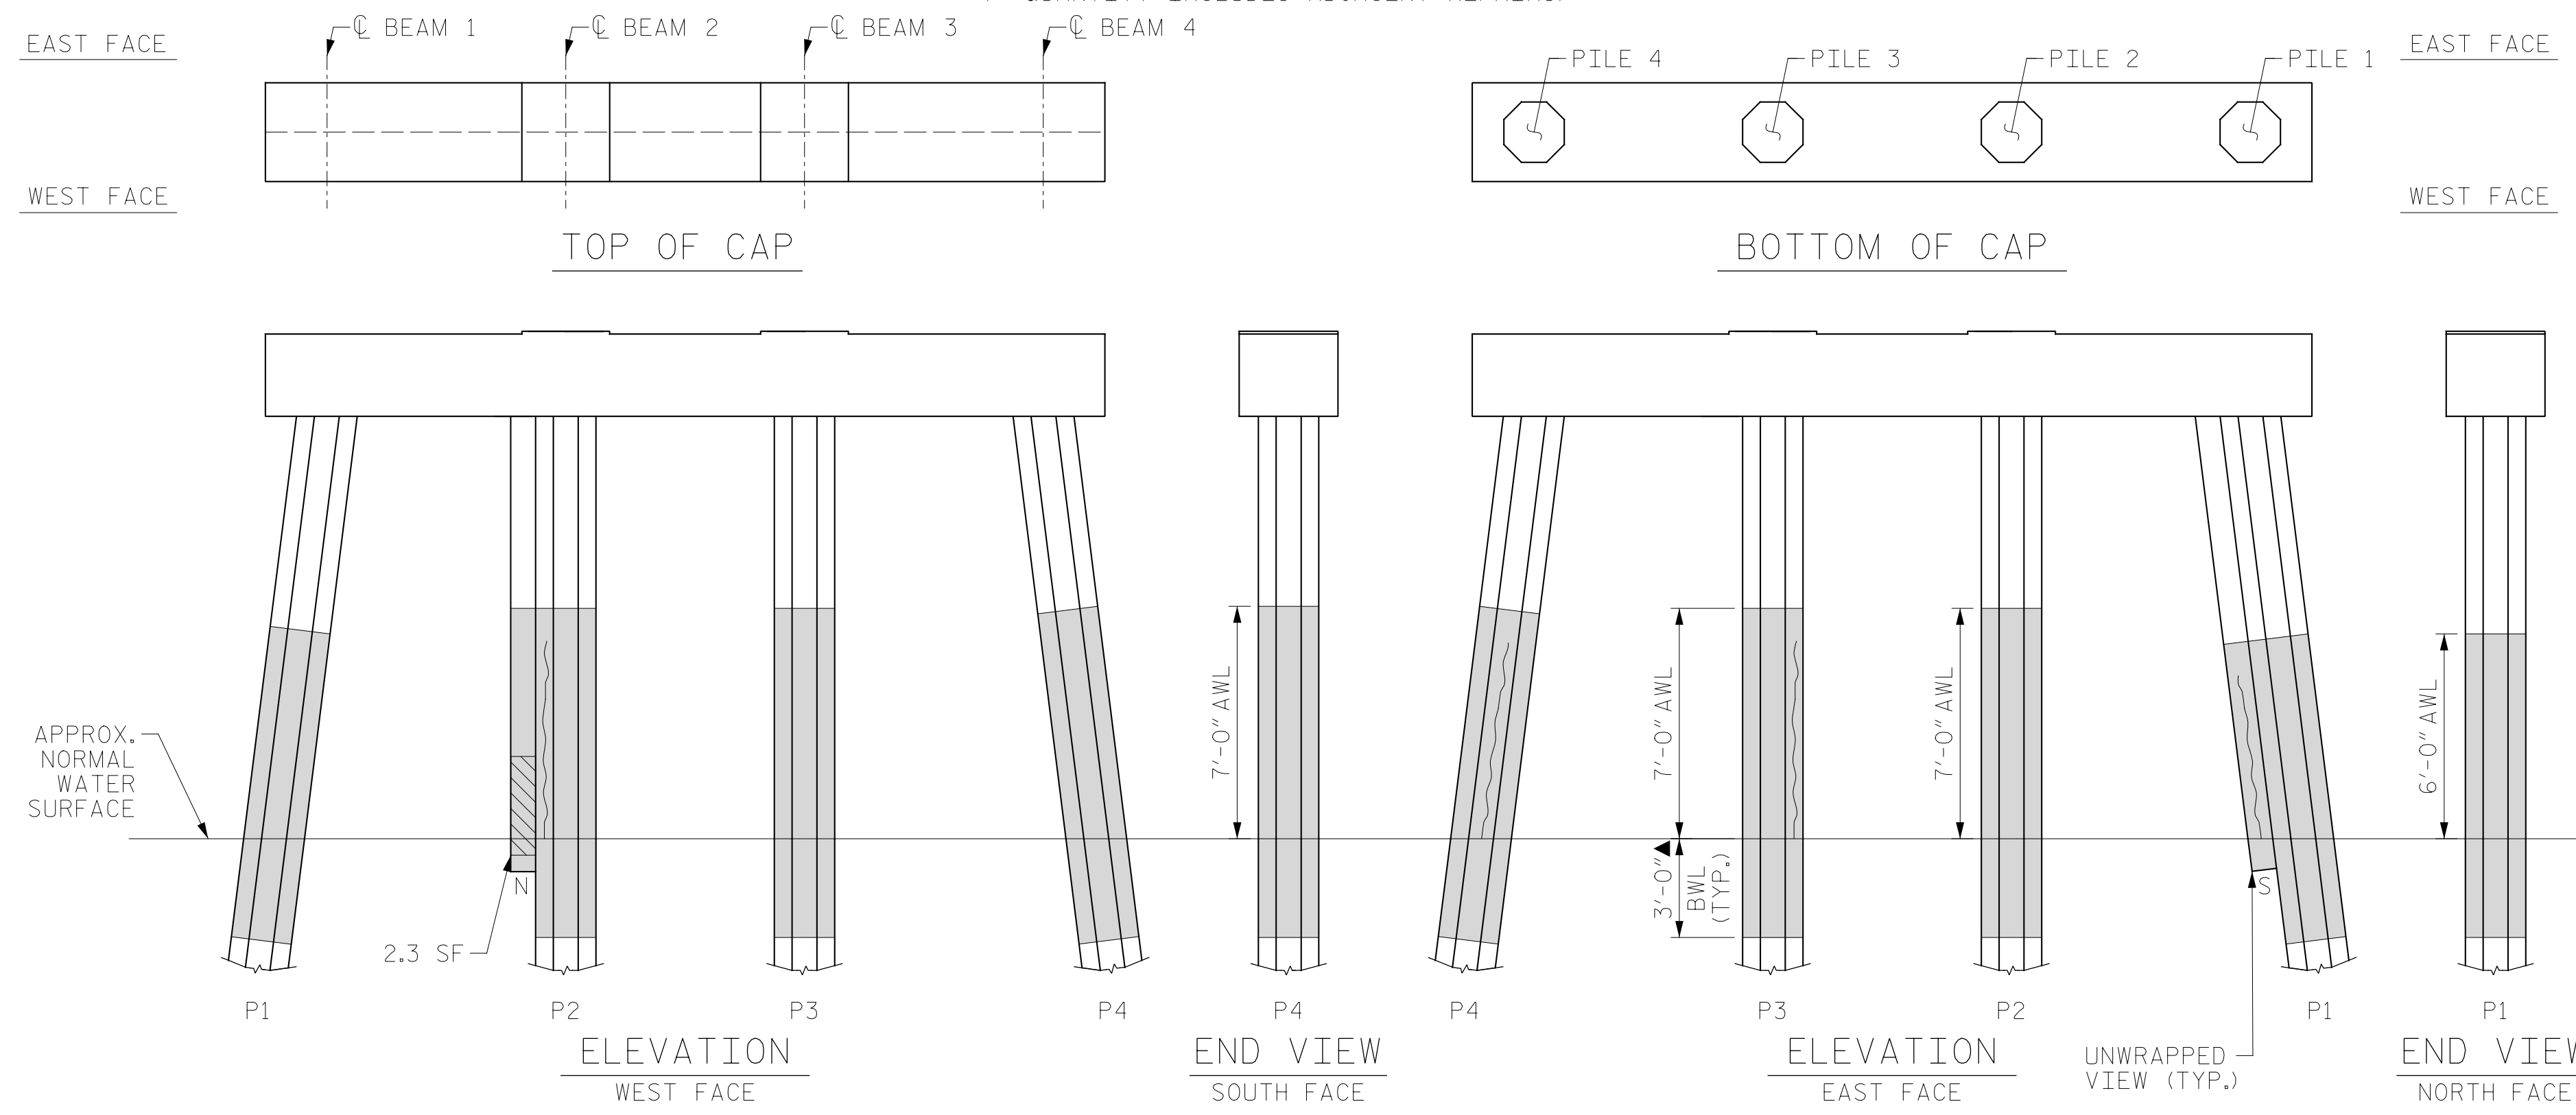
BENT 28

CAP REPAIRS		ESTIMATE			
SHOTCRETE REPAIRS	- SF	- CF	SF	CF	
EPOXY RESIN INJECTION	- LF				LF
PILE REPAIRS		ESTIMATE			
PILE CONCRETE RESTORATION	2.3 SF	1.2 CF	SF	CF	
FRP PROTECTIVE SYSTEM AWL	149.4 SF				
FRP PROTECTIVE SYSTEM BWL	66.0 SF

(AWL = ABOVE WATERLINE)
(BWL = BELOW WATERLINE)
(**QUANTITY INCLUDES ADJACENT REPAIRS)
