AS-BUILT REPAIR QUANTITY TABLE

PROJECT NO. HB-0017
DARE COUNTY
BRIDGE NO. 270009

BENT 31 & BENT 32

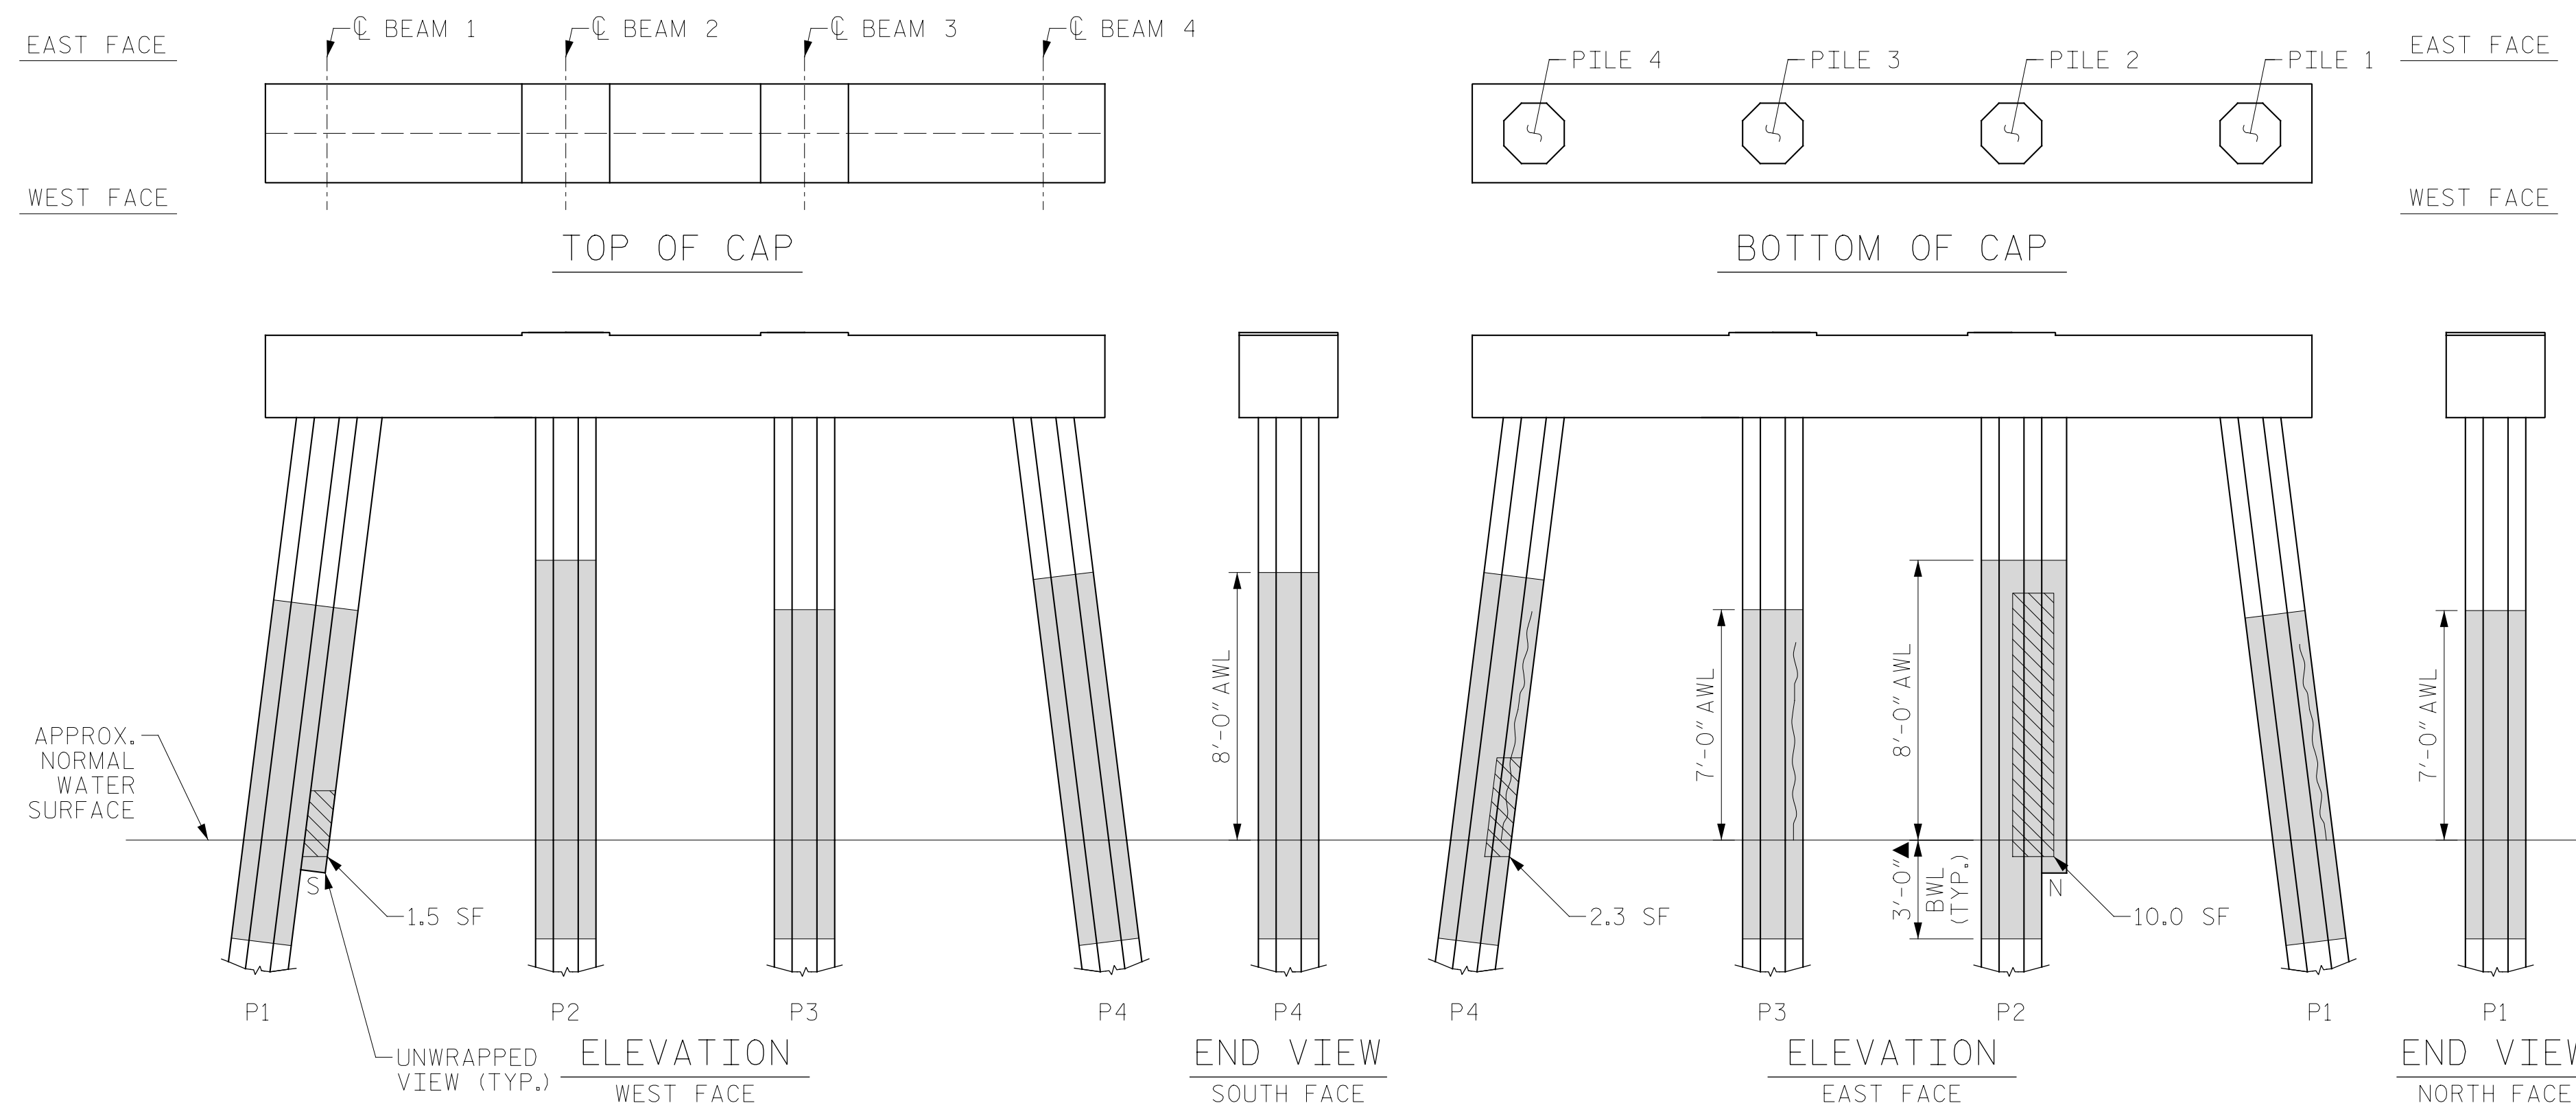
BENT 31				
CAP REPAIRS		ESTIMATE		
SHOTCRETE REPAIRS	- SF	- CF	SF	CF
EPOXY RESIN INJECTION	- LF			LF
PILE REPAIRS		ESTIMATE		
PILE CONCRETE RESTORATION	13.8 SF	6.3 CF	SF	CF
FRP PROTECTIVE SYSTEM AWL	166.0 SF			
FRP PROTECTIVE SYSTEM BWL	66.0 SF

(AWL = ABOVE WATERLINE)
(BWL = BELOW WATERLINE)
(**QUANTITY INCLUDES ADJACENT REPAIRS)

FOR CAP REPAIRS: VALUES IN CHART REPRESENT ESTIMATED REPAIR TOTALS AFTER REMOVAL OF UNSOUND CONCRETE, MIN. OF 1" BEHIND REBAR AND MIN. 2" CL. TO SAWCUT. SEE REPAIR DETAILS.

FOR SHOTCRETE REPAIRS, SEE SPECIAL PROVISIONS.
FOR CONCRETE REPAIR DETAILS, SEE "TYPICAL CAP, COLUMN & UNDERDECK REPAIR DETAILS" & "PILE CONCRETE RESTORATION DETAILS" SHEETS.
FOR PILE CONCRETE RESTORATION, SEE SPECIAL PROVISIONS.
FOR FRP PROTECTIVE SYSTEM, SEE SPECIAL PROVISIONS.
FOR FRP PROTECTIVE SYSTEM DETAILS AND UNDERWATER MORTAR REPAIRS, SEE "PILE FRP PROTECTIVE SYSTEM DETAILS" SHEET.

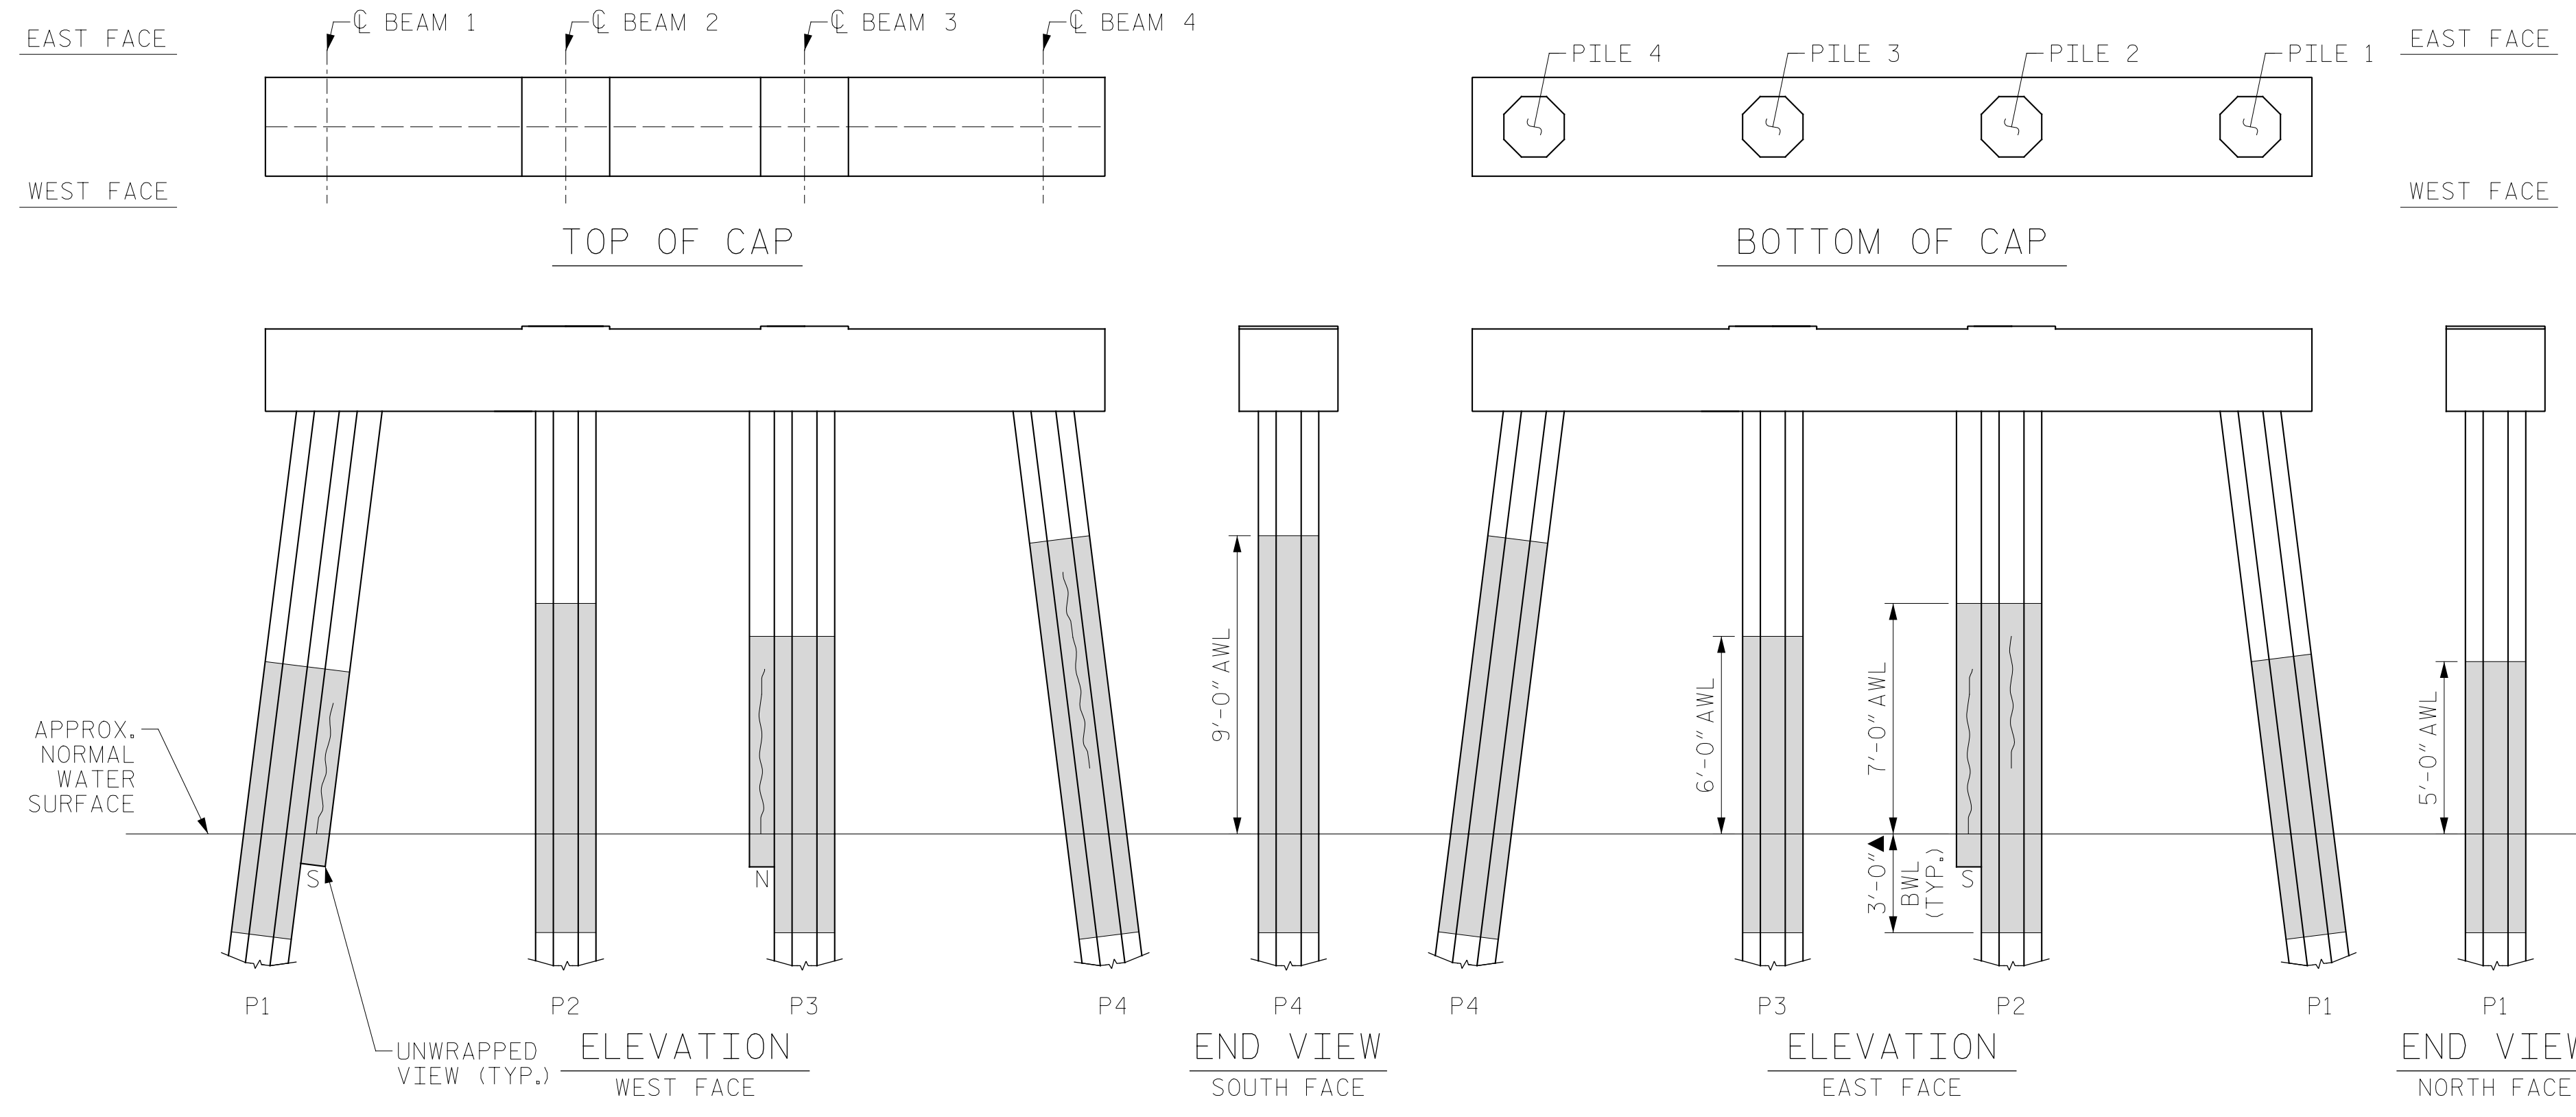
BENT 32				
CAP REPAIRS		ESTIMATE		
SHOTCRETE REPAIRS	- SF	- CF	SF	CF
EPOXY RESIN INJECTION	- LF			LF
PILE REPAIRS		ESTIMATE		
PILE CONCRETE RESTORATION	- SF	- CF	SF	CF
FRP PROTECTIVE SYSTEM AWL	149.4 SF			
FRP PROTECTIVE SYSTEM BWL	66.0 SF

(AWL = ABOVE WATERLINE)
(BWL = BELOW WATERLINE)
(**QUANTITY INCLUDES ADJACENT REPAIRS)
