AS-BUILT REPAIR QUANTITY TABLE

PROJECT NO. HB-0017
DARE COUNTY
BRIDGE NO. 270009

BENT 45 & BENT 46

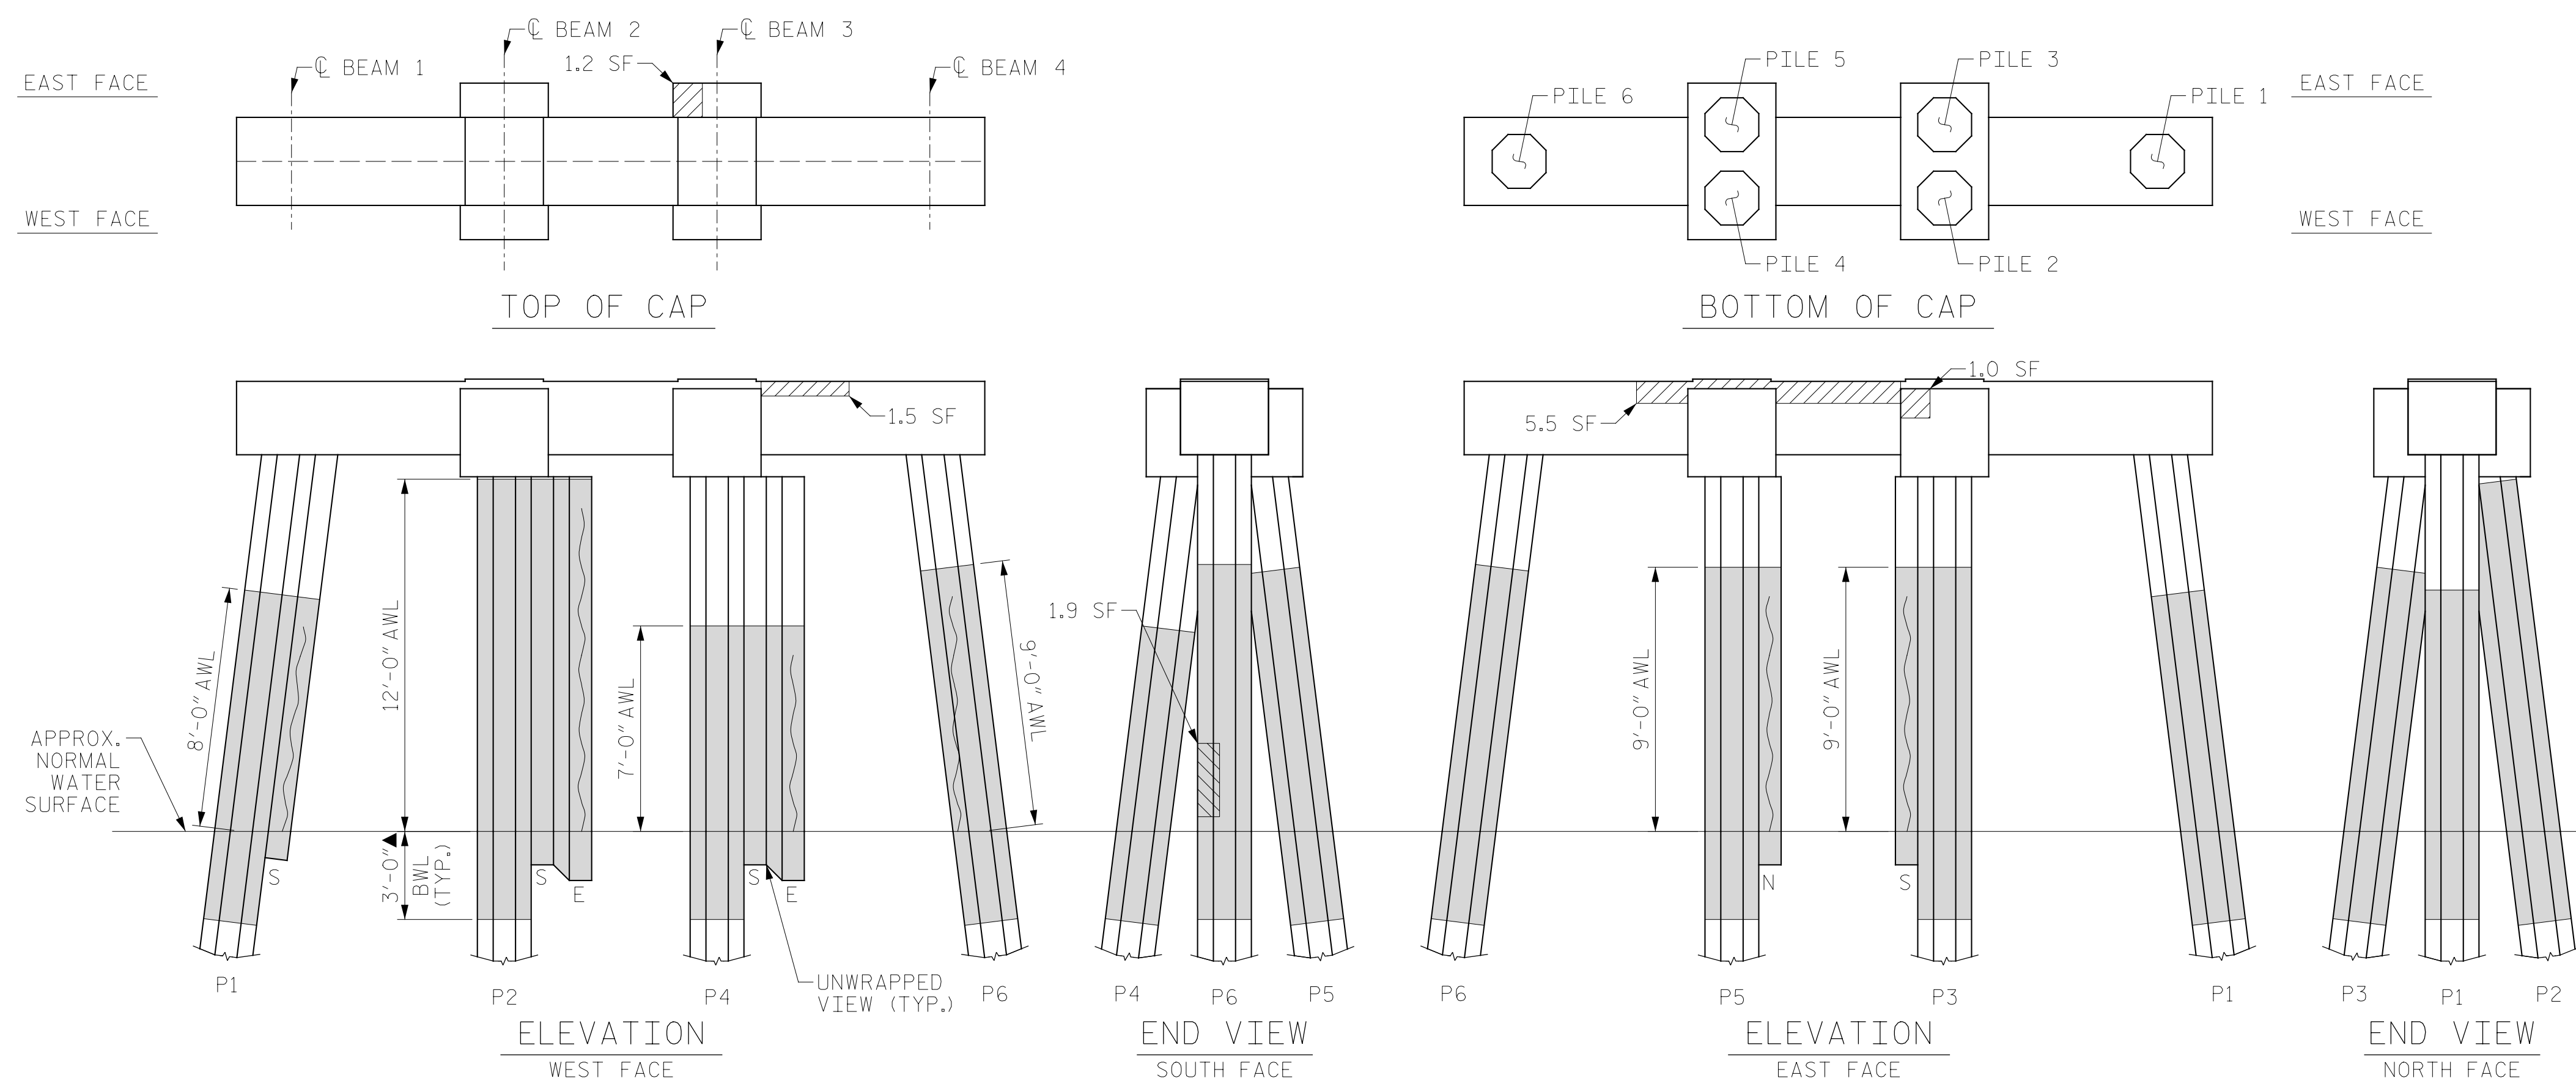
BENT 45

CAP REPAIRS		ESTIMATE			
SHOTCRETE REPAIRS	9.2 SF	4.7 CF	SF	CF	
EPOXY RESIN INJECTION	- LF				LF
PILE REPAIRS		ESTIMATE			
PILE CONCRETE RESTORATION	1.9 SF	1.0 CF	SF	CF	
FRP PROTECTIVE SYSTEM AWL	297.9 SF				
FRP PROTECTIVE SYSTEM BWL	99.0 SF

(AWL = ABOVE WATERLINE)
(BWL = BELOW WATERLINE)
(**QUANTITY INCLUDES ADJACENT REPAIRS)

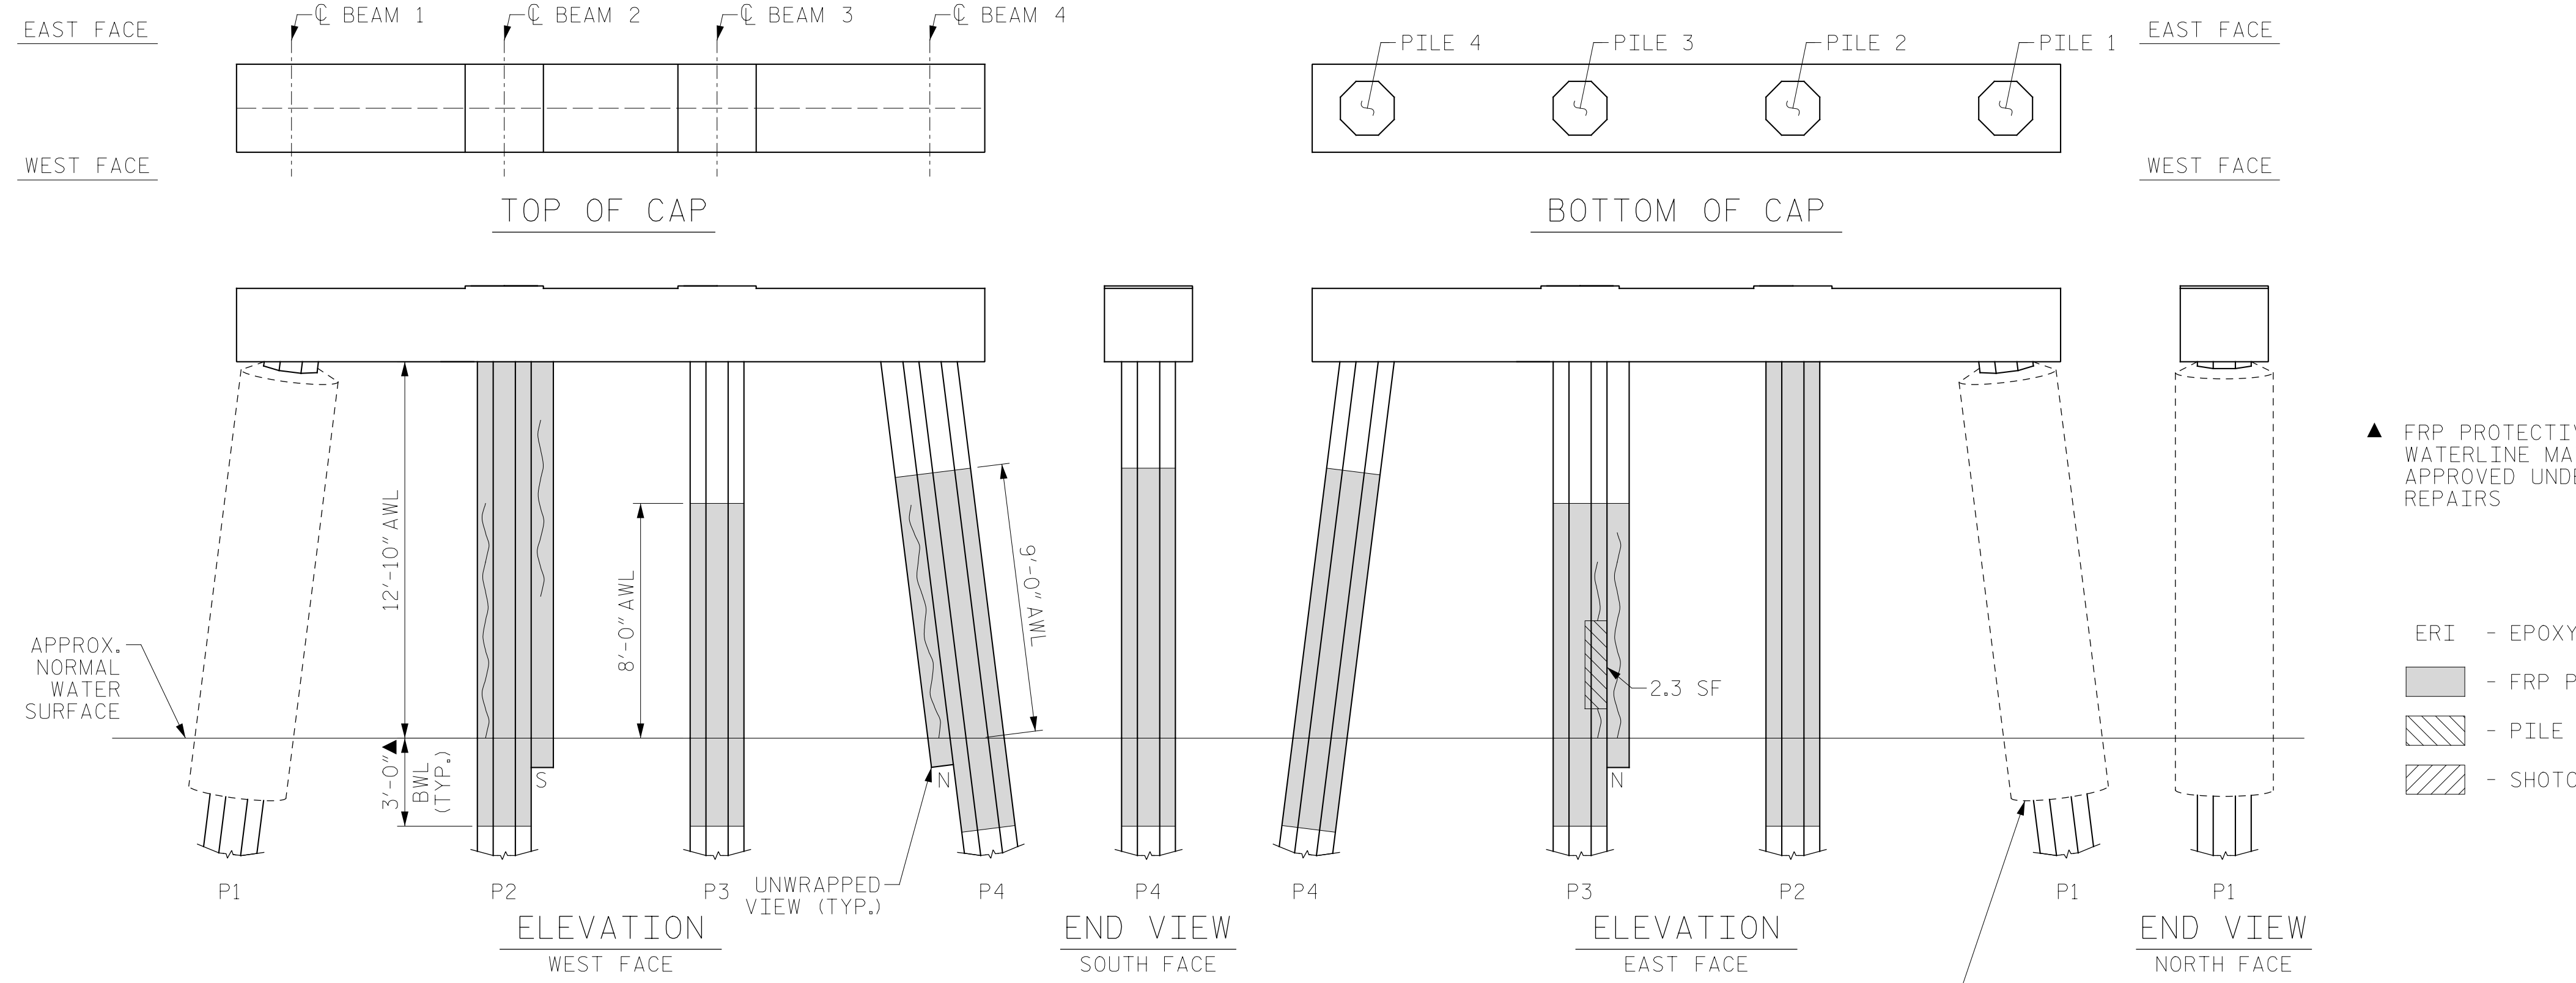
BENT 46

CAP REPAIRS		ESTIMATE			
SHOTCRETE REPAIRS	- SF	- CF	SF	CF	
EPOXY RESIN INJECTION	- LF				LF
PILE REPAIRS		ESTIMATE			
PILE CONCRETE RESTORATION	2.3 SF	1.2 CF	SF	CF	
FRP PROTECTIVE SYSTEM AWL	164.5 SF				
FRP PROTECTIVE SYSTEM BWL	49.5 SF

(AWL = ABOVE WATERLINE)
(BWL = BELOW WATERLINE)
(**QUANTITY INCLUDES ADJACENT REPAIRS)
