AS-BUILT REPAIR QUANTITY TABLE

PROJECT NO. HB-0017
DARE COUNTY
BRIDGE NO. 270009

STATE OF NORTH CAROLINA
DEPARTMENT OF TRANSPORTATION
RALEIGH

BENT 53 & BENT 54

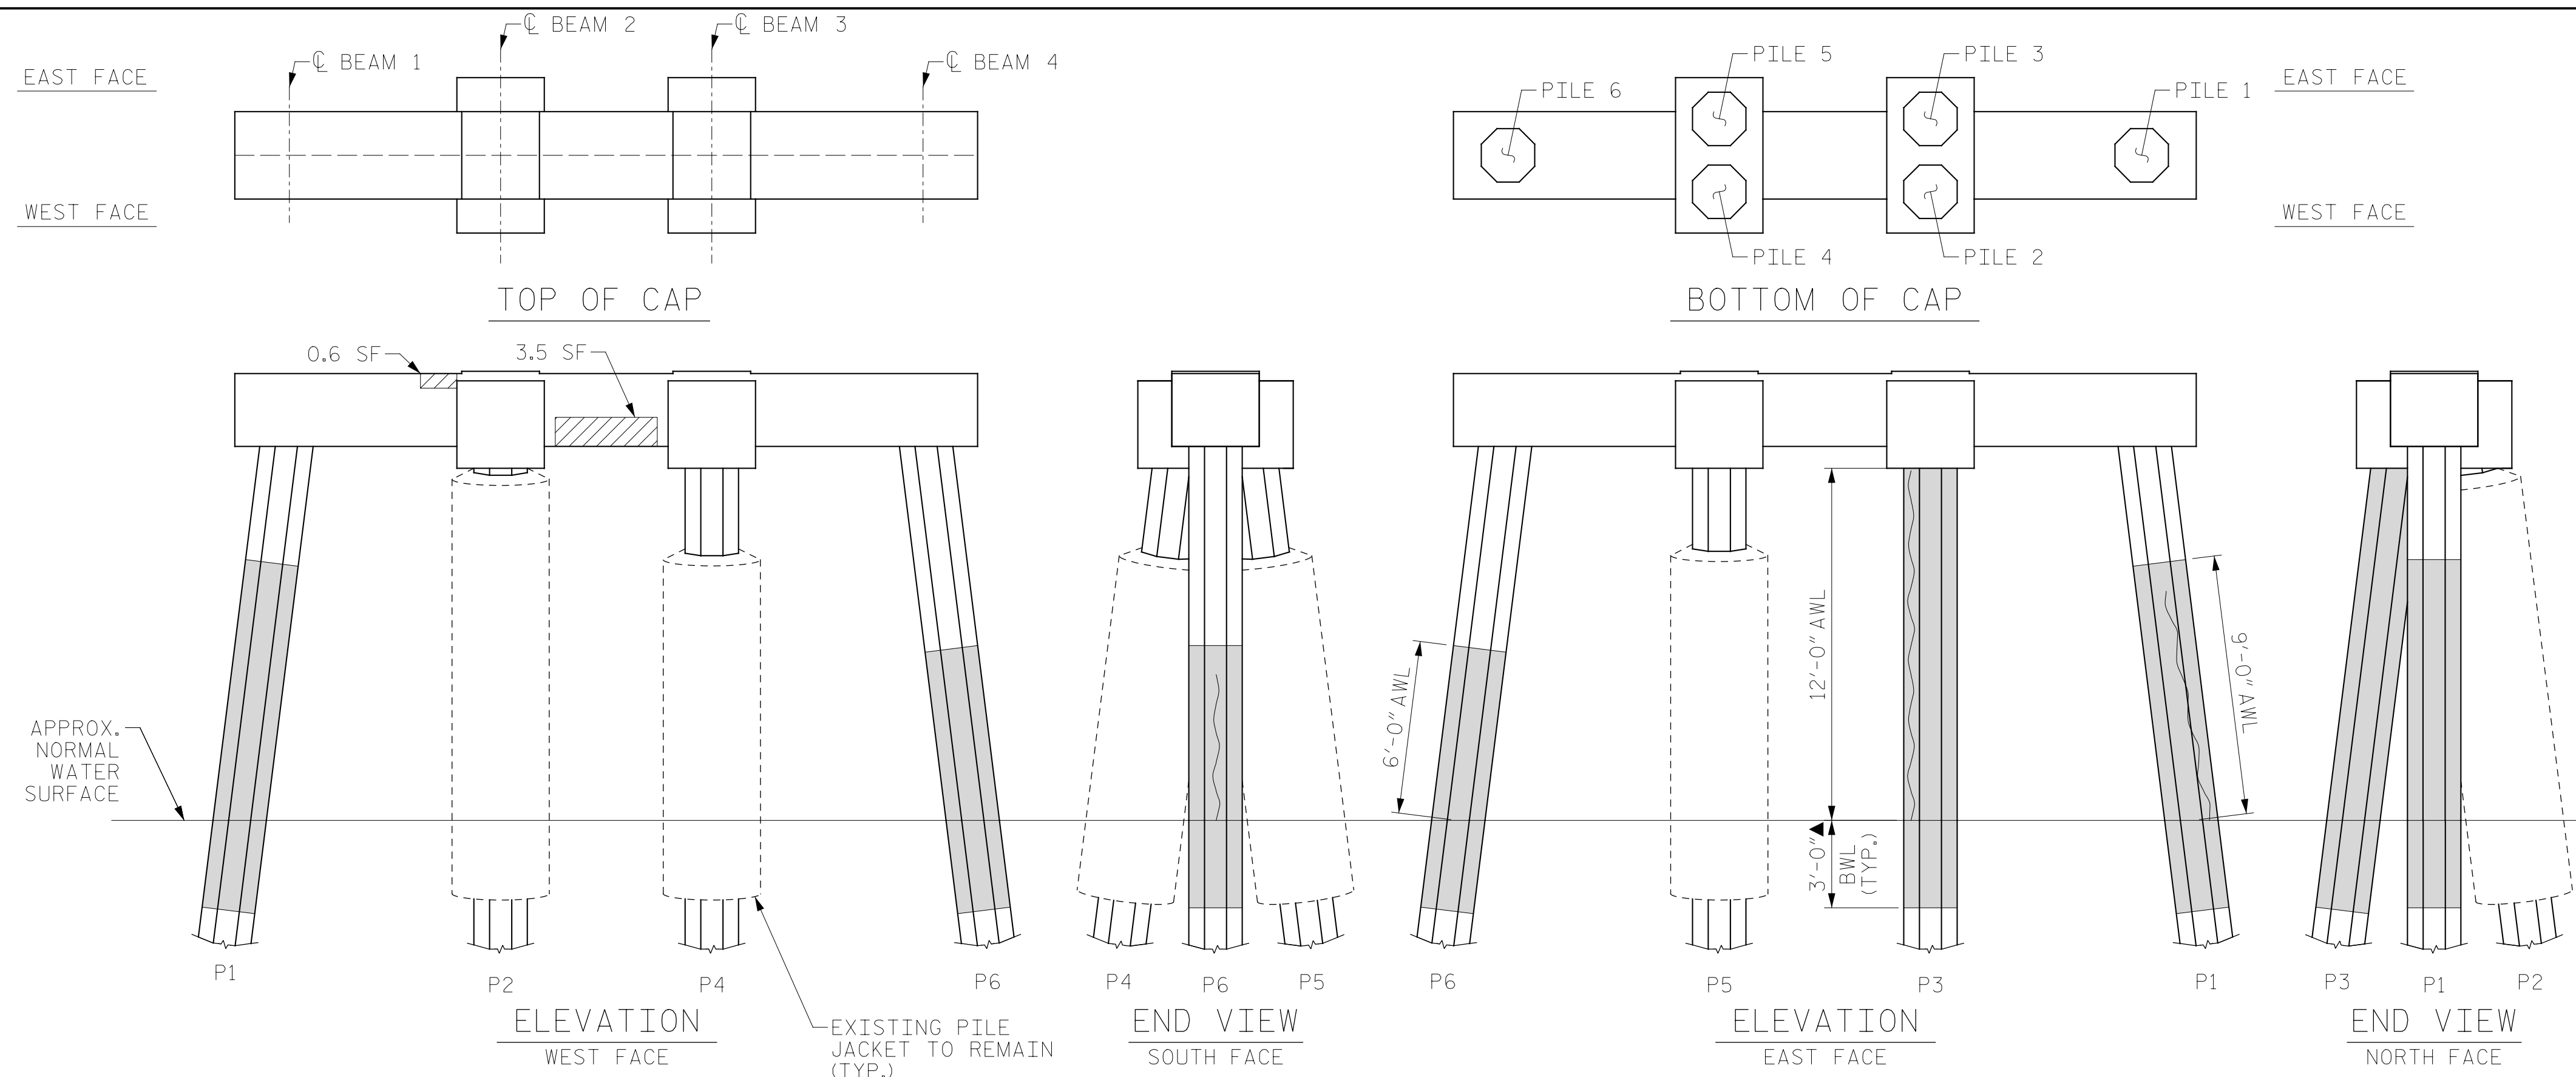
BENT 53

CAP REPAIRS			
SHOTCRETE REPAIRS	4.1 SF	2.1 CF	SF CF
EPOXY RESIN INJECTION	- LF		LF
PILE REPAIRS			
PILE CONCRETE RESTORATION	- SF	- CF	SF CF
FRP PROTECTIVE SYSTEM AWL	149.4 SF		
FRP PROTECTIVE SYSTEM BWL	49.5 SF

(AWL = ABOVE WATERLINE)
(BWL = BELOW WATERLINE)

(**QUANTITY INCLUDES ADJACENT REPAIRS)

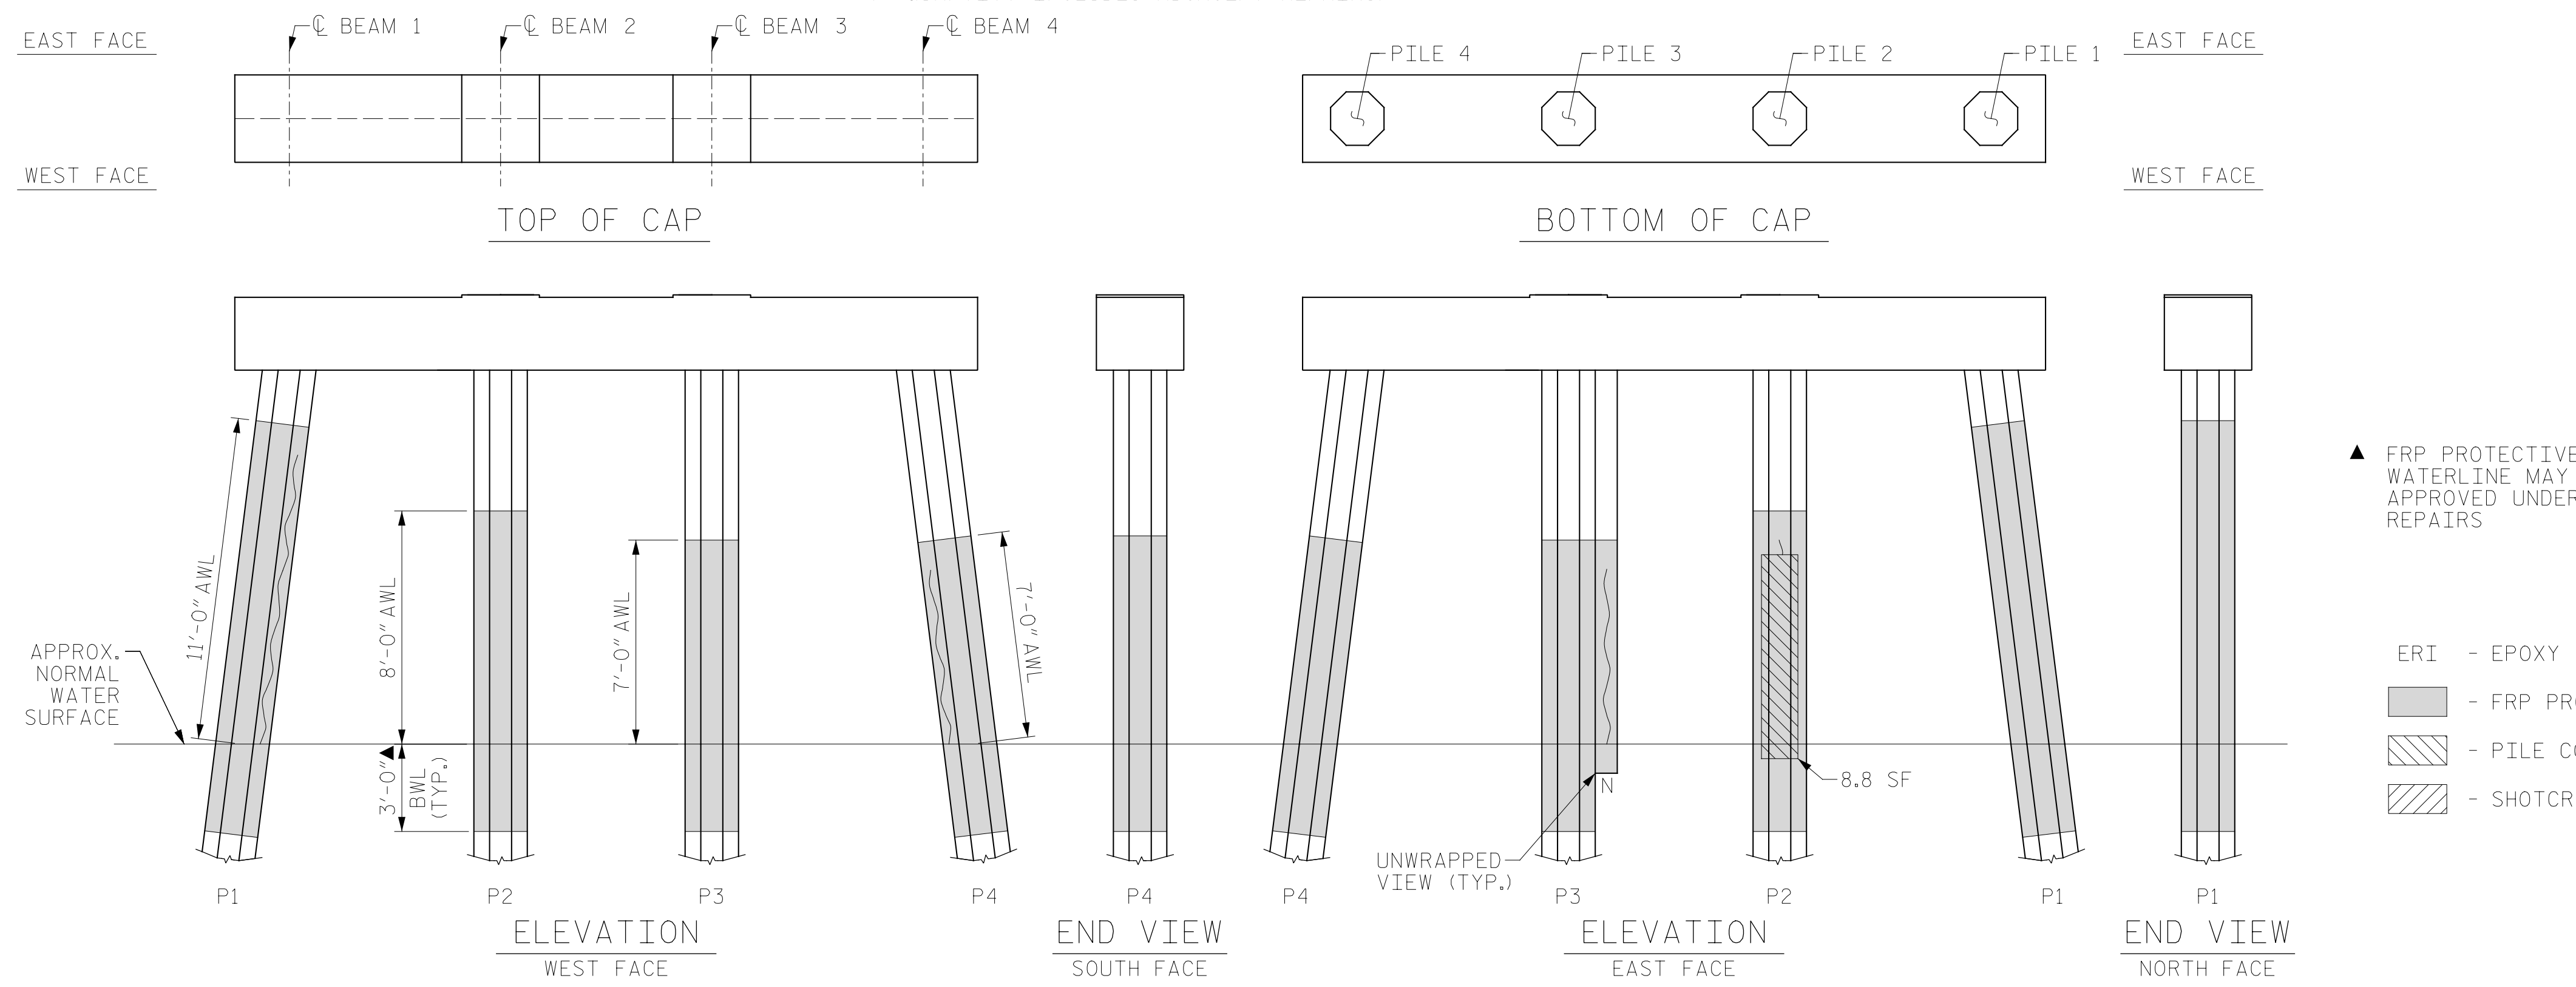
BENT 54

CAP REPAIRS			
SHOTCRETE REPAIRS	- SF	- CF	SF CF
EPOXY RESIN INJECTION	- LF		LF
PILE REPAIRS			
PILE CONCRETE RESTORATION	8.8 SF	3.7 CF	SF CF
FRP PROTECTIVE SYSTEM AWL	182.4 SF		
FRP PROTECTIVE SYSTEM BWL	66.0 SF

(AWL = ABOVE WATERLINE)
(BWL = BELOW WATERLINE)

(**QUANTITY INCLUDES ADJACENT REPAIRS)

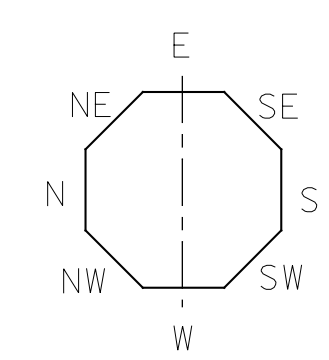
▲ FRP PROTECTIVE SYSTEM BELOW WATERLINE MAY INCLUDE APPROVED UNDERWATER MORTAR REPAIRS

- ERI - EPOXY RESIN INJECTION
- [Hatched Box] - FRP PROTECTIVE SYSTEM
- [Diagonal Lines Box] - PILE CONCRETE RESTORATION
- [Cross-hatched Box] - SHOTCRETE REPAIRS
