AS-BUILT REPAIR QUANTITY TABLE

PROJECT NO. HB-0017
DARE COUNTY
 BRIDGE NO. 270009

STATE OF NORTH CAROLINA
 DEPARTMENT OF TRANSPORTATION
 RALEIGH

BENT 55 & BENT 56

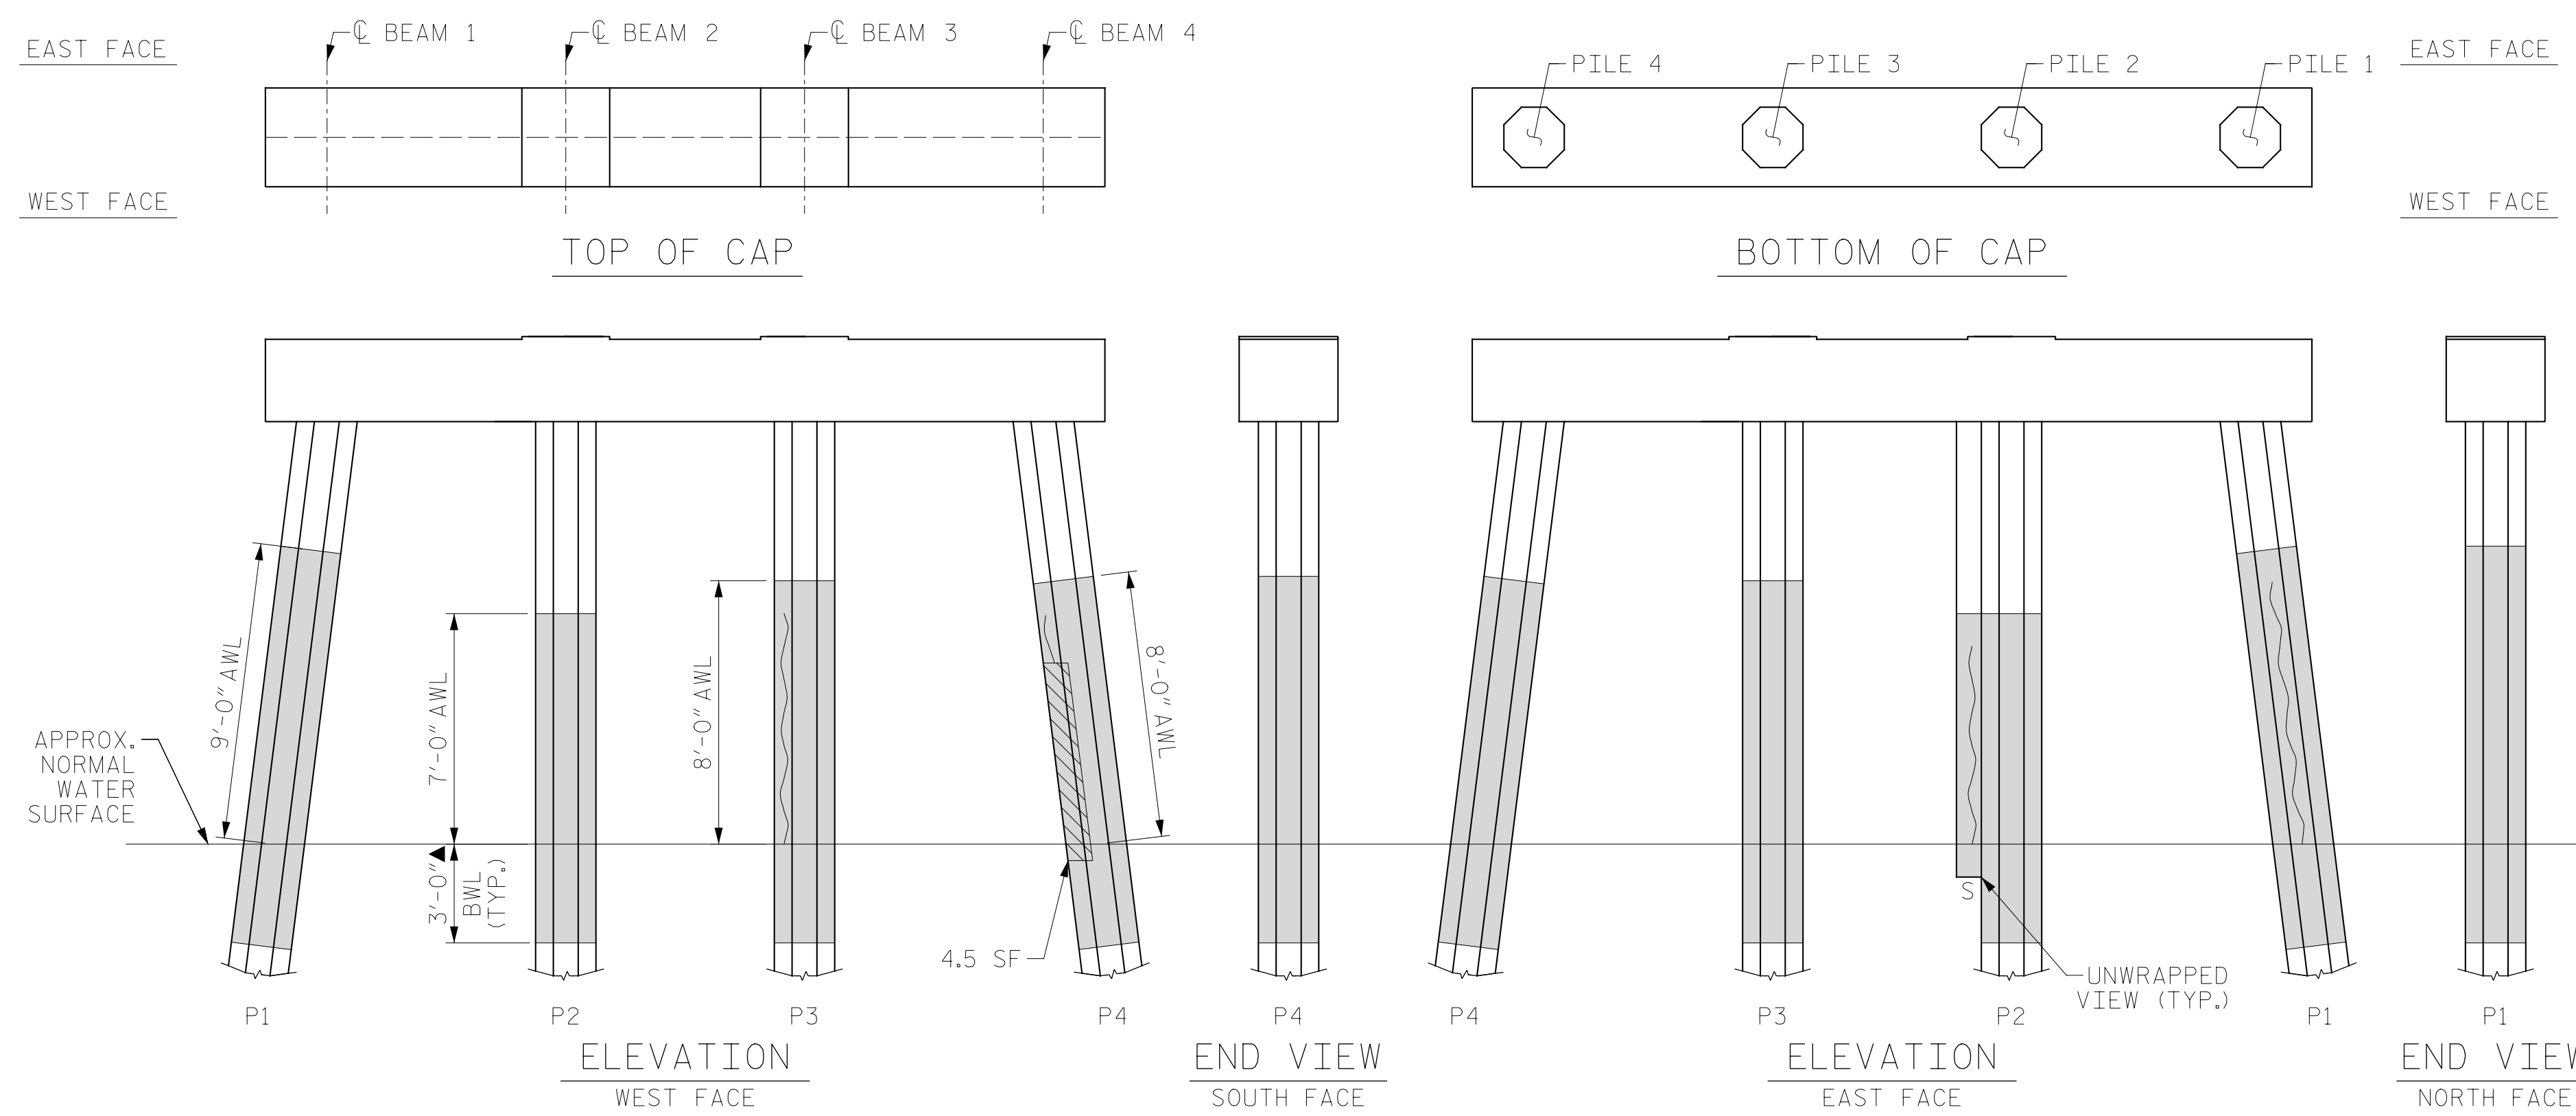
BENT 55

CAP REPAIRS			
SHOTCRETE REPAIRS	- SF	- CF	SF CF
EPOXY RESIN INJECTION	- LF		LF
PILE REPAIRS			
PILE CONCRETE RESTORATION	4.5 SF	2.4 CF	SF CF
FRP PROTECTIVE SYSTEM AWL	176.9 SF		
FRP PROTECTIVE SYSTEM BWL	66.0 SF

(AWL = ABOVE WATERLINE)
(BWL = BELOW WATERLINE)
(*QUANTITY INCLUDES ADJACENT REPAIRS)

FOR CAP REPAIRS: VALUES IN CHART REPRESENT ESTIMATED REPAIR TOTALS AFTER REMOVAL OF UNSOUND CONCRETE, MIN. OF 1" BEHIND REBAR AND MIN. 2" CL. TO SAWCUT. SEE REPAIR DETAILS.

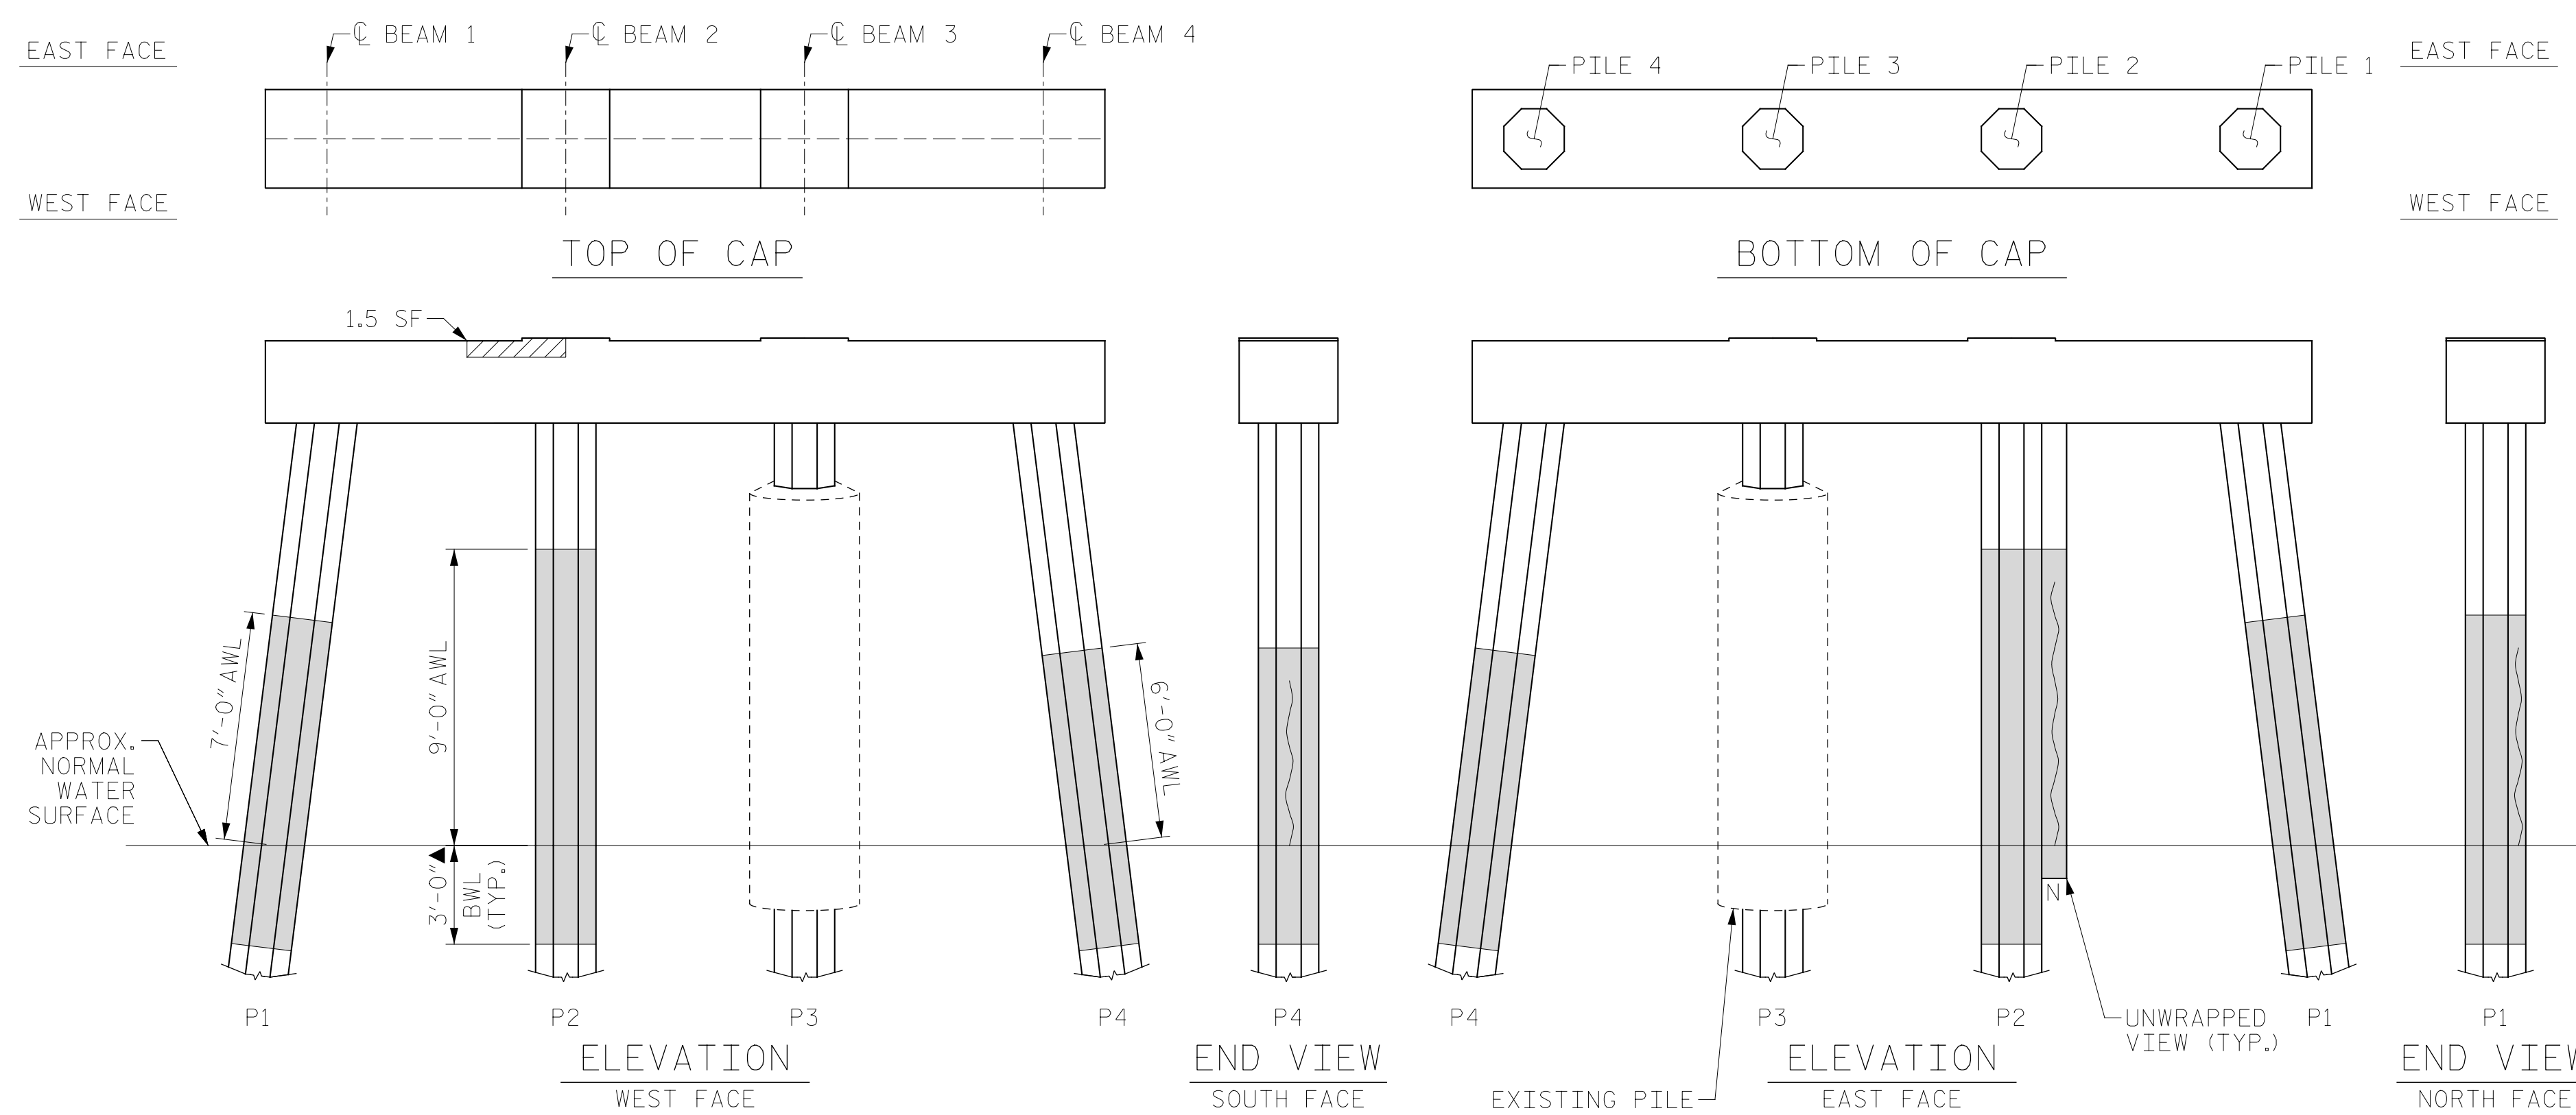
BENT 56

CAP REPAIRS			
SHOTCRETE REPAIRS	1.5 SF	0.8 CF	SF CF
EPOXY RESIN INJECTION	- LF		LF
PILE REPAIRS			
PILE CONCRETE RESTORATION	- SF	- CF	SF CF
FRP PROTECTIVE SYSTEM AWL	121.9 SF		
FRP PROTECTIVE SYSTEM BWL	49.5 SF

(AWL = ABOVE WATERLINE)
(BWL = BELOW WATERLINE)
(*QUANTITY INCLUDES ADJACENT REPAIRS)
