AS-BUILT REPAIR QUANTITY TABLE

PROJECT NO. HB-0017
DARE COUNTY
 BRIDGE NO. 270009

BENT 57 & BENT 58

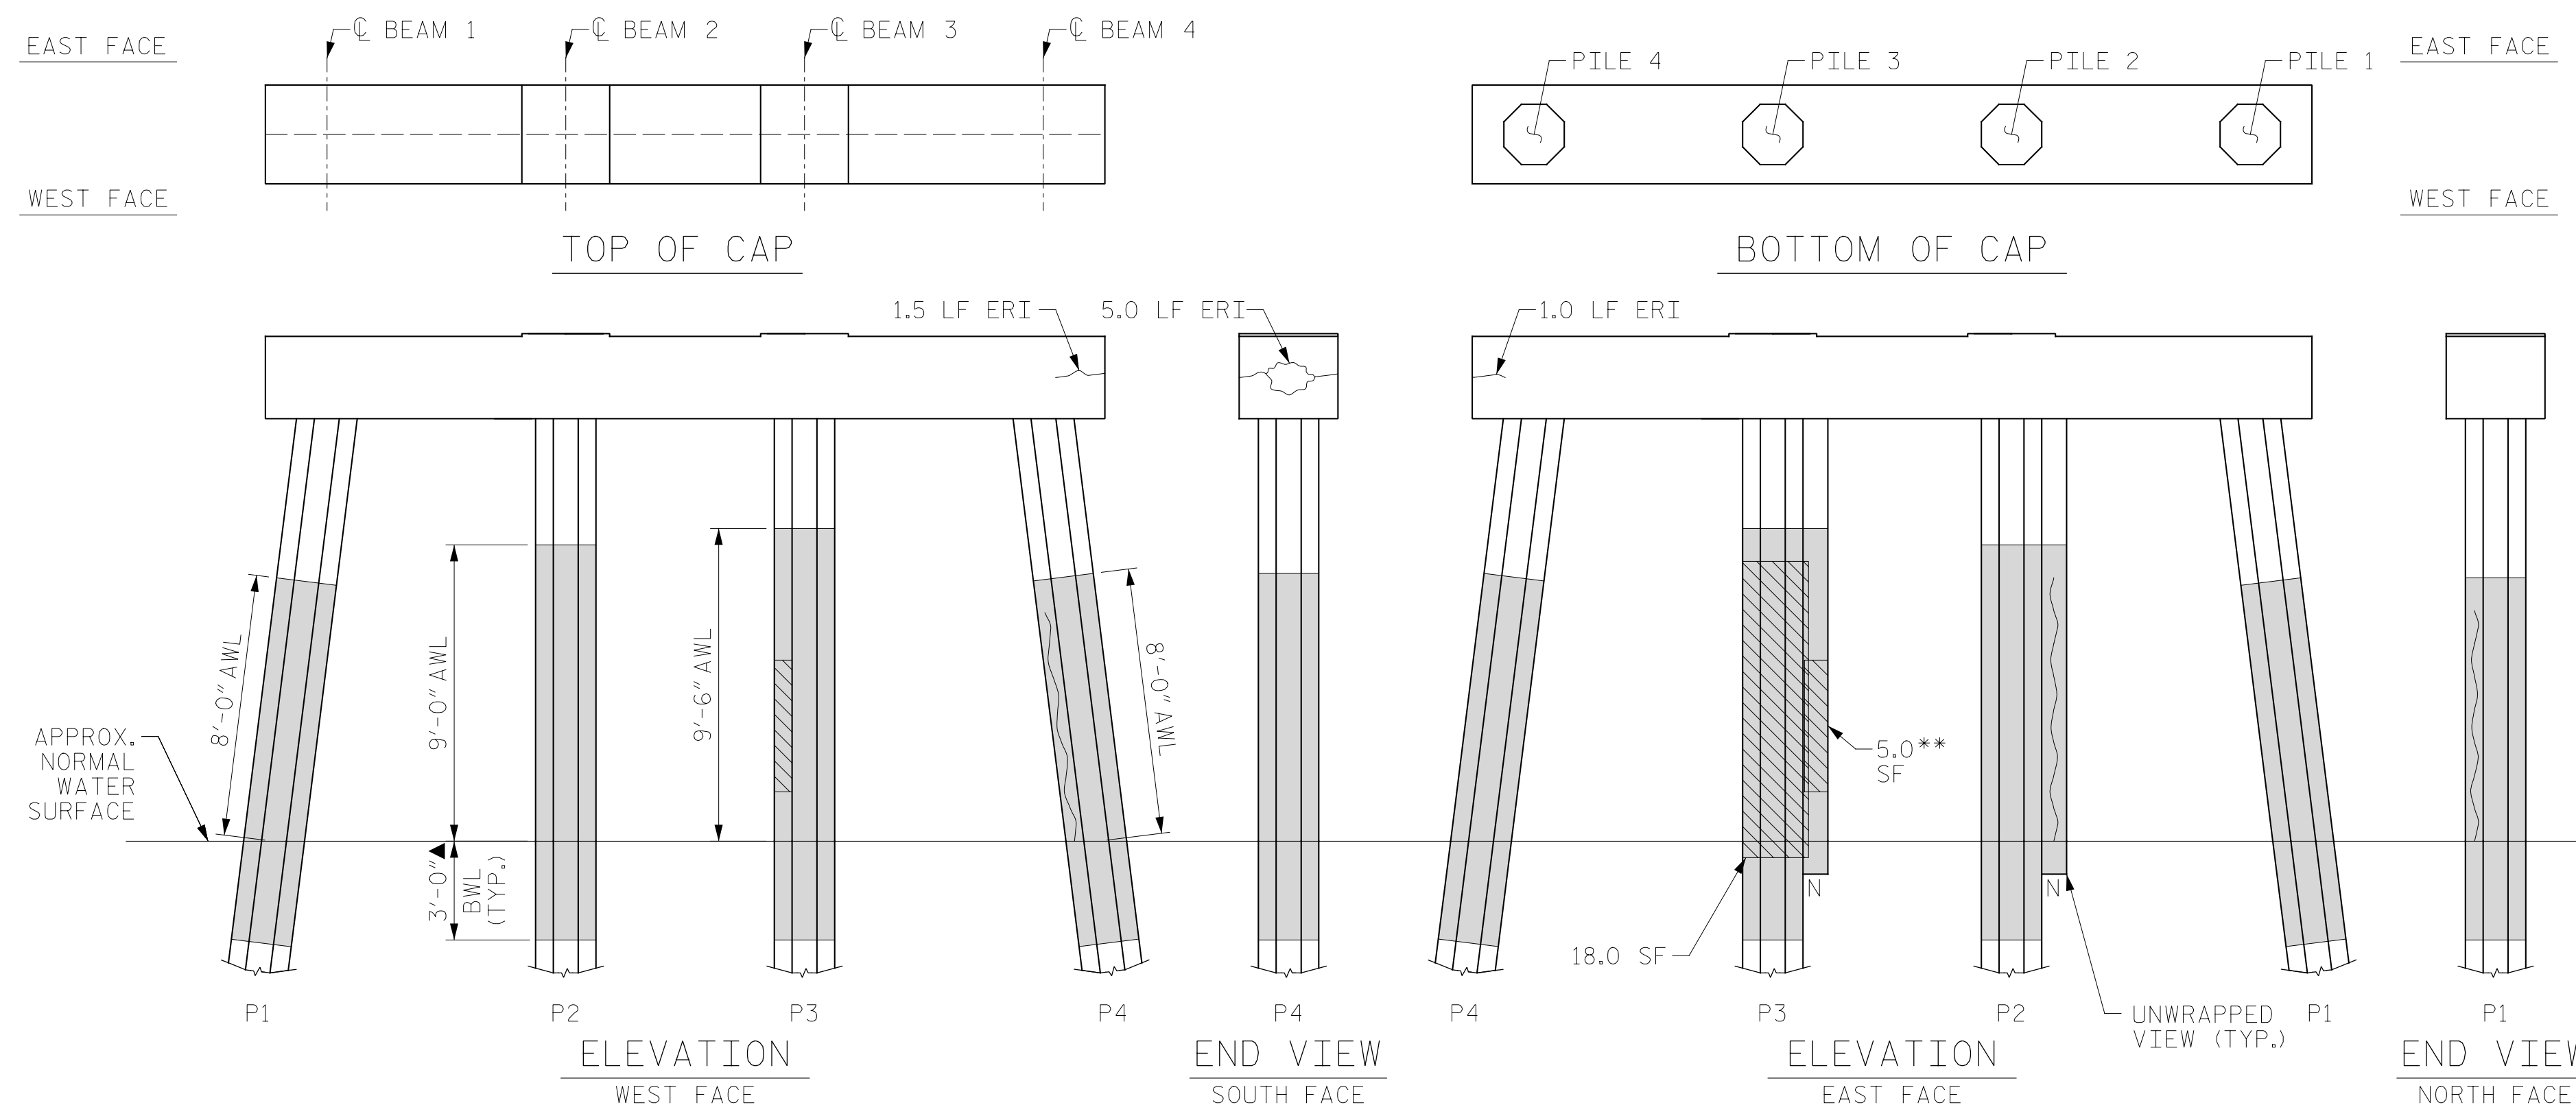
BENT 57

CAP REPAIRS			
SHOTCRETE REPAIRS	- SF	- CF	SF CF
EPOXY RESIN INJECTION	7.5 LF		LF
PILE REPAIRS			
PILE CONCRETE RESTORATION	23.0 SF	9.2 CF	SF CF
FRP PROTECTIVE SYSTEM AWL	190.7 SF		
FRP PROTECTIVE SYSTEM BWL	66.0 SF

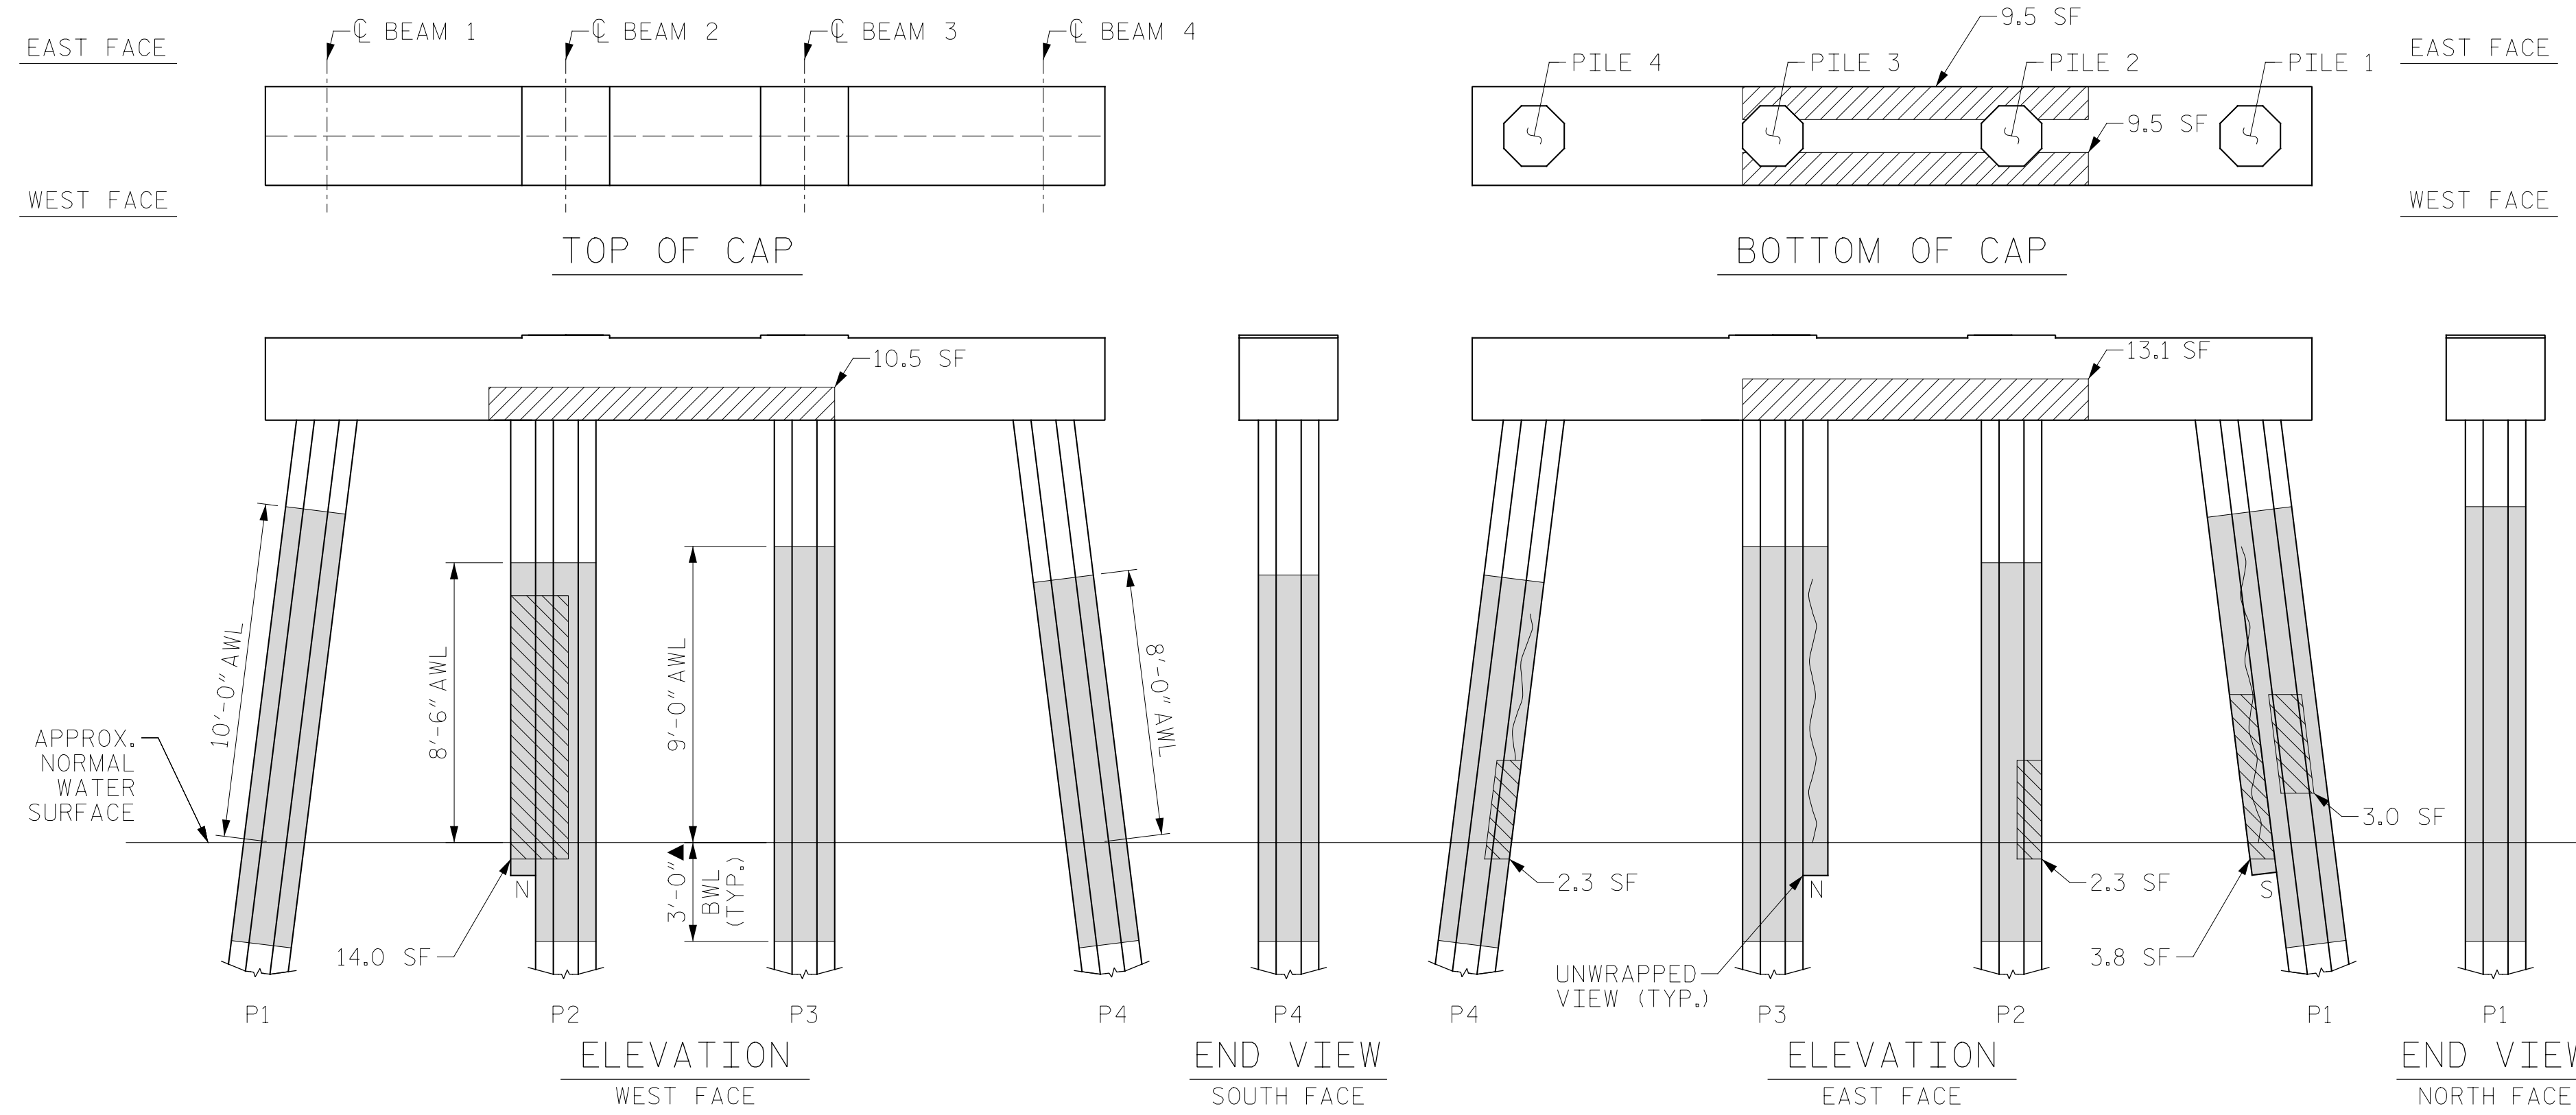
BENT 58

CAP REPAIRS			
SHOTCRETE REPAIRS	42.6 SF	23.6 CF	SF CF
EPOXY RESIN INJECTION	- LF		LF
PILE REPAIRS			
PILE CONCRETE RESTORATION	25.4 SF	11.4 CF	SF CF
FRP PROTECTIVE SYSTEM AWL	152.2 SF		
FRP PROTECTIVE SYSTEM BWL	66.0 SF
