AS-BUILT REPAIR QUANTITY TABLE

PROJECT NO. HB-0017  
DARE COUNTY  
BRIDGE NO. 270009

BENT 67 & BENT 68

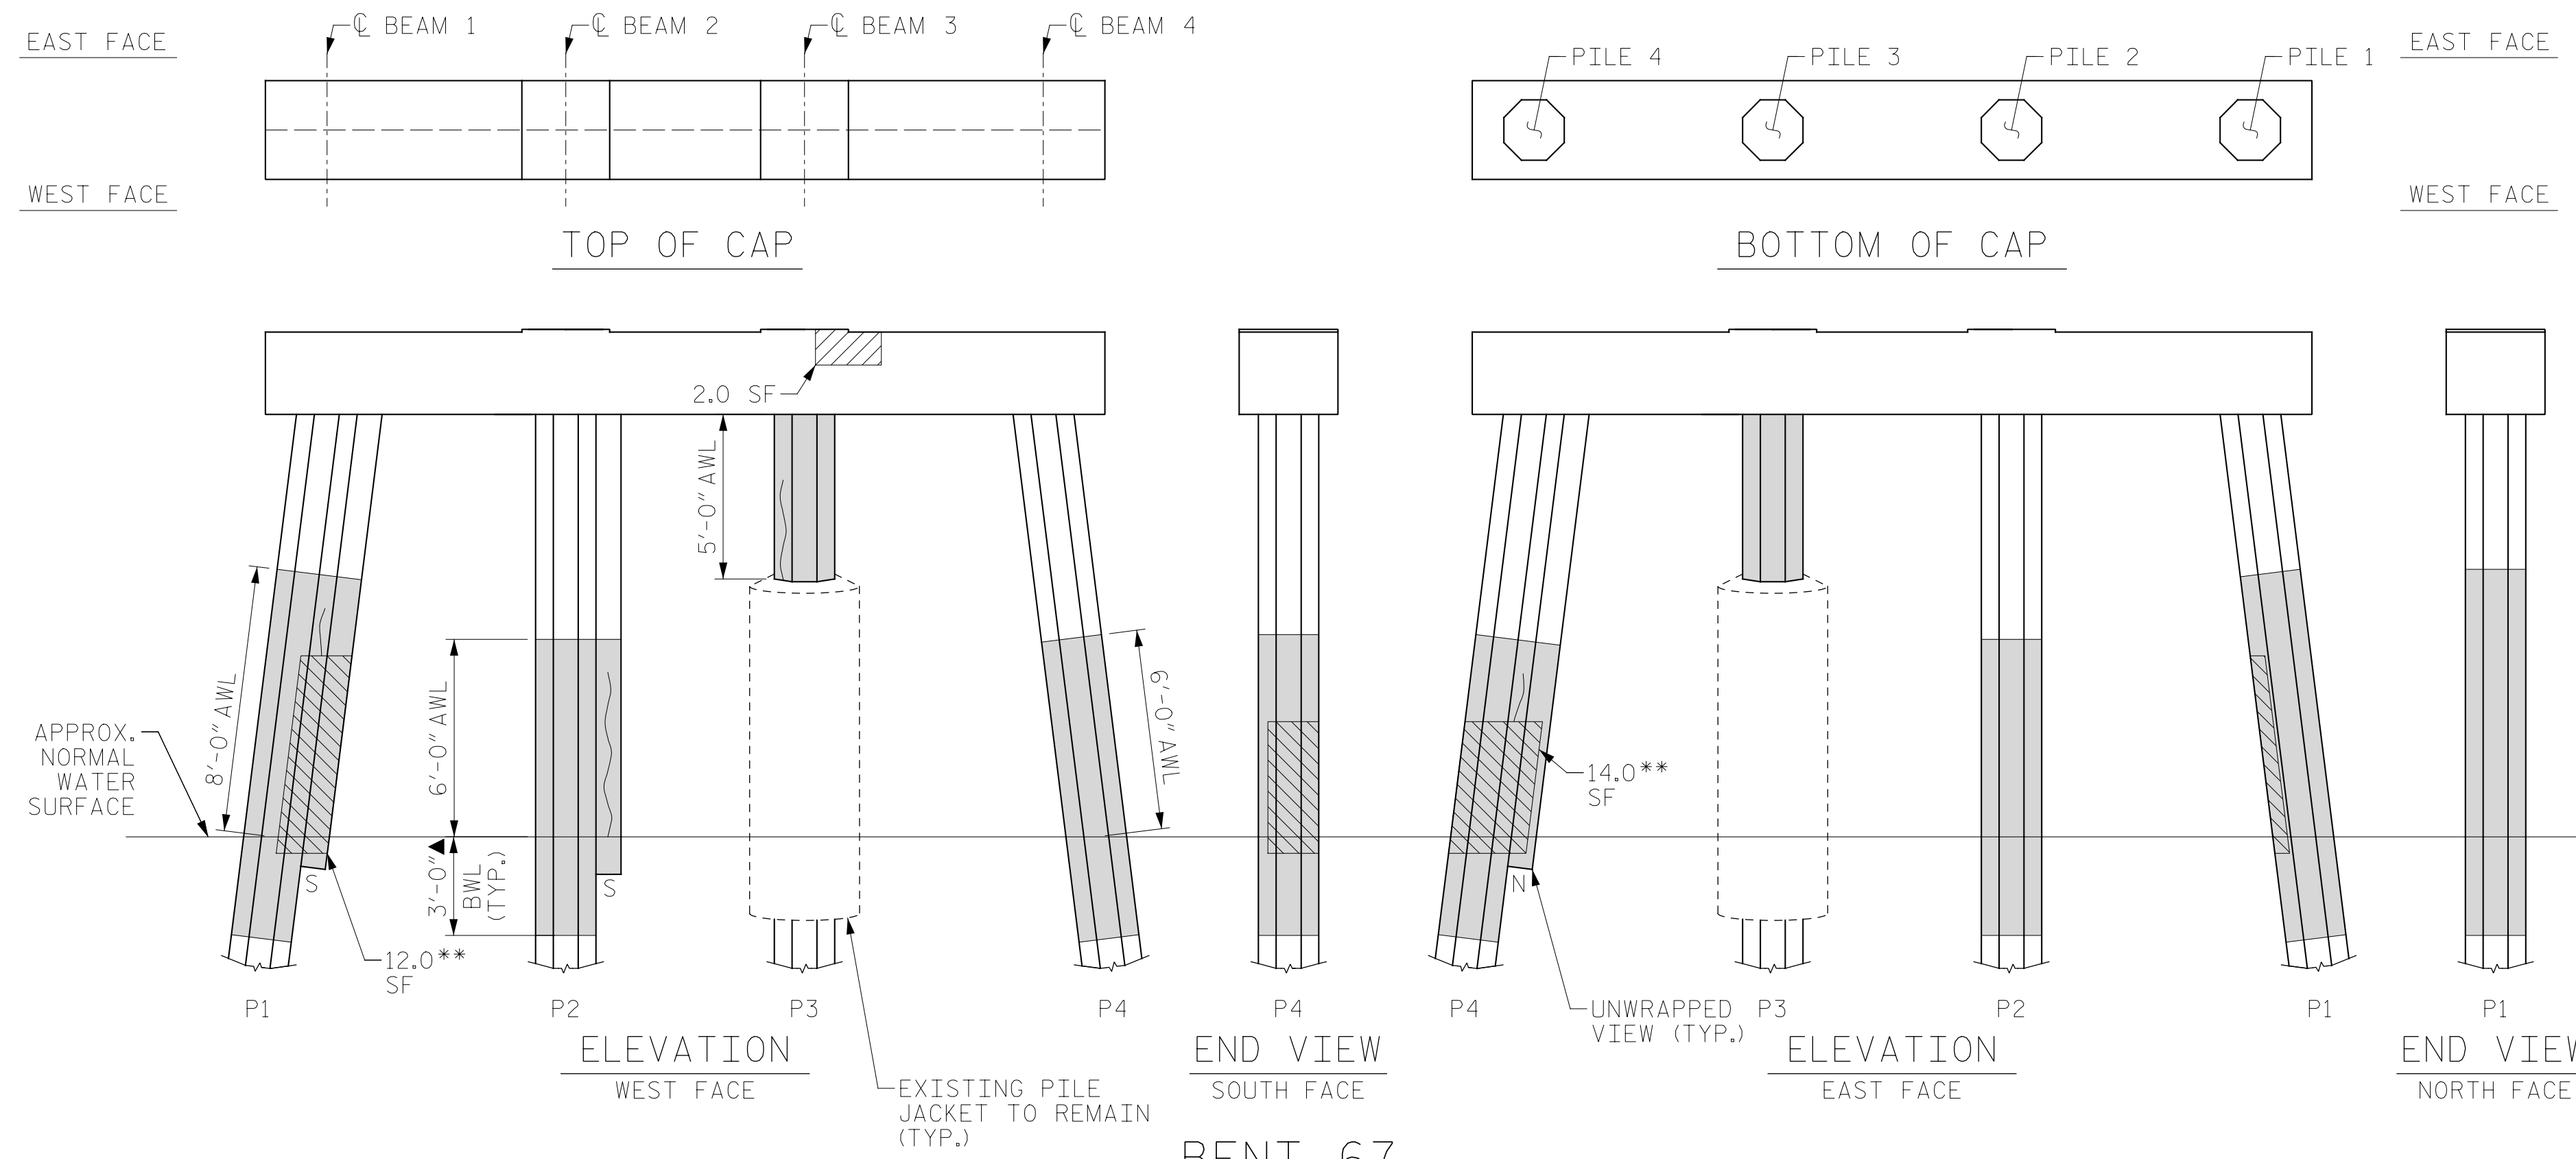
BENT 67

| CAP REPAIRS | | | |
|---|---|---|---|
| PILE CONCRETE RESTORATION | 26.0 SF | 9.9 CF | SF CF |
| FRP PROTECTIVE SYSTEM AWL | 138.4 SF | | |
| FRP PROTECTIVE SYSTEM BWL | 49.5 SF | | |

(AWL = ABOVE WATERLINE)  
(BWL = BELOW WATERLINE)  
(\*\*QUANTITY INCLUDES ADJACENT REPAIRS)

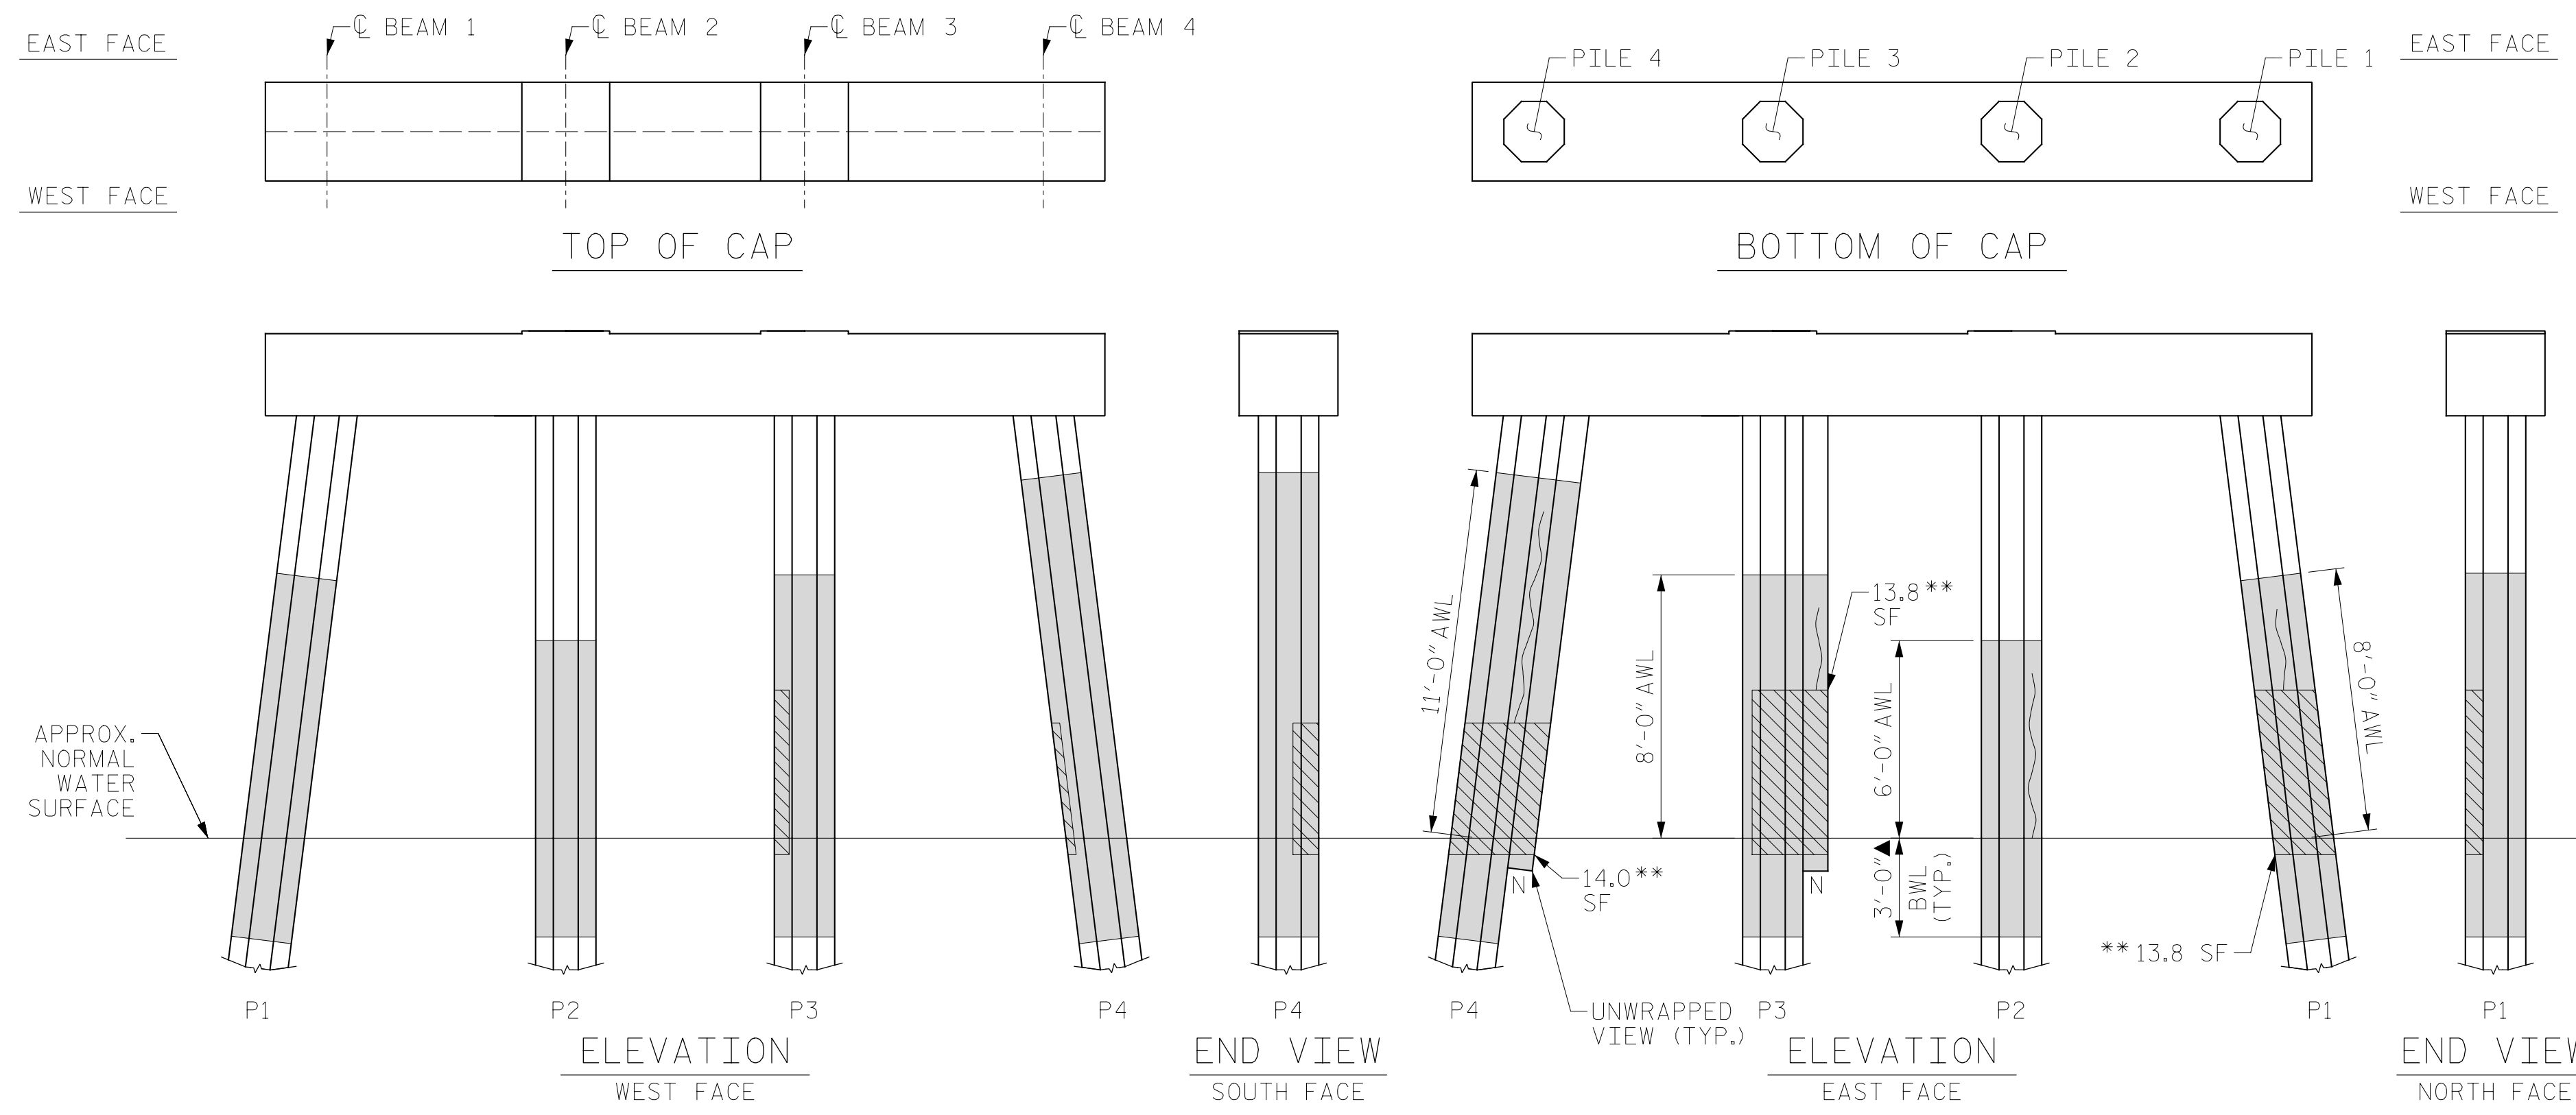
BENT 68

| CAP REPAIRS | | | |
|---|---|---|---|
| PILE CONCRETE RESTORATION | 41.6 SF | 16.0 CF | SF CF |
| FRP PROTECTIVE SYSTEM AWL | 182.4 SF | | |
| FRP PROTECTIVE SYSTEM BWL | 66.0 SF | | |

(AWL = ABOVE WATERLINE)  
(BWL = BELOW WATERLINE)  
(\*\*QUANTITY INCLUDES ADJACENT REPAIRS)
