AS-BUILT REPAIR QUANTITY TABLE

PROJECT NO. HB-0017
DARE COUNTY
 BRIDGE NO. 270009

BENT 69 & BENT 70

REVISIONS						SHEET NO. S-150
NO.	BY:	DATE:	NO.	BY:	DATE:	
1			3			TOTAL SHEETS
2			4			355

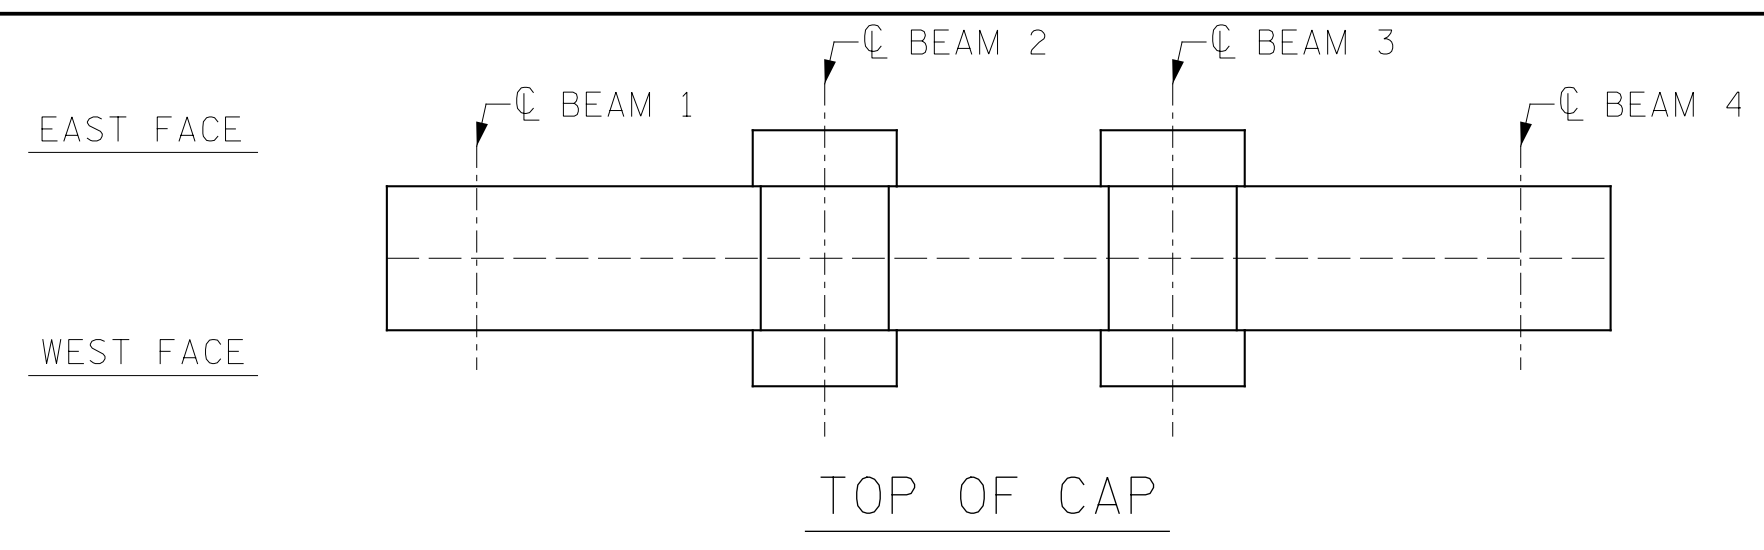
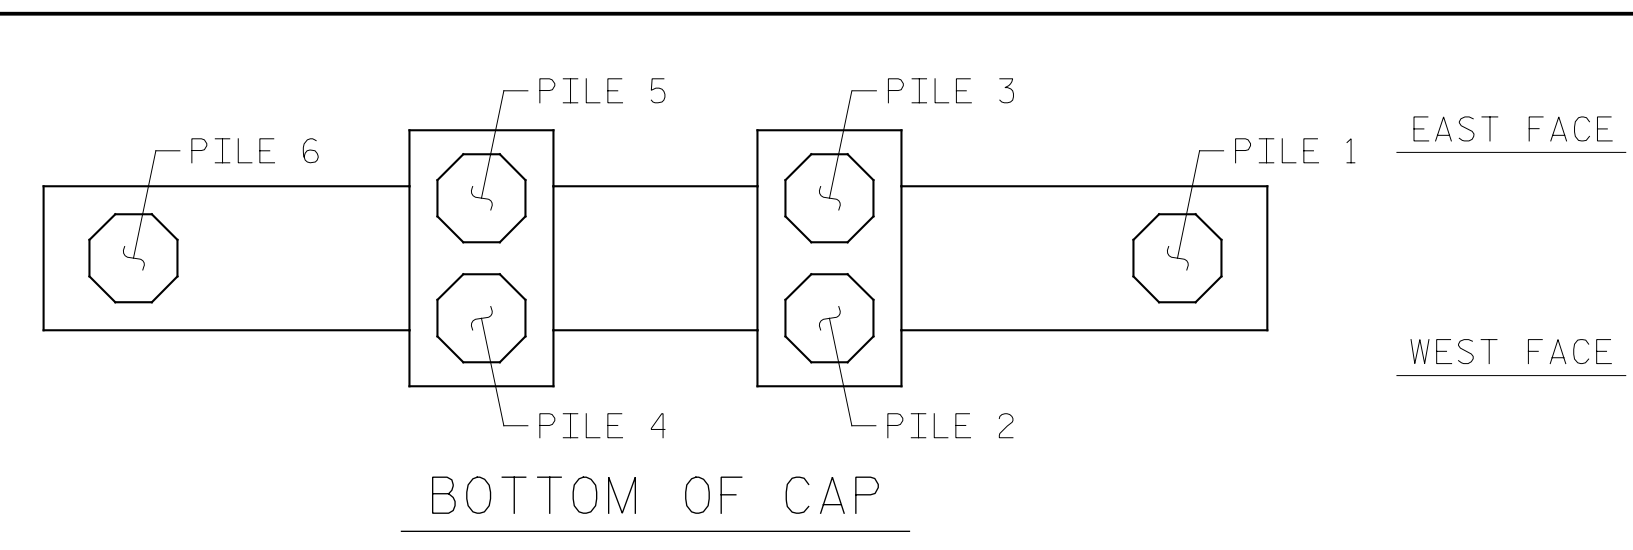
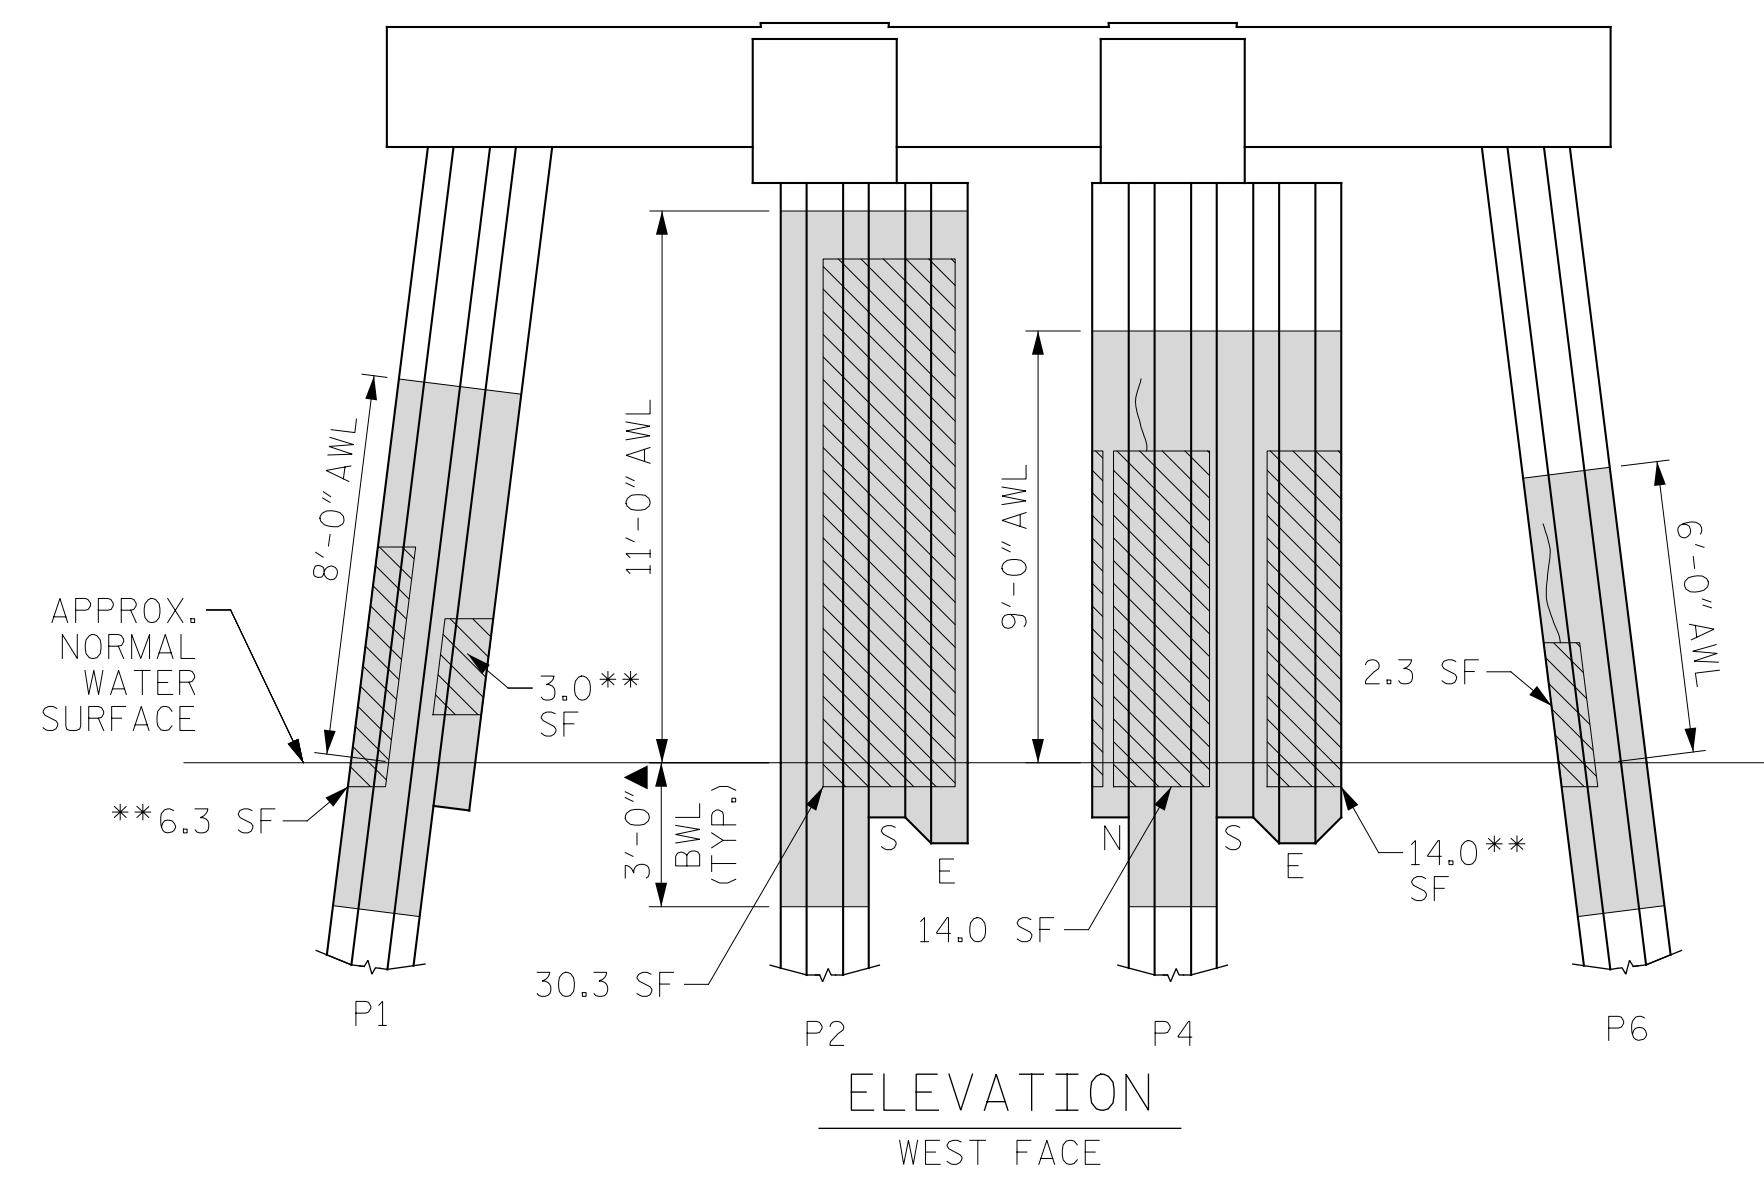
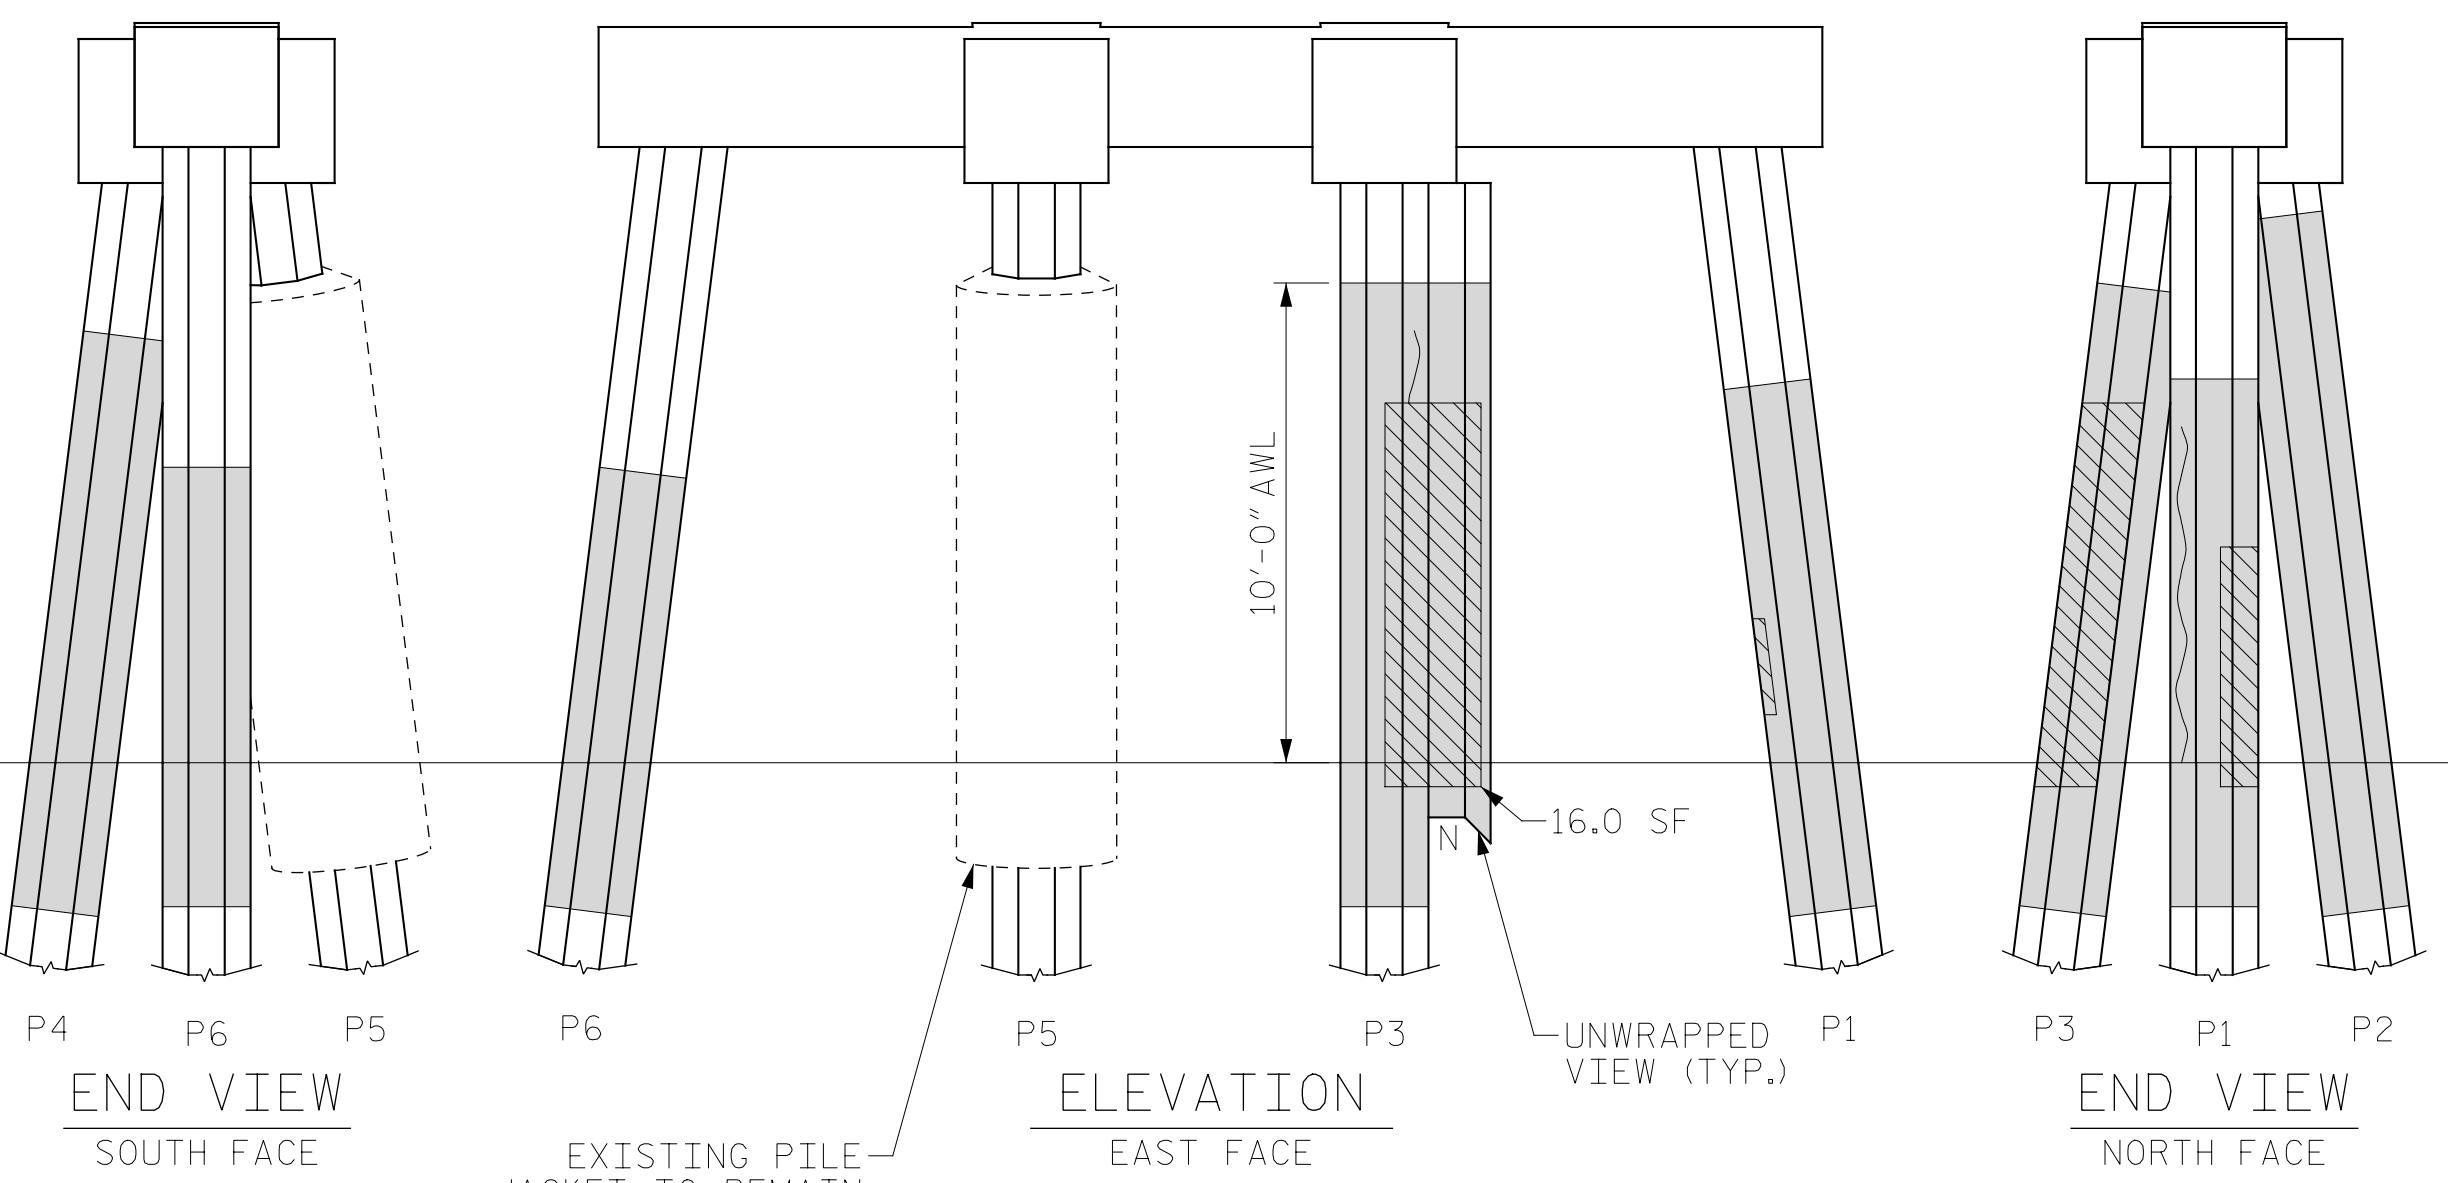
BENT 69

CAP REPAIRS			
SHOTCRETE REPAIRS	- SF	- CF	SF CF
EPOXY RESIN INJECTION	- LF		LF
PILE REPAIRS			
PILE CONCRETE RESTORATION	85.9 SF	34.4 CF	SF CF
FRP PROTECTIVE SYSTEM AWL	243.0 SF		
FRP PROTECTIVE SYSTEM BWL	82.5 SF

(AWL = ABOVE WATERLINE)
(BWL = BELOW WATERLINE)
(**QUANTITY INCLUDES ADJACENT REPAIRS)

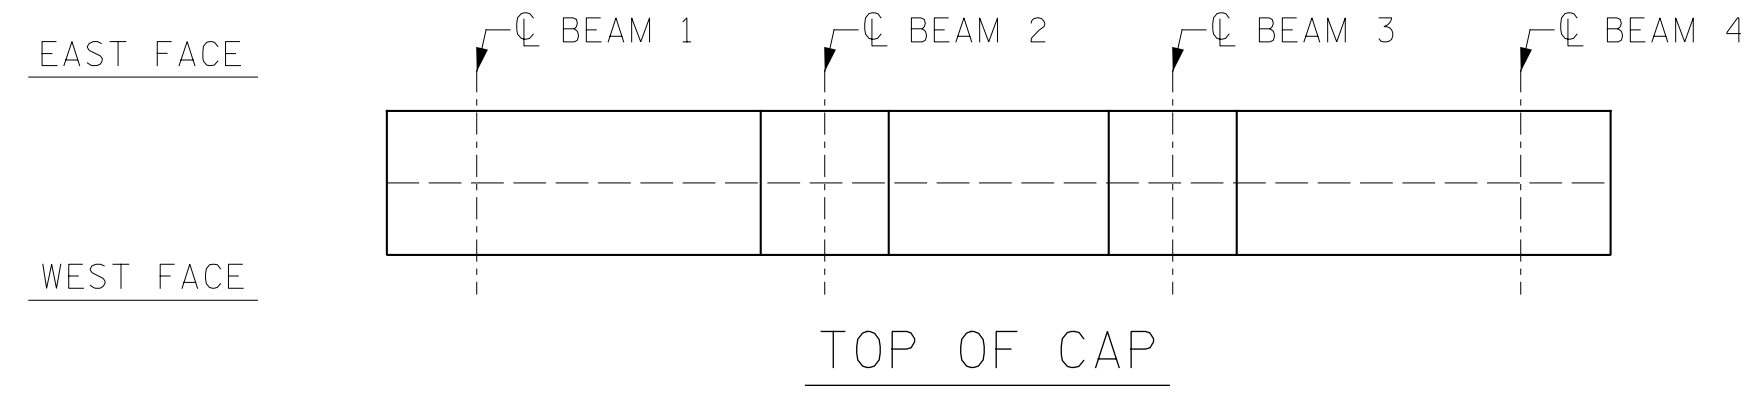
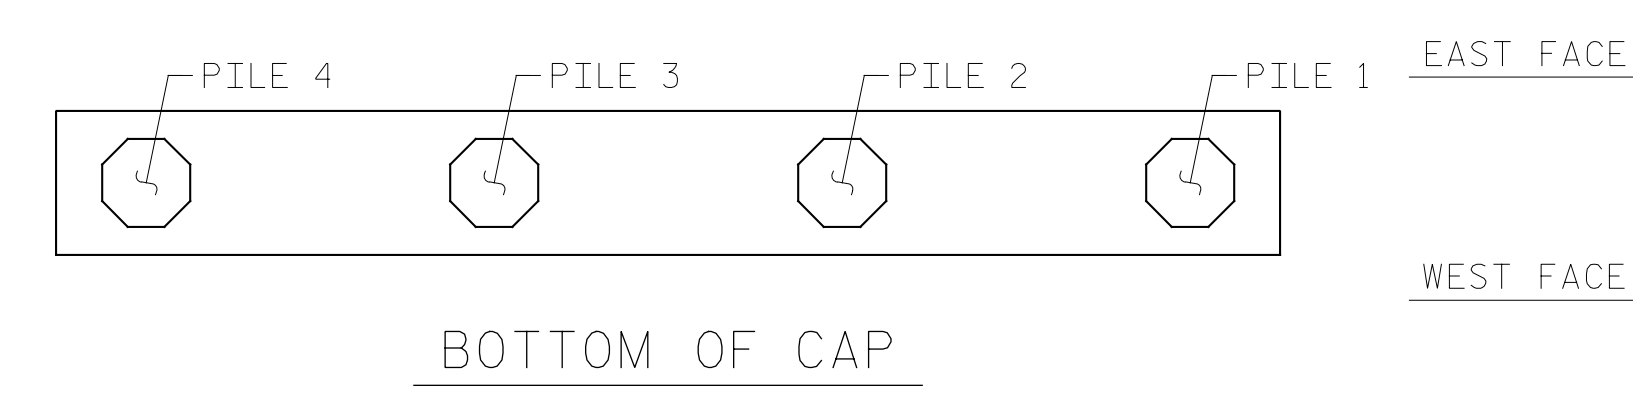
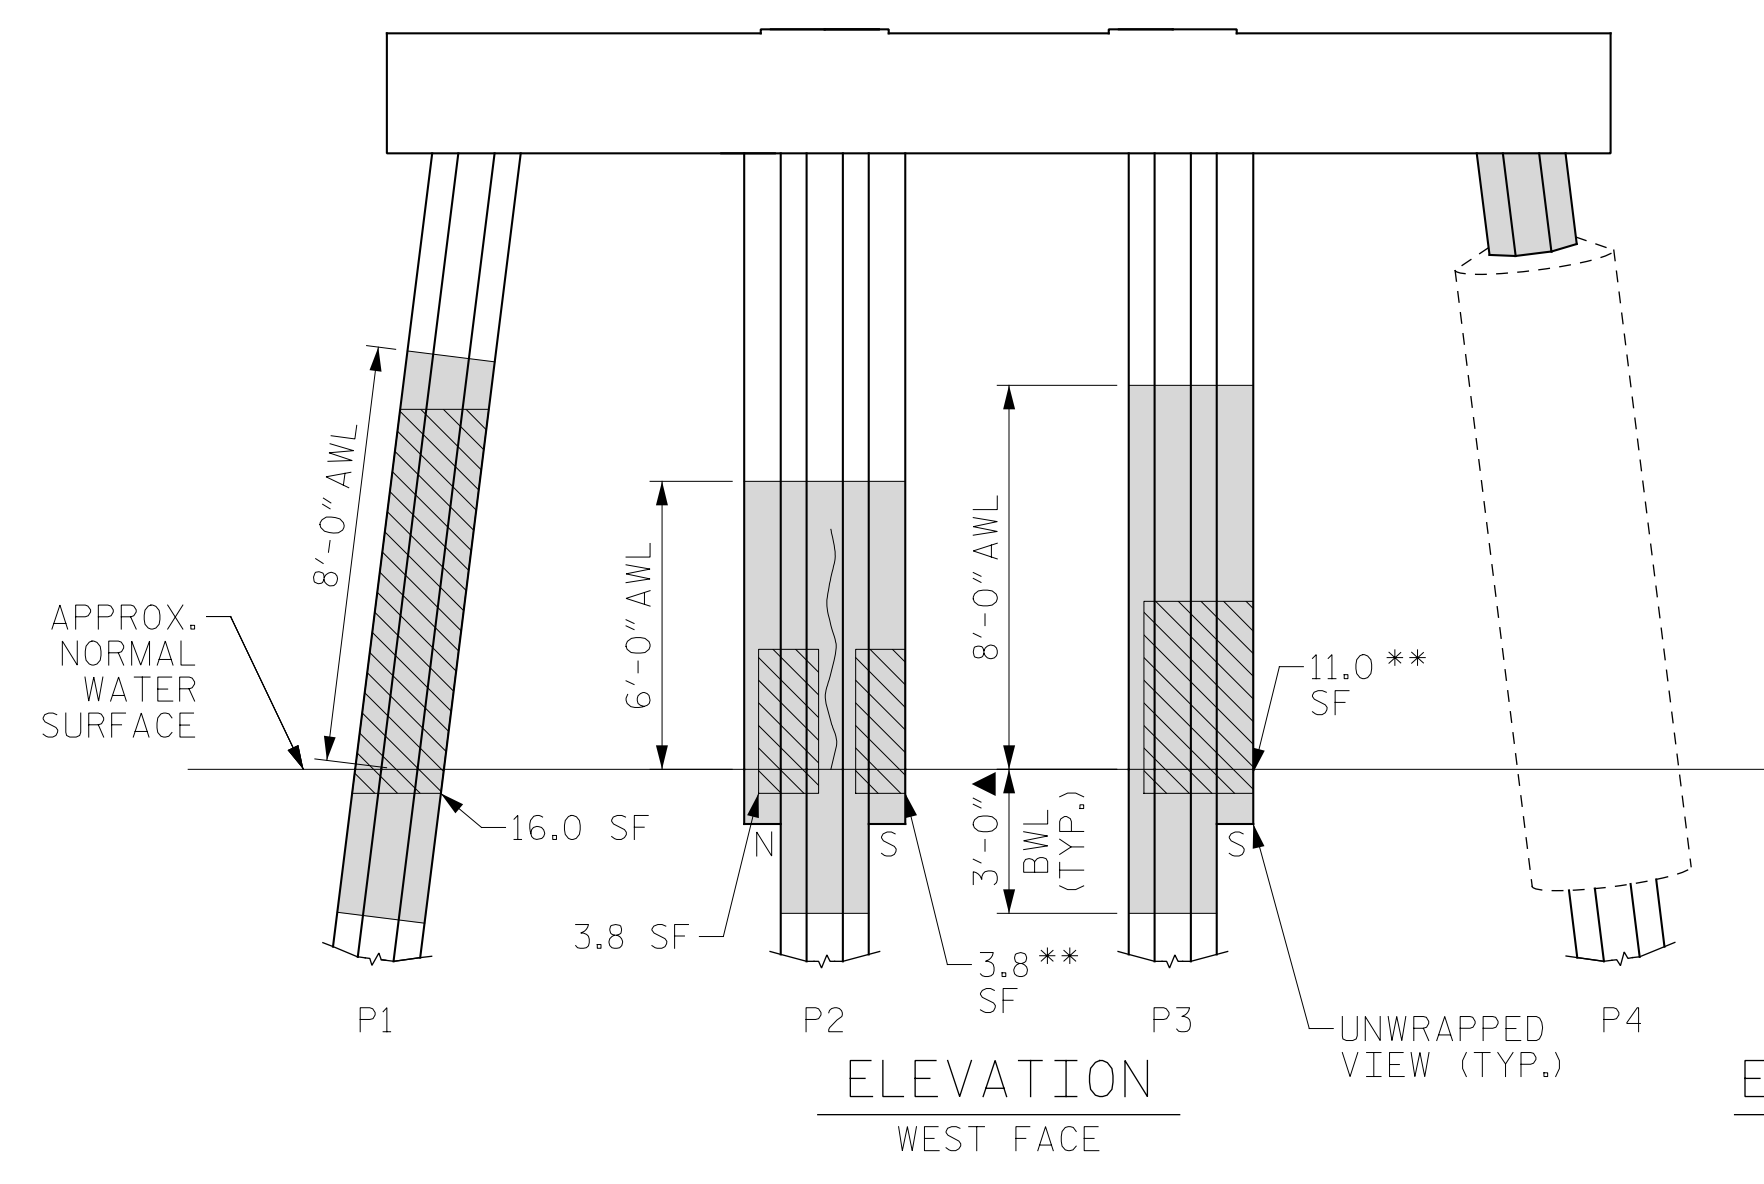
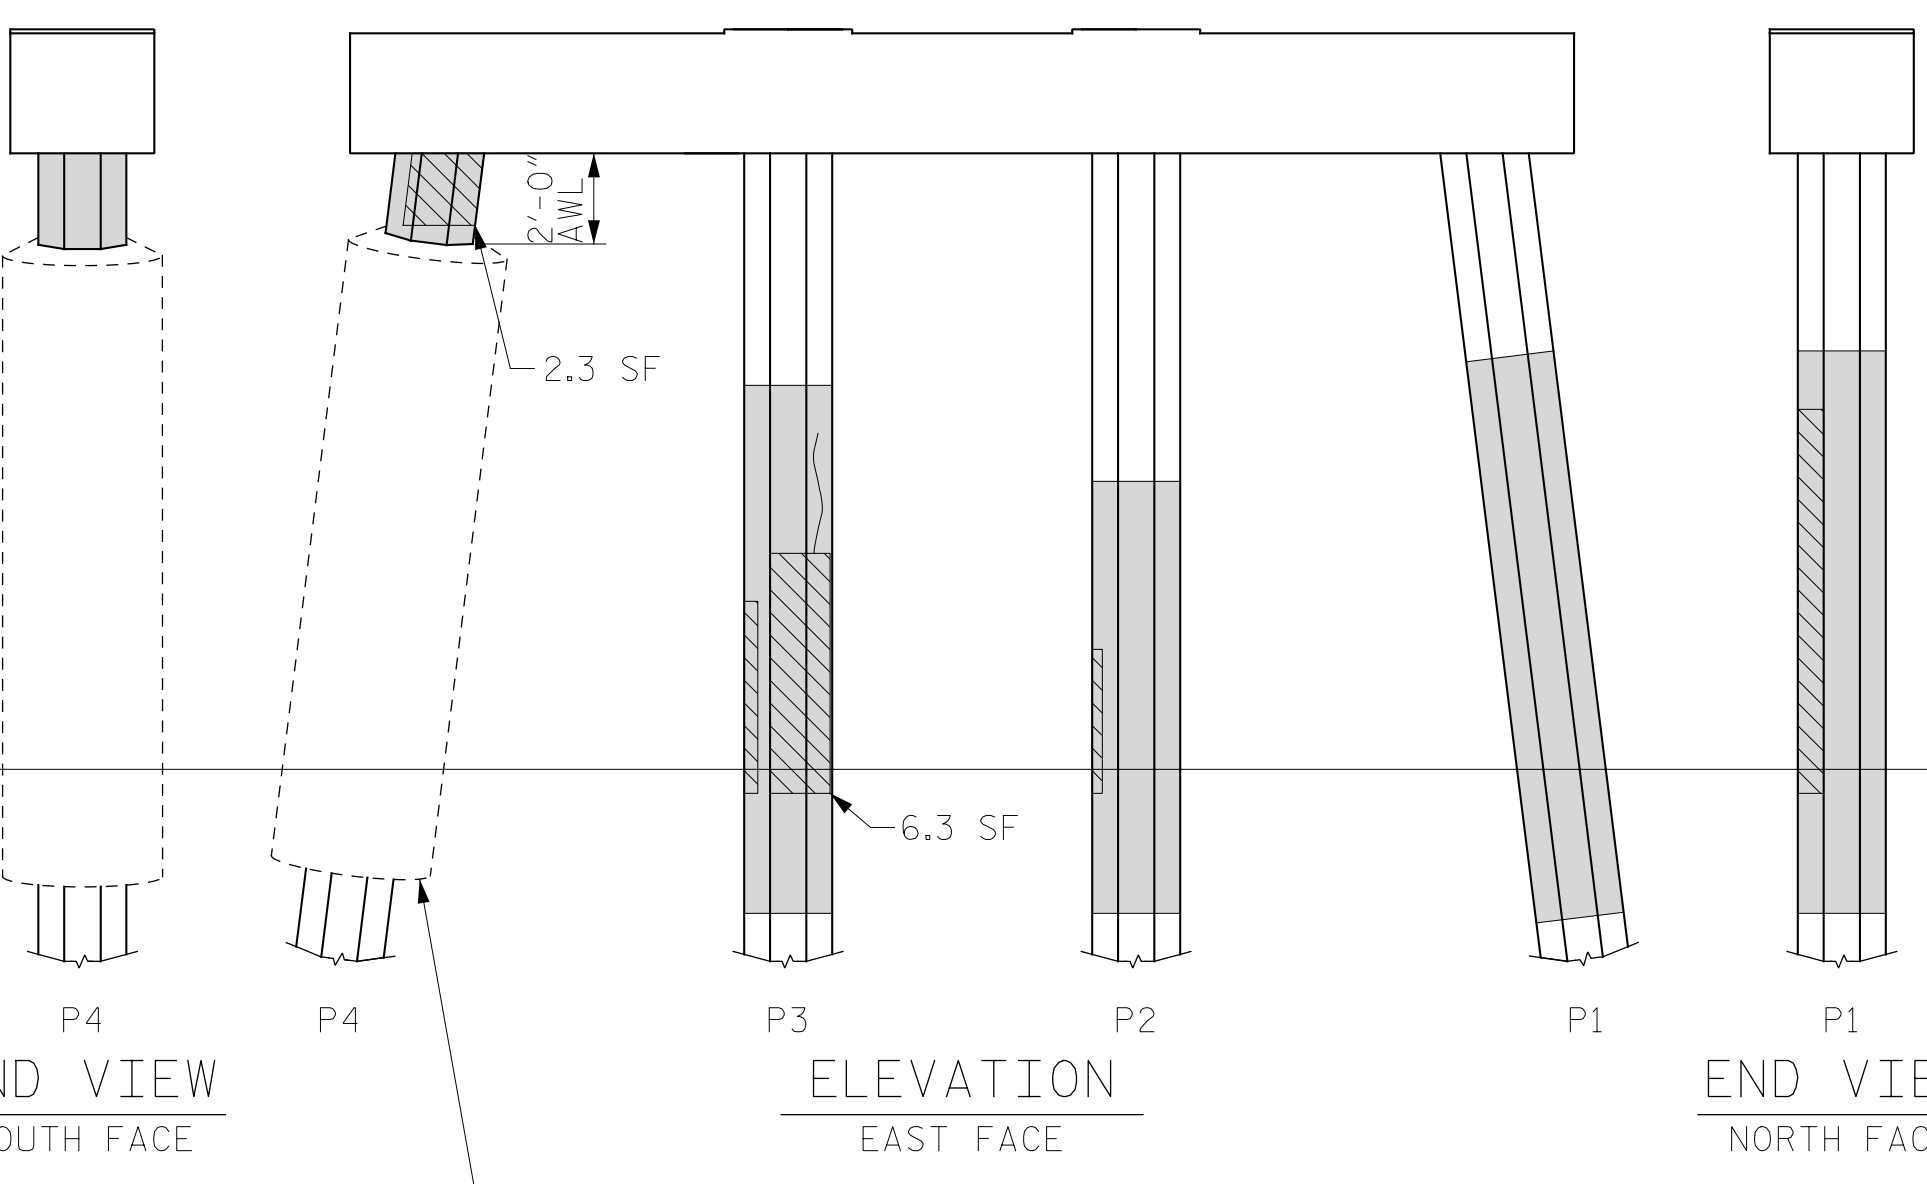
BENT 70

CAP REPAIRS			
SHOTCRETE REPAIRS	- SF	- CF	SF CF
EPOXY RESIN INJECTION	- LF		LF
PILE REPAIRS			
PILE CONCRETE RESTORATION	43.2 SF	17.5 CF	SF CF
FRP PROTECTIVE SYSTEM AWL	132.5 SF		
FRP PROTECTIVE SYSTEM BWL	49.5 SF

(AWL = ABOVE WATERLINE)
(BWL = BELOW WATERLINE)
(**QUANTITY INCLUDES ADJACENT REPAIRS)
