PROJECT NO. DARE COUNTY 270009 BRIDGE NO.

> STATE OF NORTH CAROLINA DEPARTMENT OF TRANSPORTATION RALEIGH

BENT 75 & BENT 76

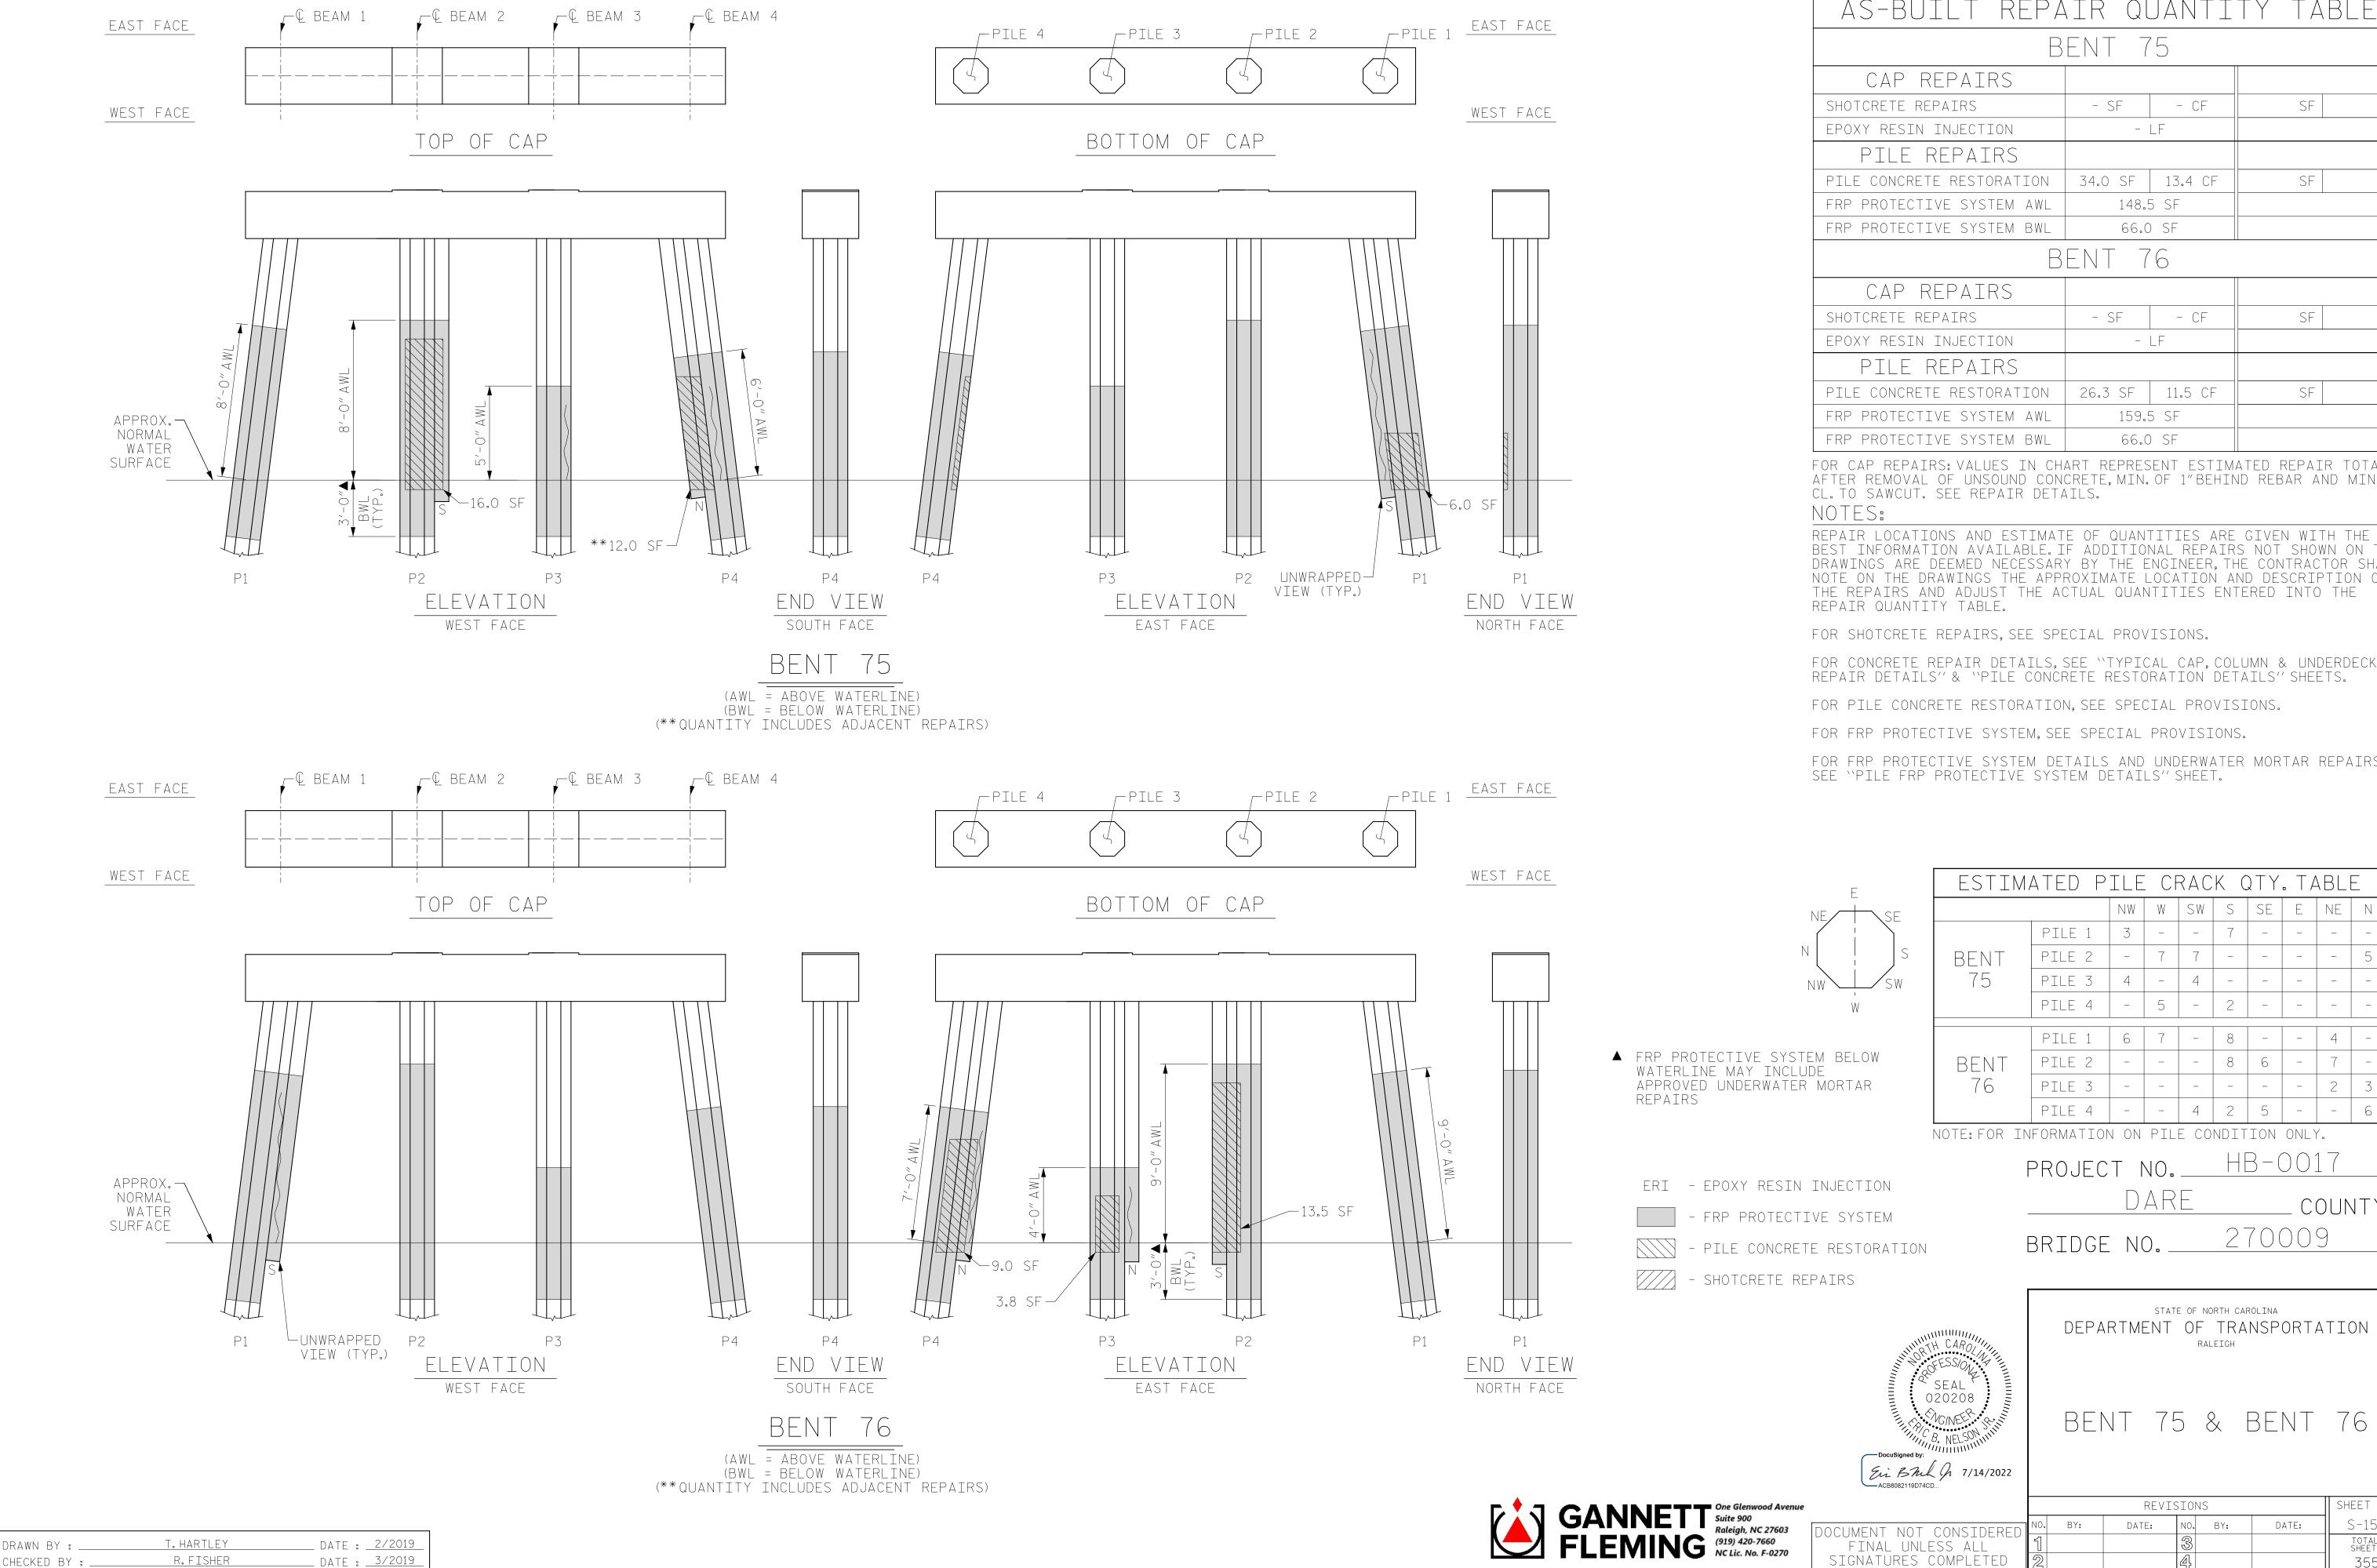
AS-BUILT REPAIR QUANTITY TABLE BENT 75 SF - SF - CF - LF PILE REPAIRS PILE CONCRETE RESTORATION | 34.0 SF | 13.4 CF SF FRP PROTECTIVE SYSTEM AWL 148.5 SF FRP PROTECTIVE SYSTEM BWL 66.0 SF BENT 76 SF - SF - CF - LF

26.3 SF | 11.5 CF

159.5 SF

66.0 SF

ESTIMATED PILE CRACK QTY. TABLE									
		NW	W	SW	S	SE	E	NE	Ν
BENT 75	PILE 1	3	_	_	7	_	_	_	_
	PILE 2	_	7	7	_	_	_	_	5
	PILE 3	4	_	4	_	_	_	_	-
	PILE 4	_	5	-	2	_	_	_	_
BENT 76	PILE 1	6	7	-	8	_	_	4	-
	PILE 2	_	_	_	8	6	_	7	_
	PILE 3	_	_	_	_	_	_	2	3
	PILE 4	-	-	4	2	5	-	-	6
OTE: FOR INFORMATION ON PILE CONDITION ONLY.

FOR CAP REPAIRS: VALUES IN CHART REPRESENT ESTIMATED REPAIR TOTALS AFTER REMOVAL OF UNSOUND CONCRETE, MIN. OF 1"BEHIND REBAR AND MIN. 2 CL. TO SAWCUT. SEE REPAIR DETAILS.

FOR CONCRETE REPAIR DETAILS, SEE "TYPICAL CAP, COLUMN & UNDERDECK REPAIR DETAILS" & "PILE CONCRETE RESTORATION DETAILS" SHEETS.

FOR FRP PROTECTIVE SYSTEM DETAILS AND UNDERWATER MORTAR REPAIRS, SEE "PILE FRP PROTECTIVE SYSTEM DETAILS" SHEET.
