AS-BUILT REPAIR QUANTITY TABLE

PROJECT NO. HB-0017
DARE COUNTY
BRIDGE NO. 270009

BENT 91 & BENT 92

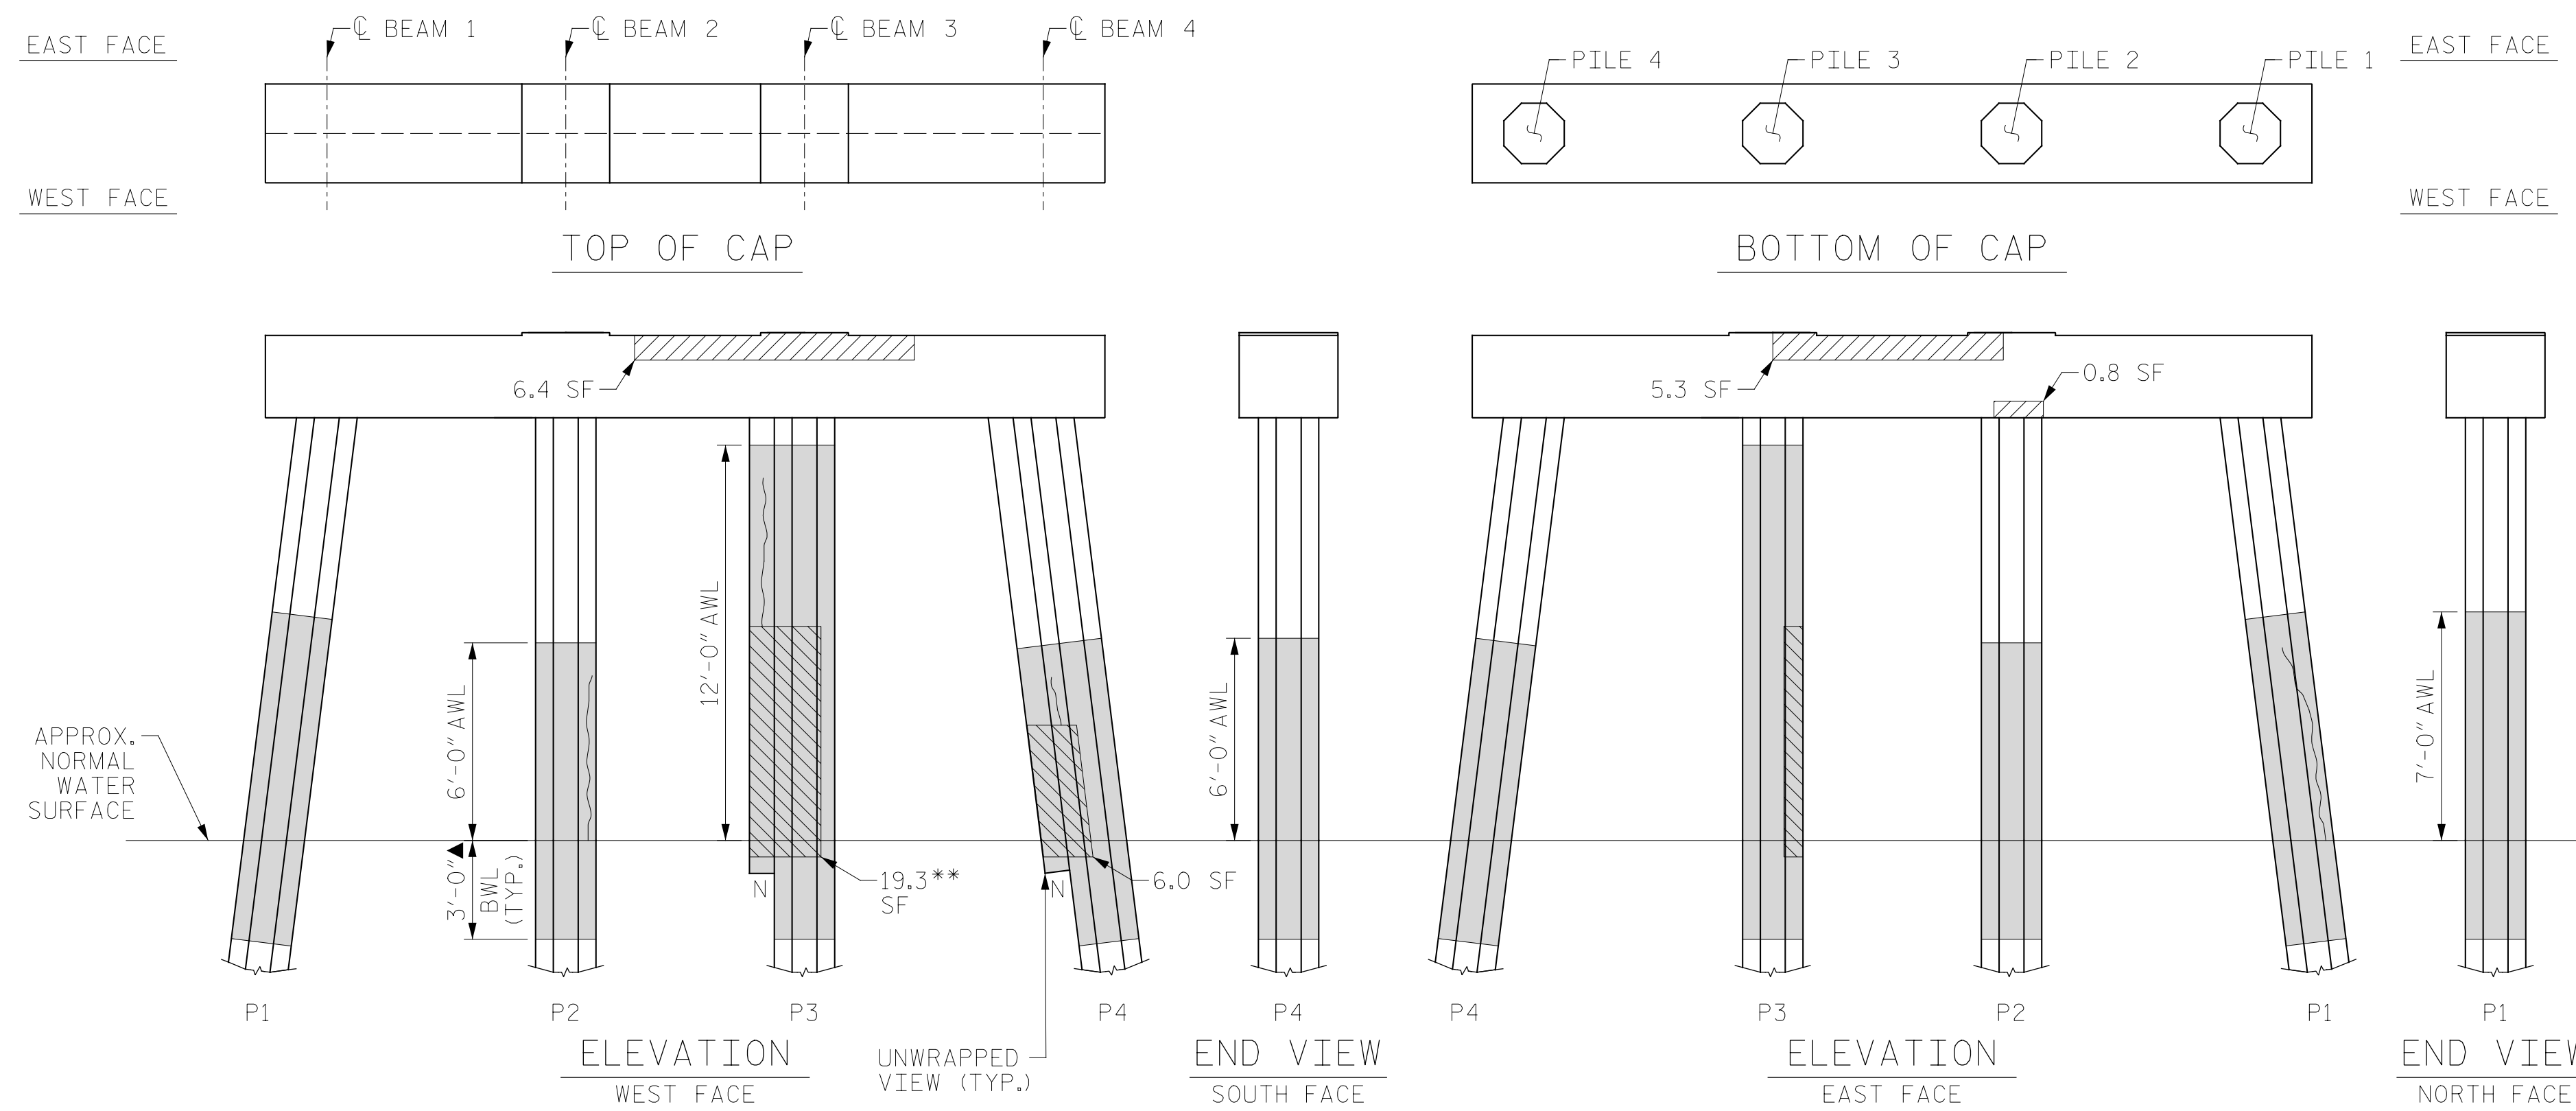
BENT 91

CAP REPAIRS			
SHOTCRETE REPAIRS	12.5 SF	6.3 CF	
EPOXY RESIN INJECTION		- LF	
PILE REPAIRS			
PILE CONCRETE RESTORATION	25.3 SF	10.2 CF	
FRP PROTECTIVE SYSTEM AWL	170.5 SF		
FRP PROTECTIVE SYSTEM BWL	66.0 SF

(AWL = ABOVE WATERLINE)
(BWL = BELOW WATERLINE)
(*QUANTITY INCLUDES ADJACENT REPAIRS)

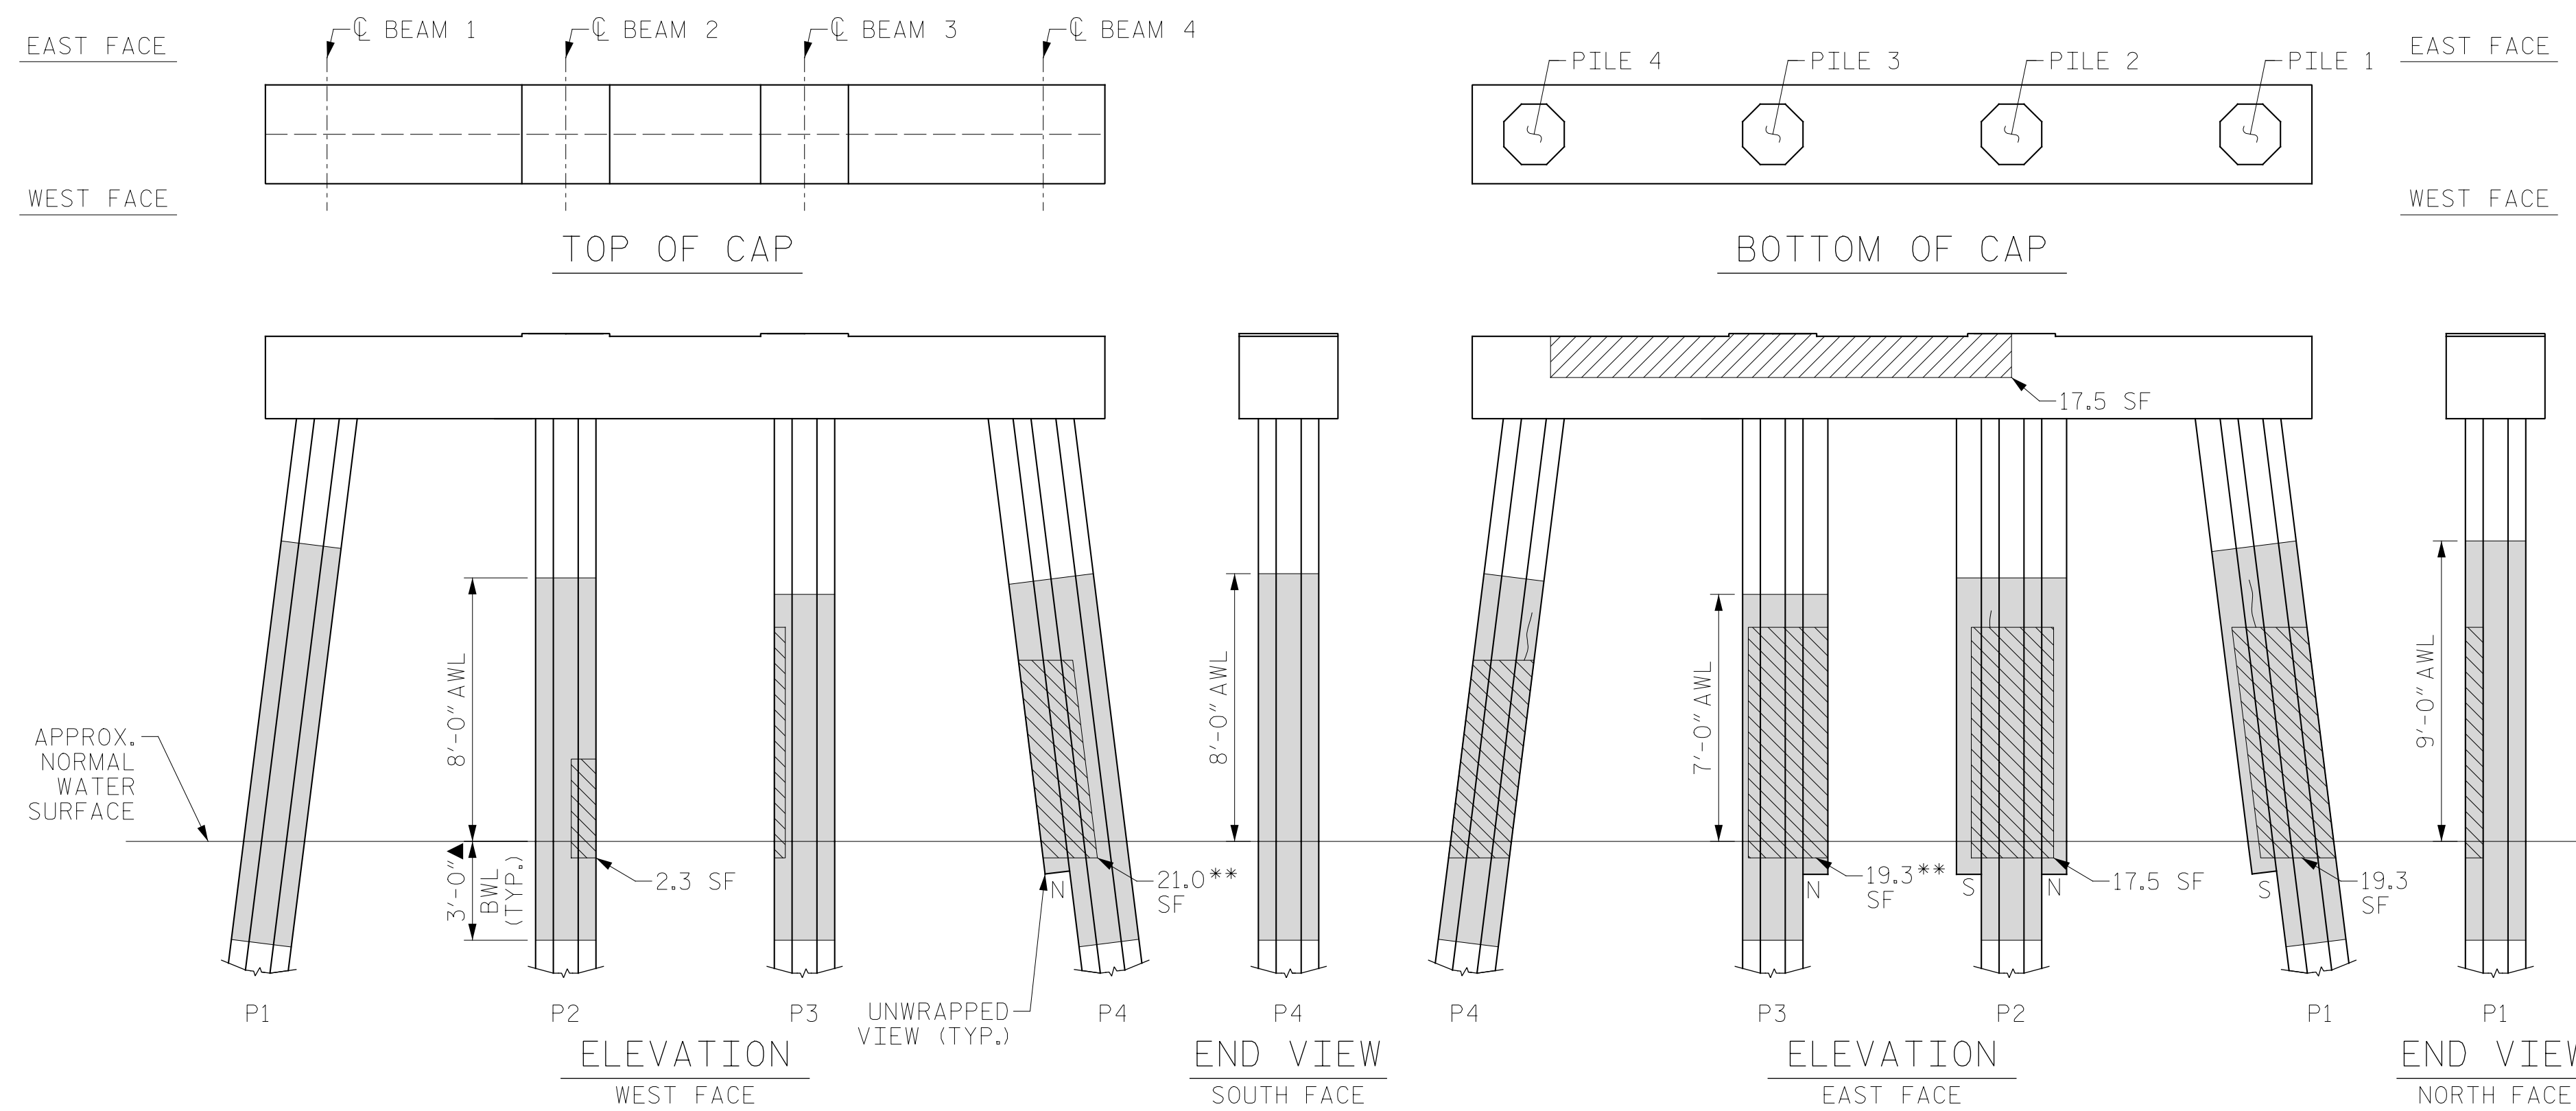
BENT 92

CAP REPAIRS			
SHOTCRETE REPAIRS	17.5 SF	8.8 CF	
EPOXY RESIN INJECTION		- LF	
PILE REPAIRS			
PILE CONCRETE RESTORATION	79.4 SF	30.8 CF	
FRP PROTECTIVE SYSTEM AWL	176.0 SF		
FRP PROTECTIVE SYSTEM BWL	66.0 SF

(AWL = ABOVE WATERLINE)
(BWL = BELOW WATERLINE)
(*QUANTITY INCLUDES ADJACENT REPAIRS)
