AS-BUILT REPAIR QUANTITY TABLE

NOTE: FOR INFORMATION ON PILE CONDITION ONLY.
PROJECT NO. HB-0017
DARE COUNTY
BRIDGE NO. 270009

STATE OF NORTH CAROLINA
DEPARTMENT OF TRANSPORTATION
RALEIGH
BENT 99 & BENT 100

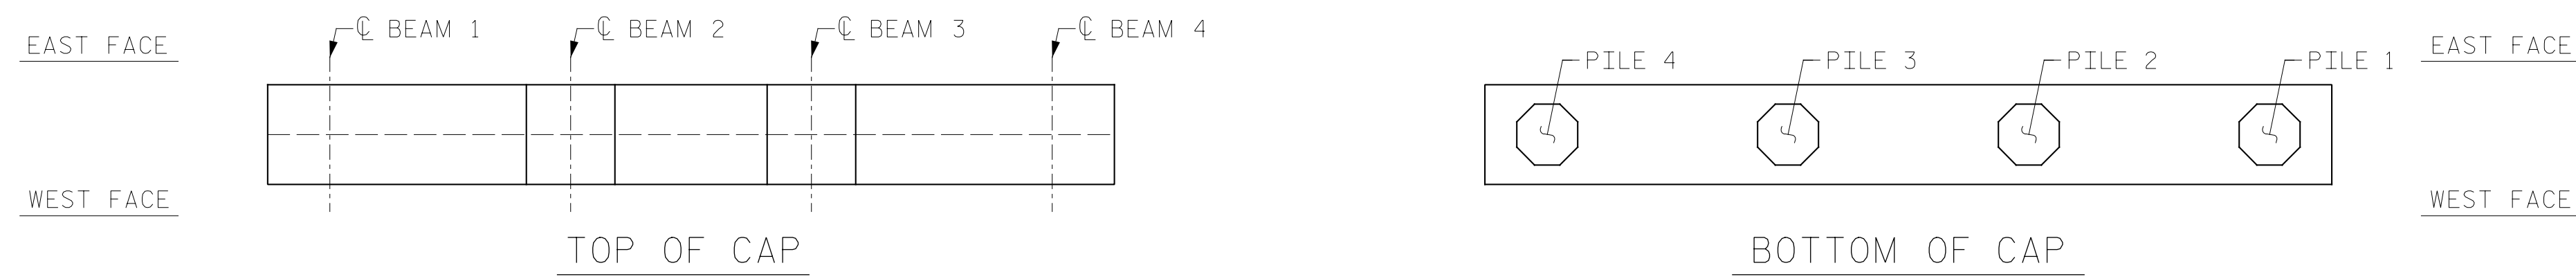
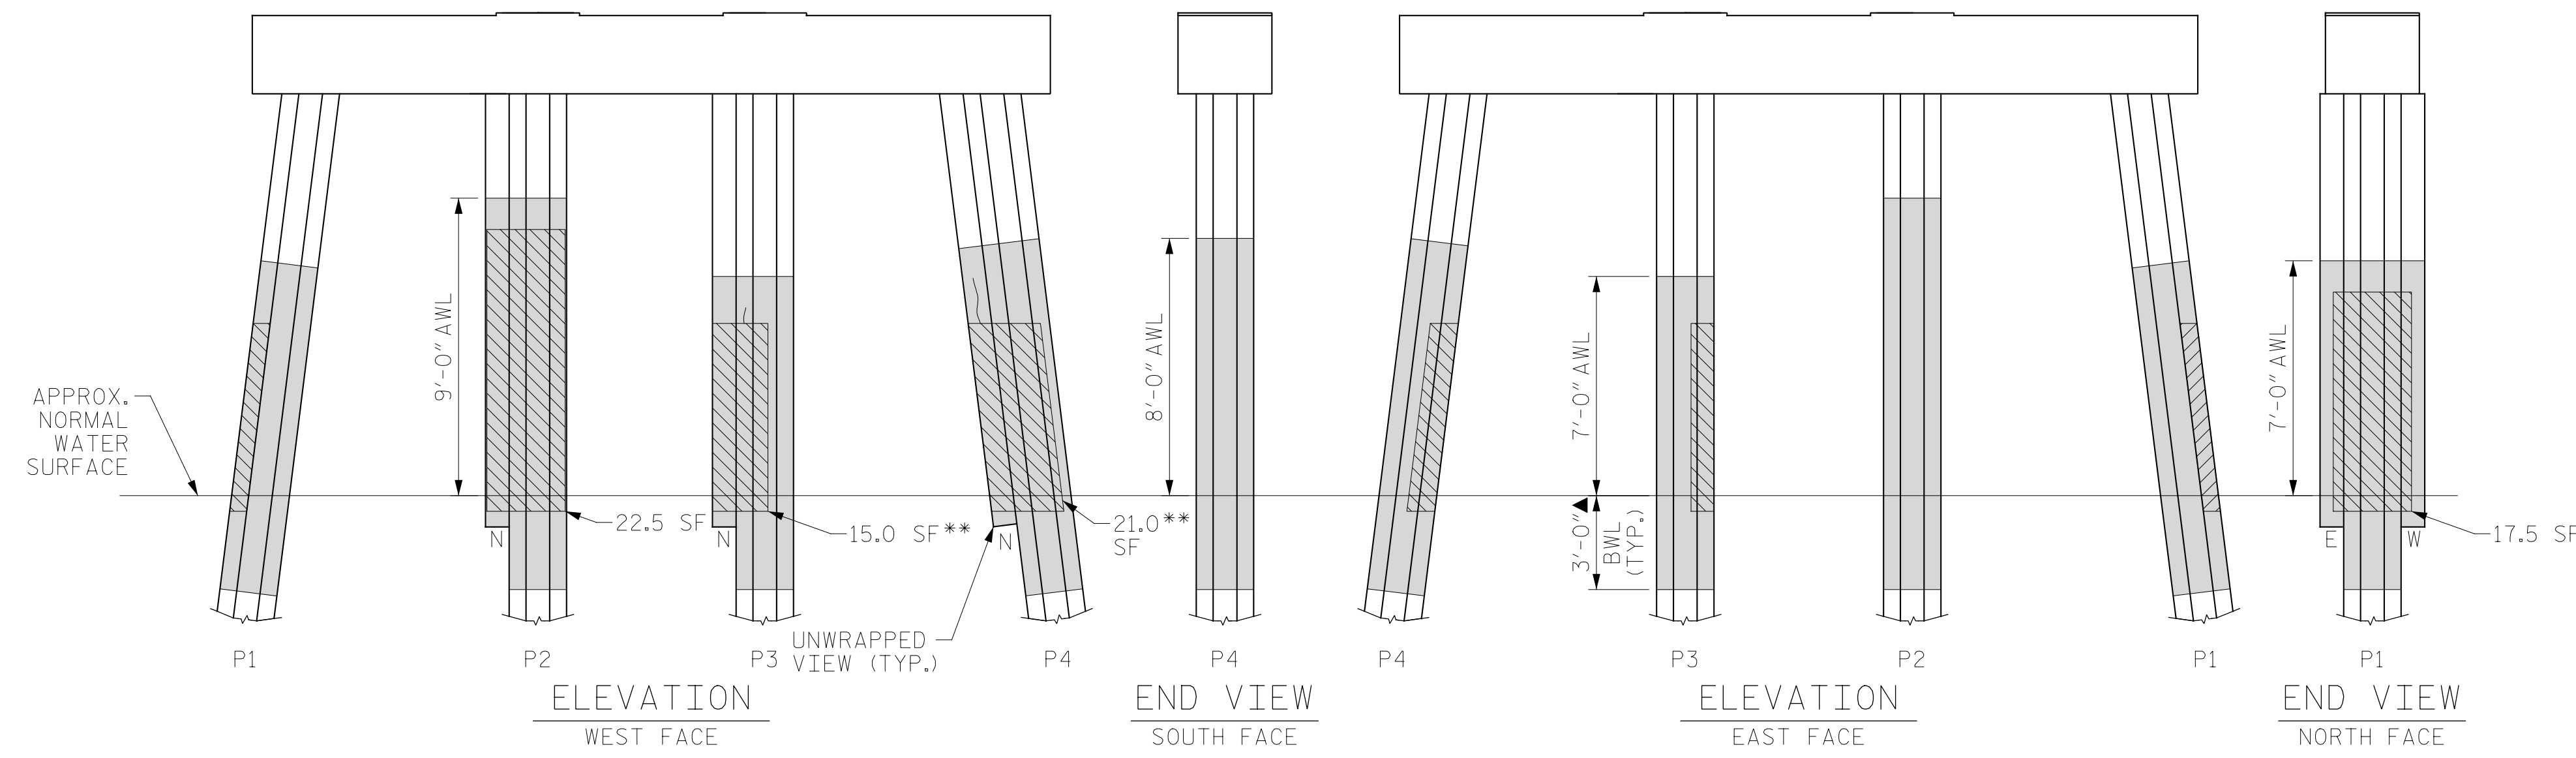
BENT 99

CAP REPAIRS			
SHOTCRETE REPAIRS	- SF	- CF	SF CF
EPOXY RESIN INJECTION	- LF		LF
PILE REPAIRS			
PILE CONCRETE RESTORATION	76.0 SF	28.9 CF	SF CF
FRP PROTECTIVE SYSTEM AWL	170.5 SF		
FRP PROTECTIVE SYSTEM BWL	66.0 SF

(AWL = ABOVE WATERLINE)
(BWL = BELOW WATERLINE)
(**QUANTITY INCLUDES ADJACENT REPAIRS)

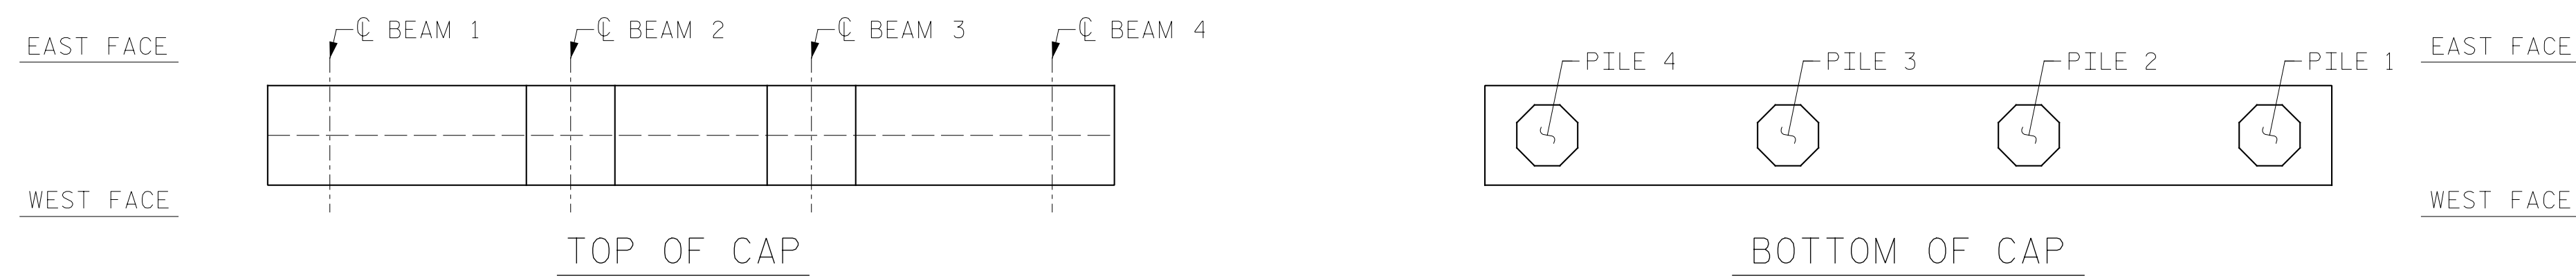
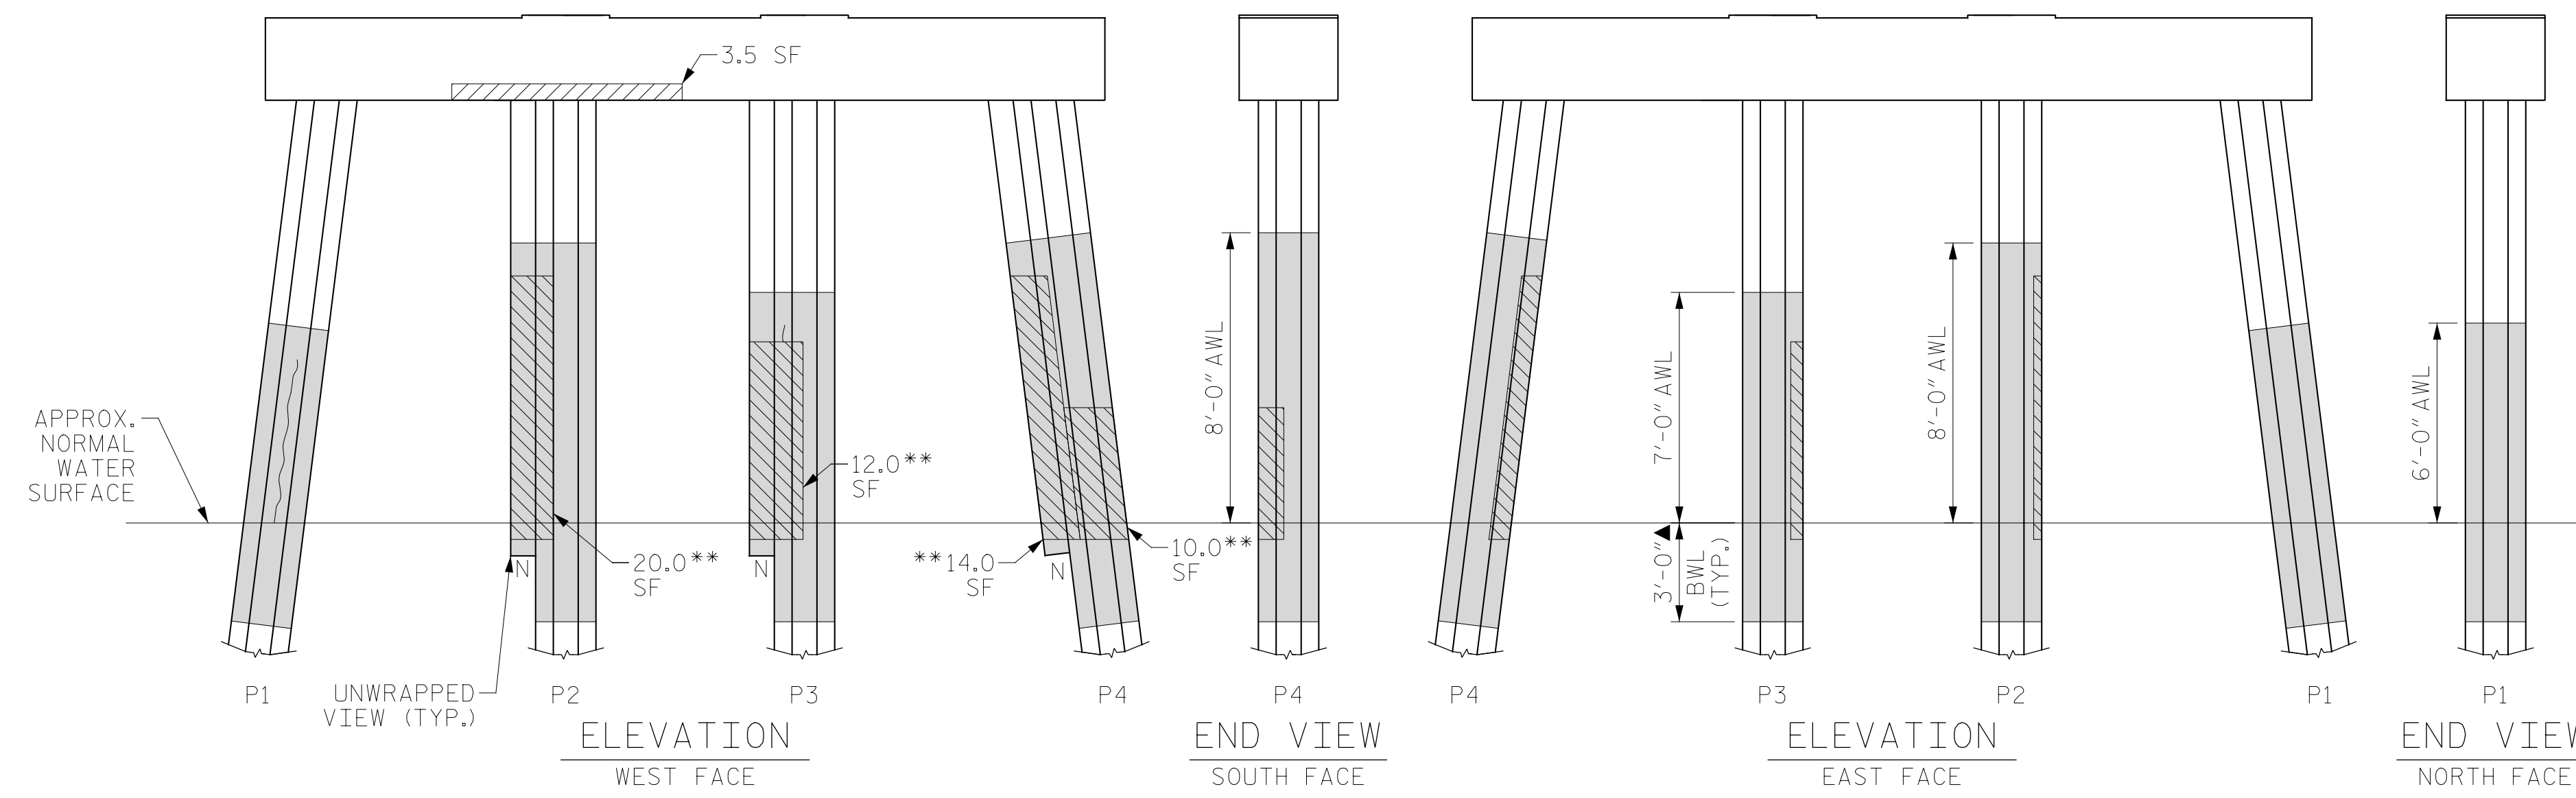
BENT 100

CAP REPAIRS			
SHOTCRETE REPAIRS	3.5 SF	1.8 CF	SF CF
EPOXY RESIN INJECTION	- LF		LF
PILE REPAIRS			
PILE CONCRETE RESTORATION	56.0 SF	22.1 CF	SF CF
FRP PROTECTIVE SYSTEM AWL	159.5 SF		
FRP PROTECTIVE SYSTEM BWL	66.0 SF

(AWL = ABOVE WATERLINE)
(BWL = BELOW WATERLINE)
(**QUANTITY INCLUDES ADJACENT REPAIRS)
