AS-BUILT REPAIR QUANTITY TABLE

PROJECT NO. HB-0017
DARE COUNTY
 BRIDGE NO. 270009

BENT 105 & BENT 106

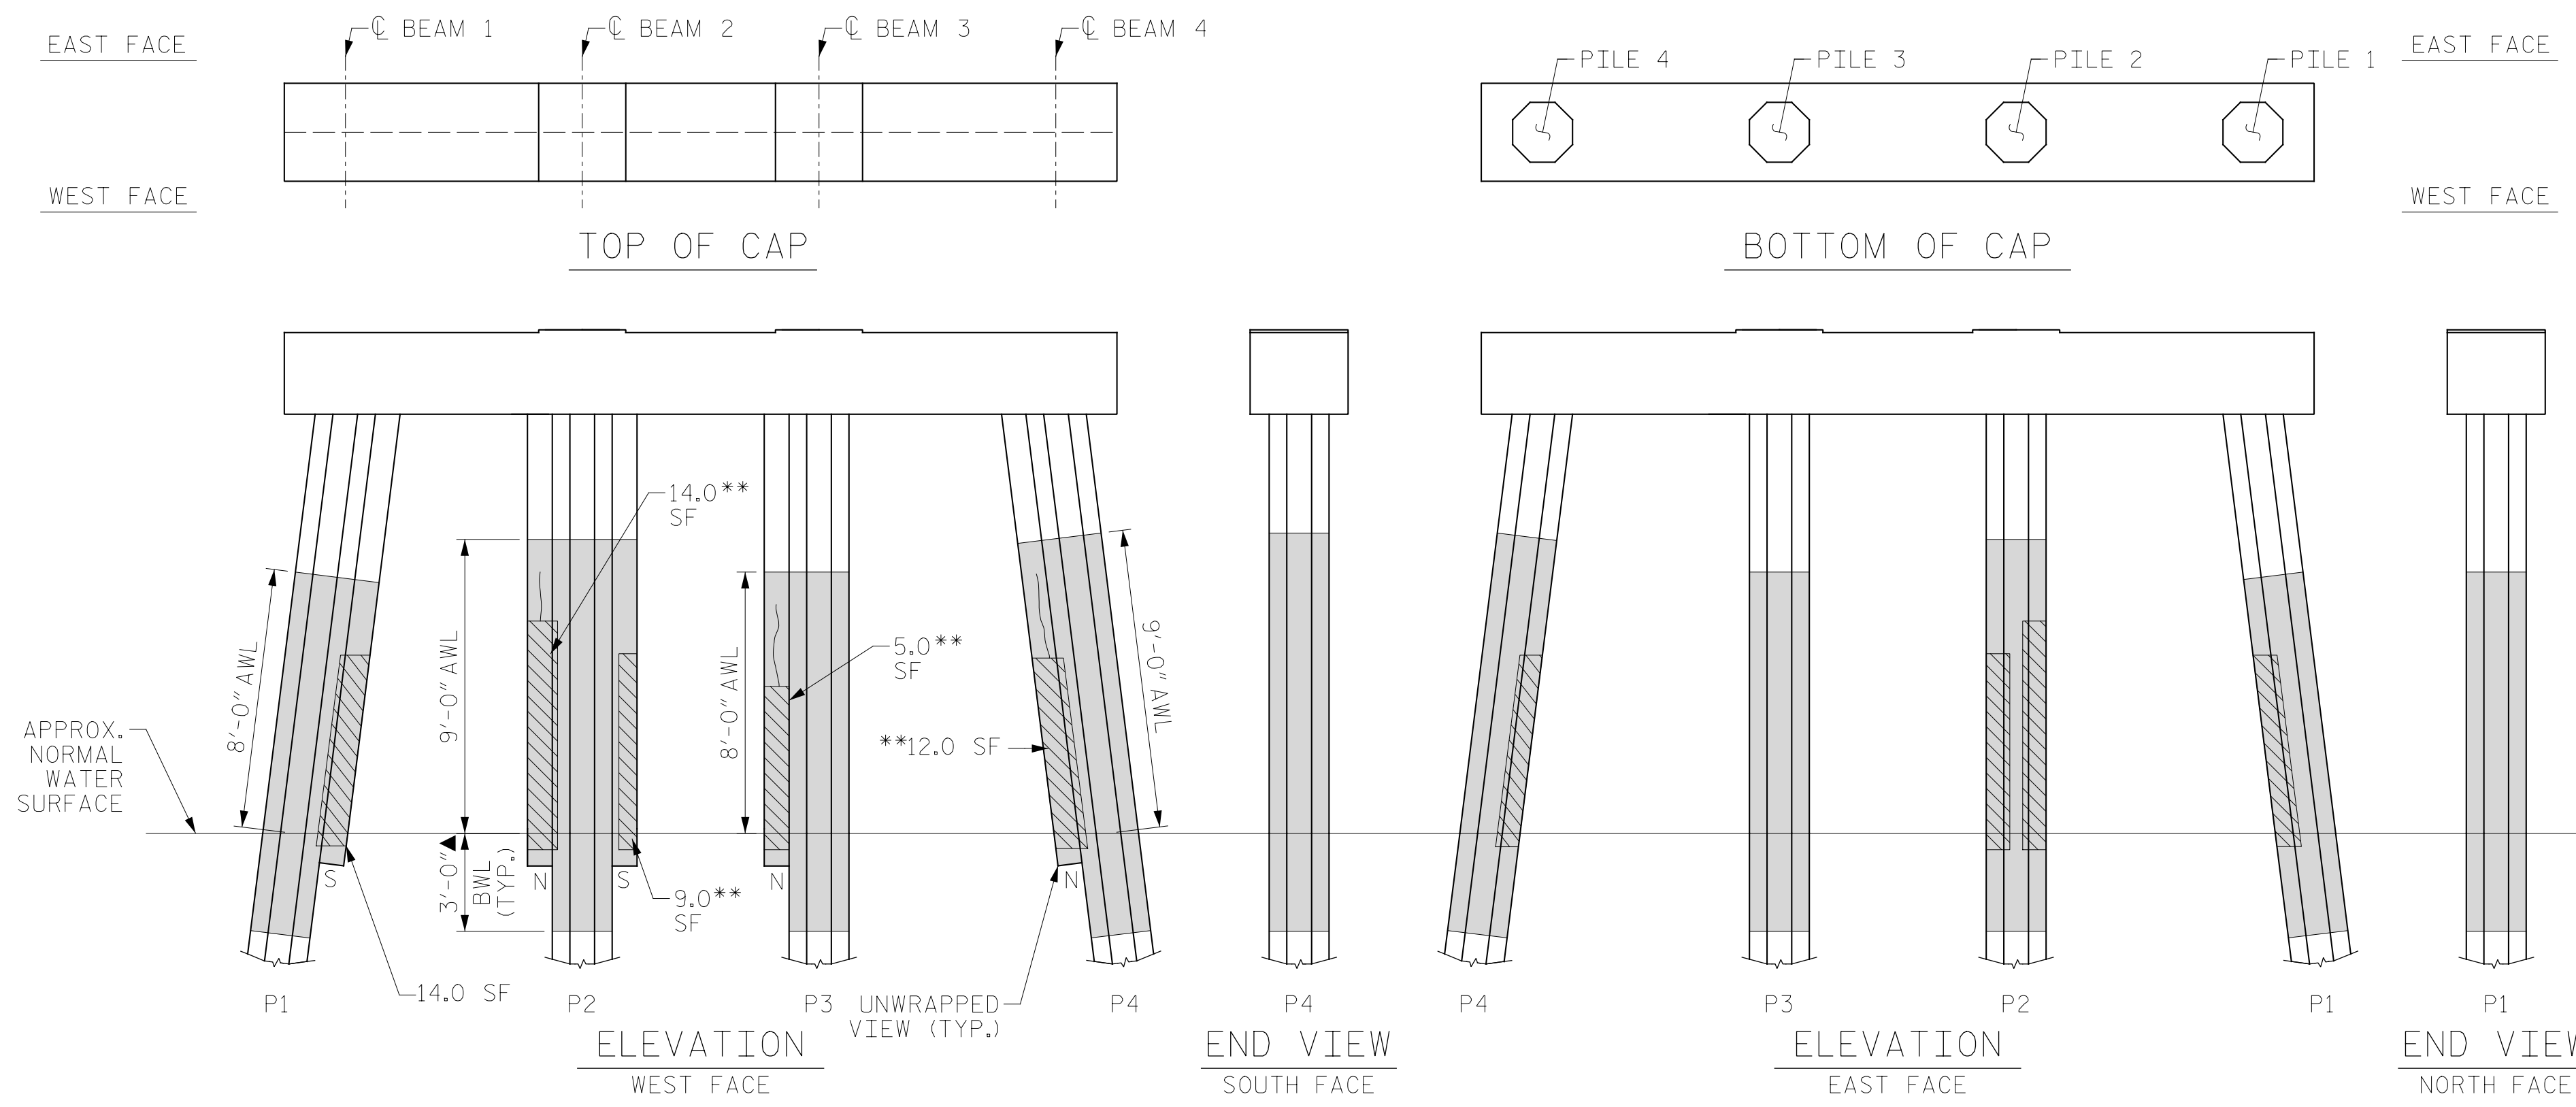
BENT 105

CAP REPAIRS				
SHOTCRETE REPAIRS	- SF	- CF	SF	CF
EPOXY RESIN INJECTION	- LF			LF
PILE REPAIRS				
PILE CONCRETE RESTORATION	52.5 SF	21.8 CF	SF	CF
FRP PROTECTIVE SYSTEM AWL	187.0 SF			
FRP PROTECTIVE SYSTEM BWL	66.0 SF

(AWL = ABOVE WATERLINE)
(BWL = BELOW WATERLINE)
(*QUANTITY INCLUDES ADJACENT REPAIRS)

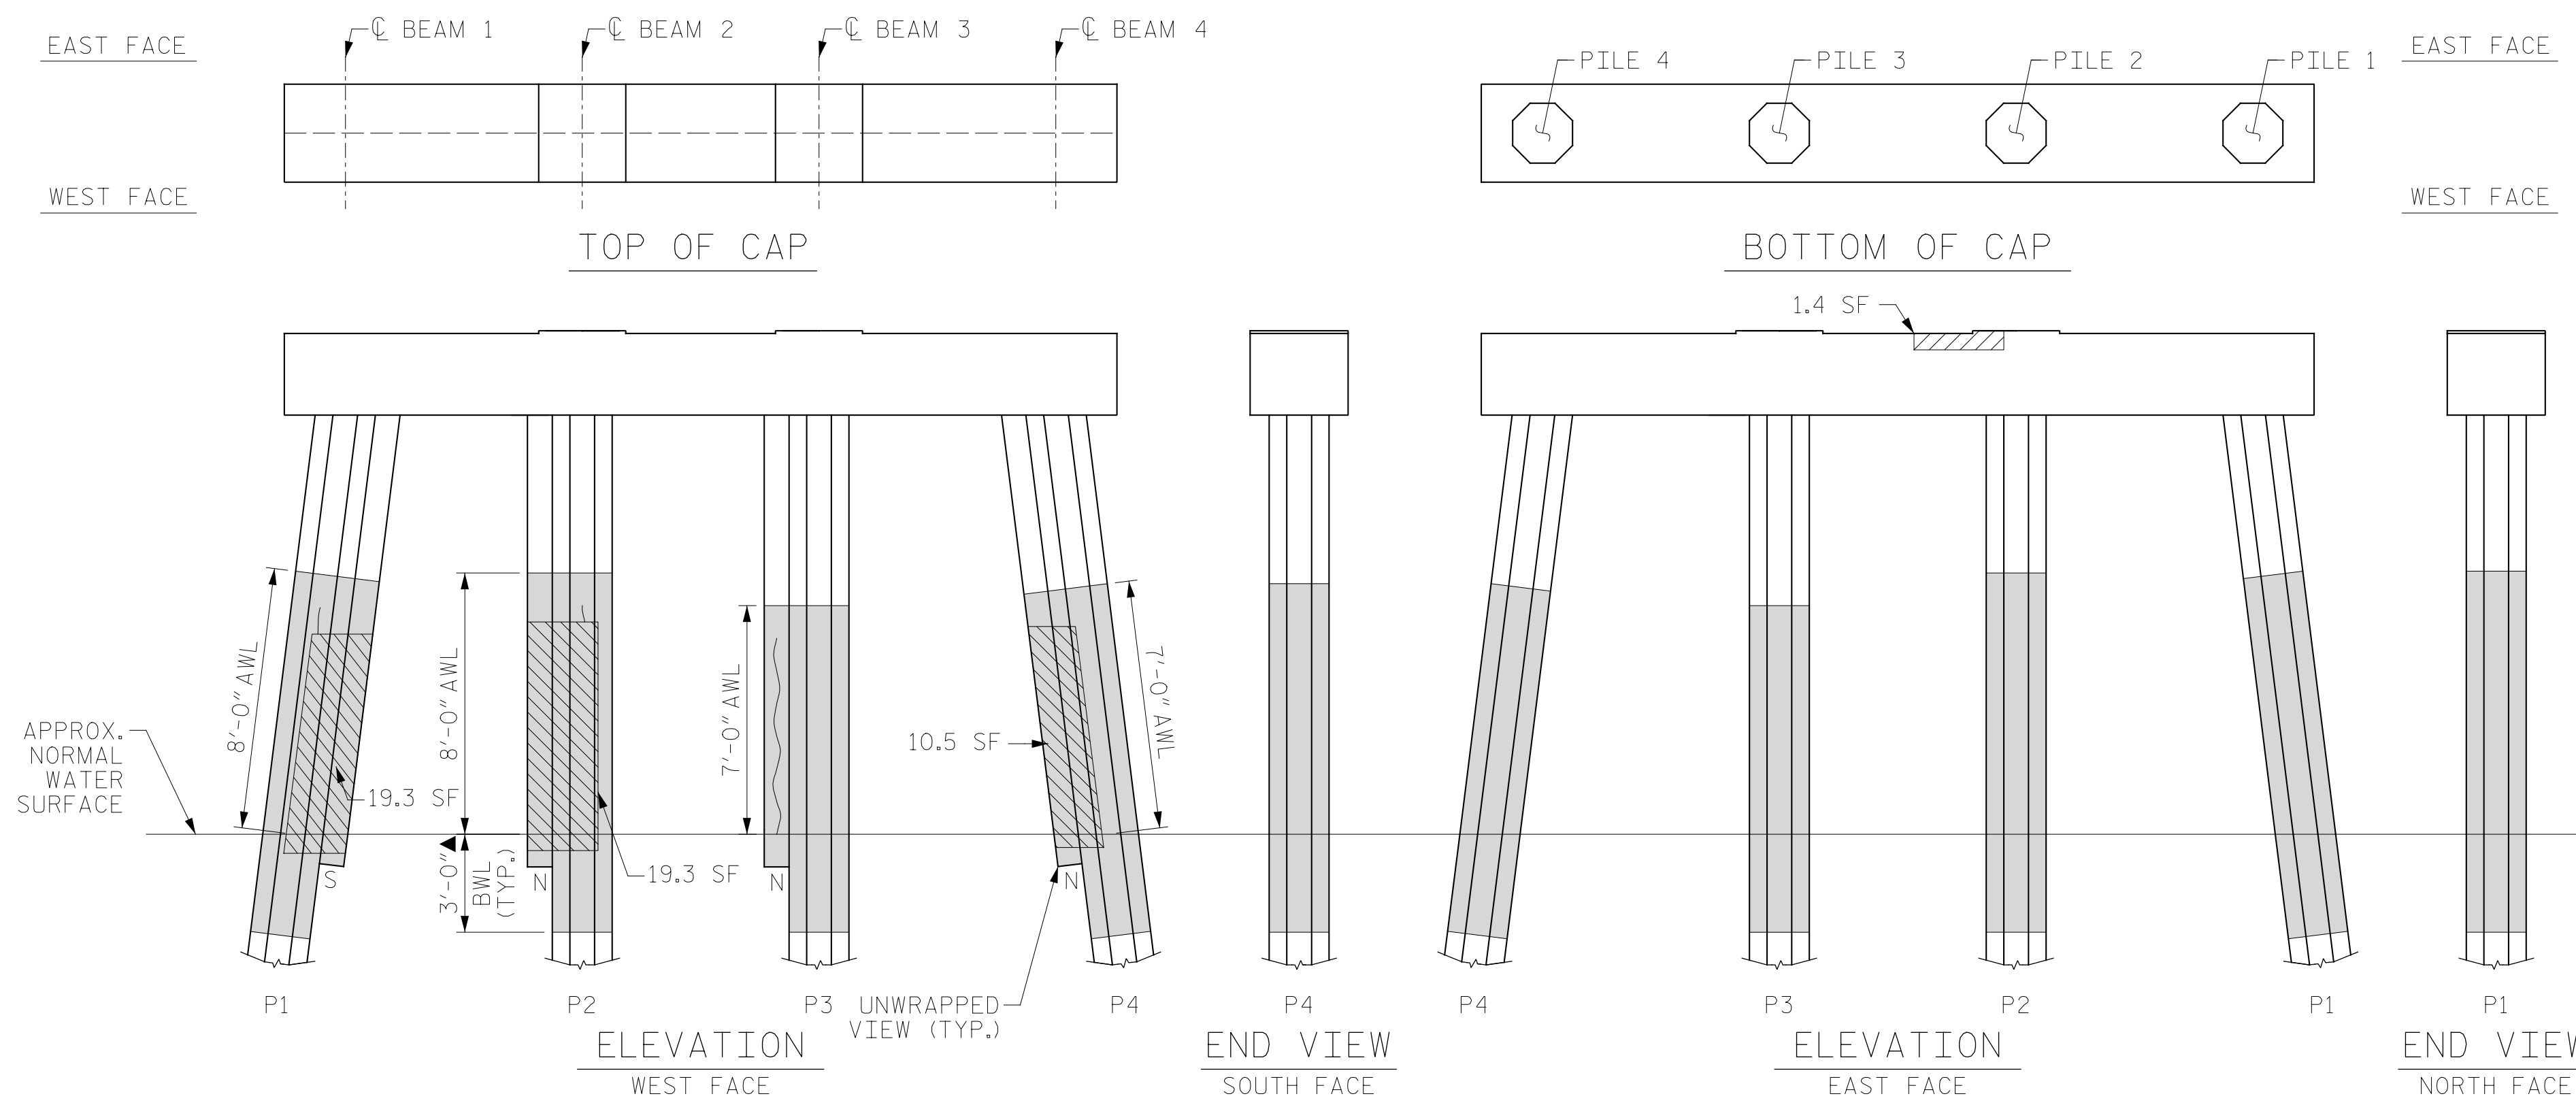
BENT 106

CAP REPAIRS				
SHOTCRETE REPAIRS	1.4 SF	0.7 CF	SF	CF
EPOXY RESIN INJECTION	- LF			LF
PILE REPAIRS				
PILE CONCRETE RESTORATION	49.1 SF	19.8 CF	SF	CF
FRP PROTECTIVE SYSTEM AWL	165.0 SF			
FRP PROTECTIVE SYSTEM BWL	66.0 SF

(AWL = ABOVE WATERLINE)
(BWL = BELOW WATERLINE)
(*QUANTITY INCLUDES ADJACENT REPAIRS)
