PROJECT NO. HB-0017
DARE COUNTY
 BRIDGE NO. 270009

**BENT 122
 EAST FACE**

BENT 122
 (AWL = ABOVE WATERLINE)
 (BWL = BELOW WATERLINE)

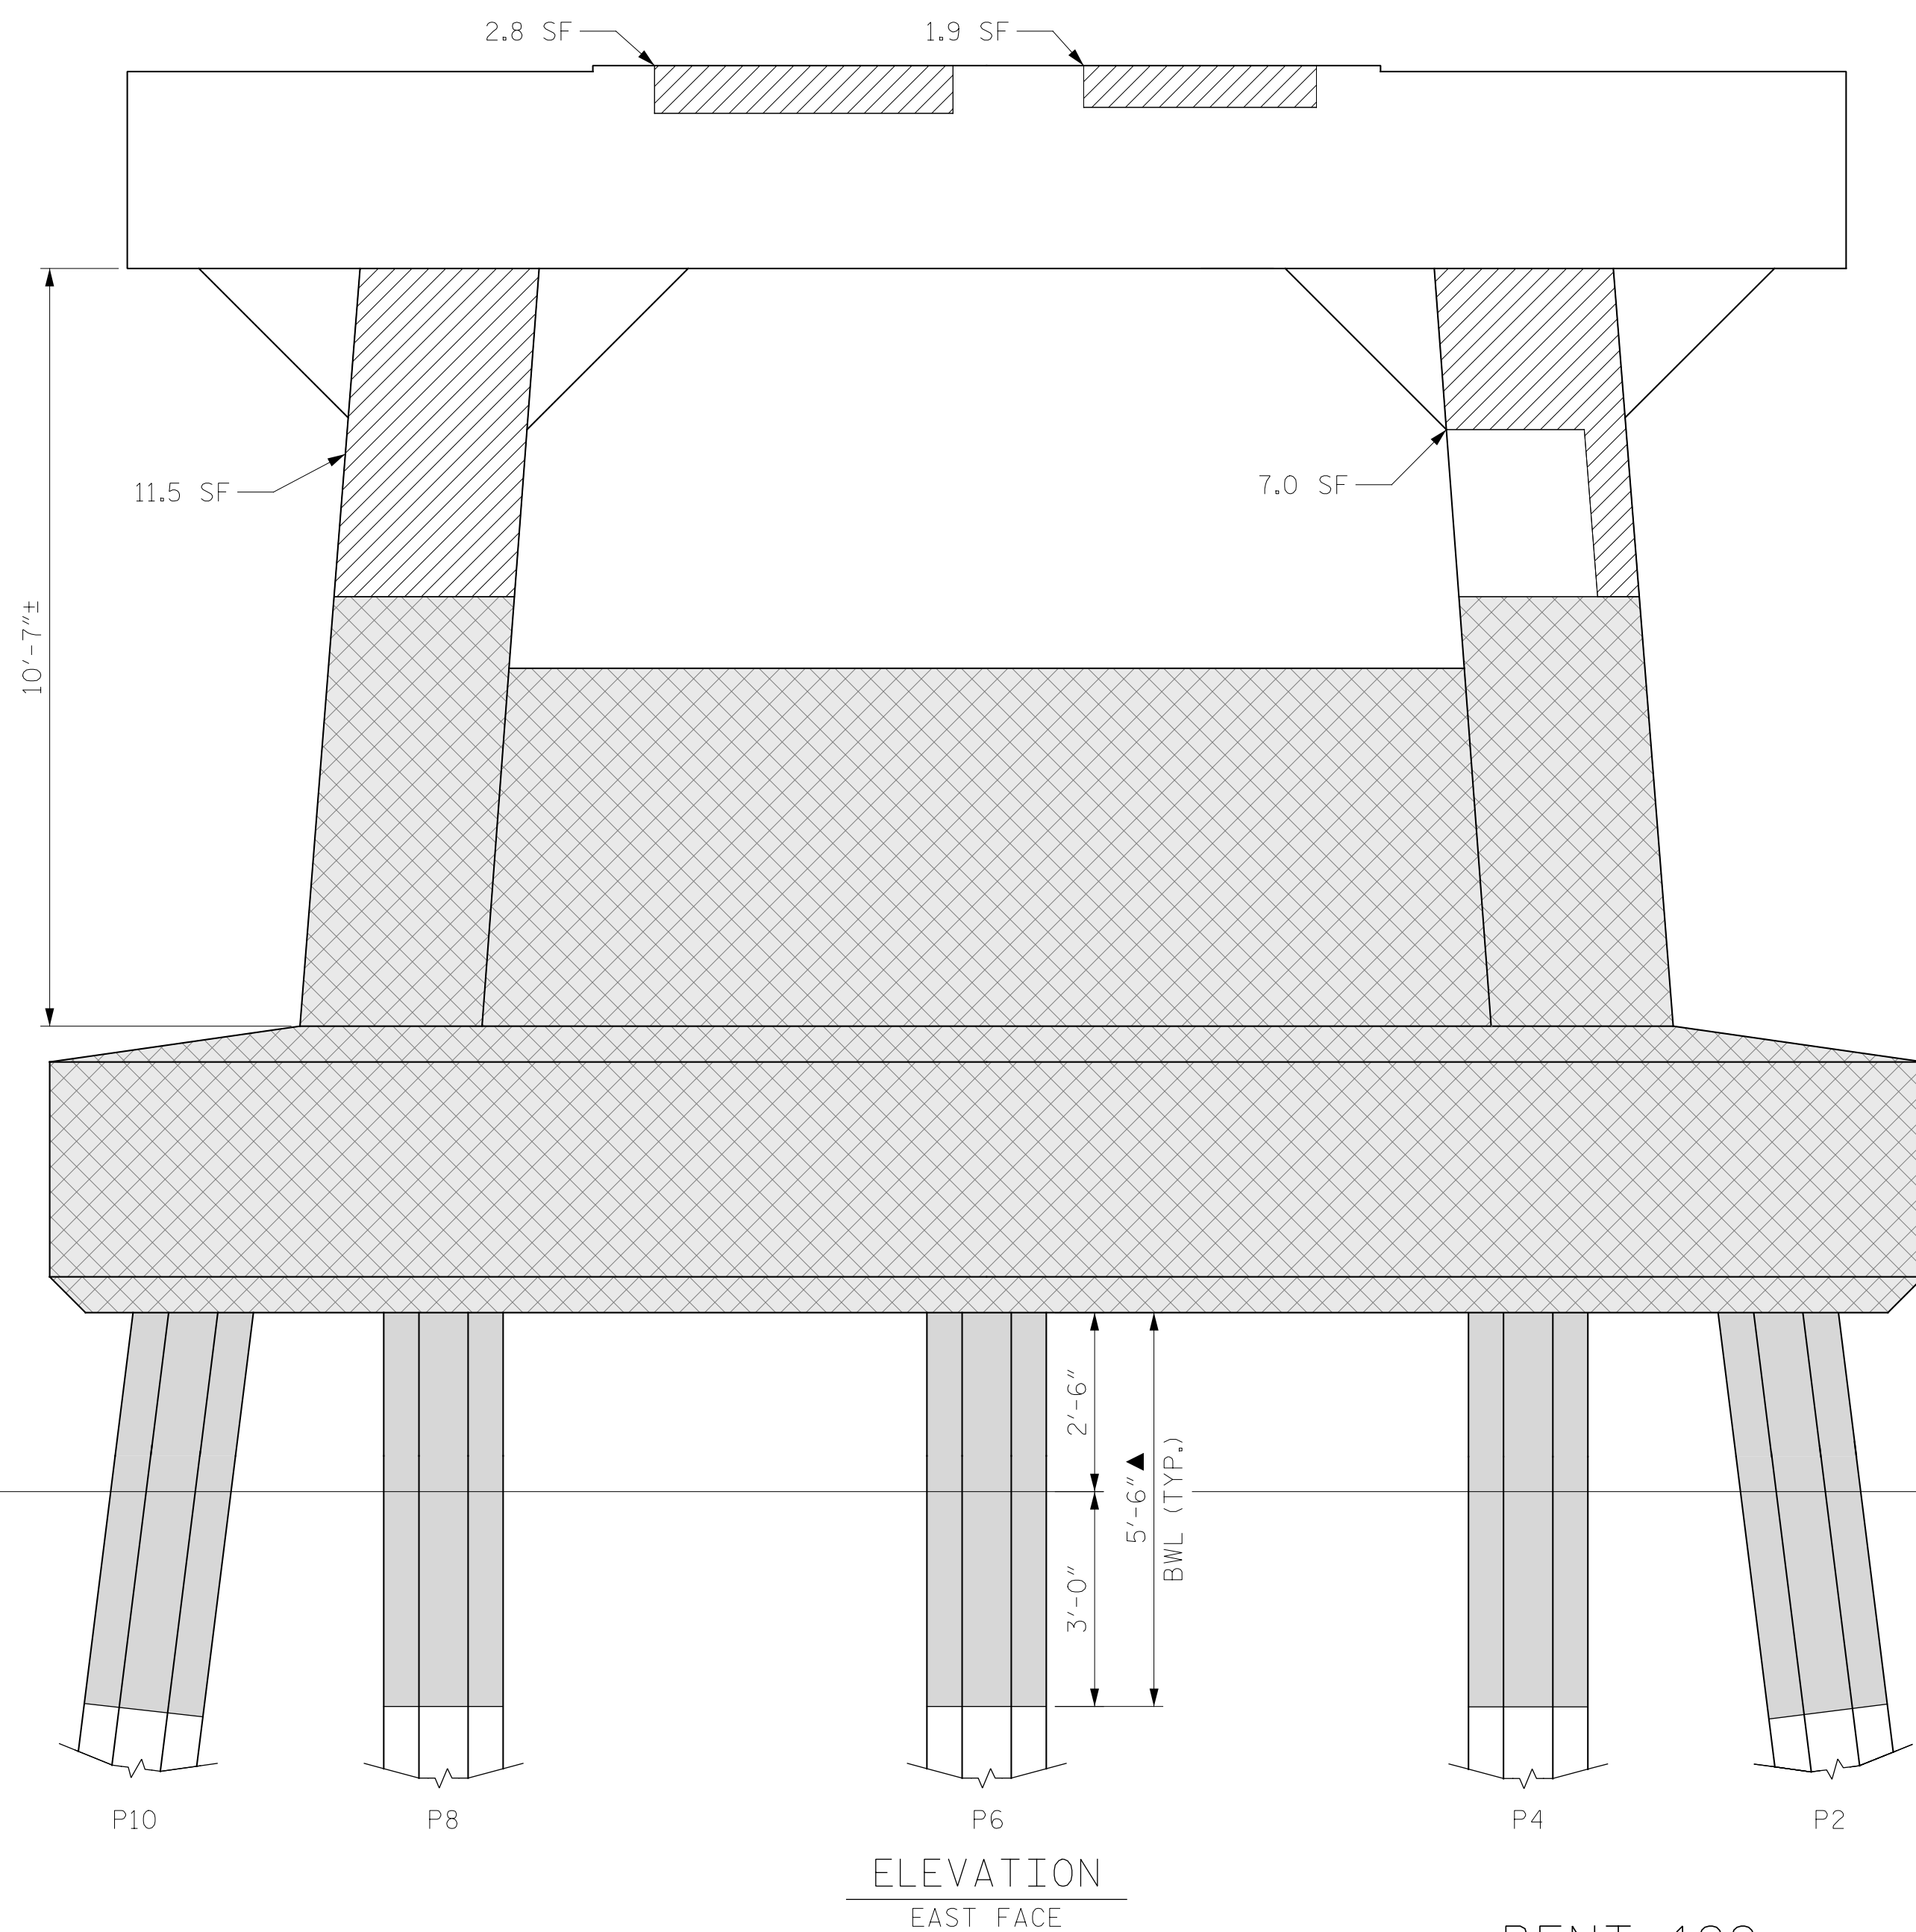
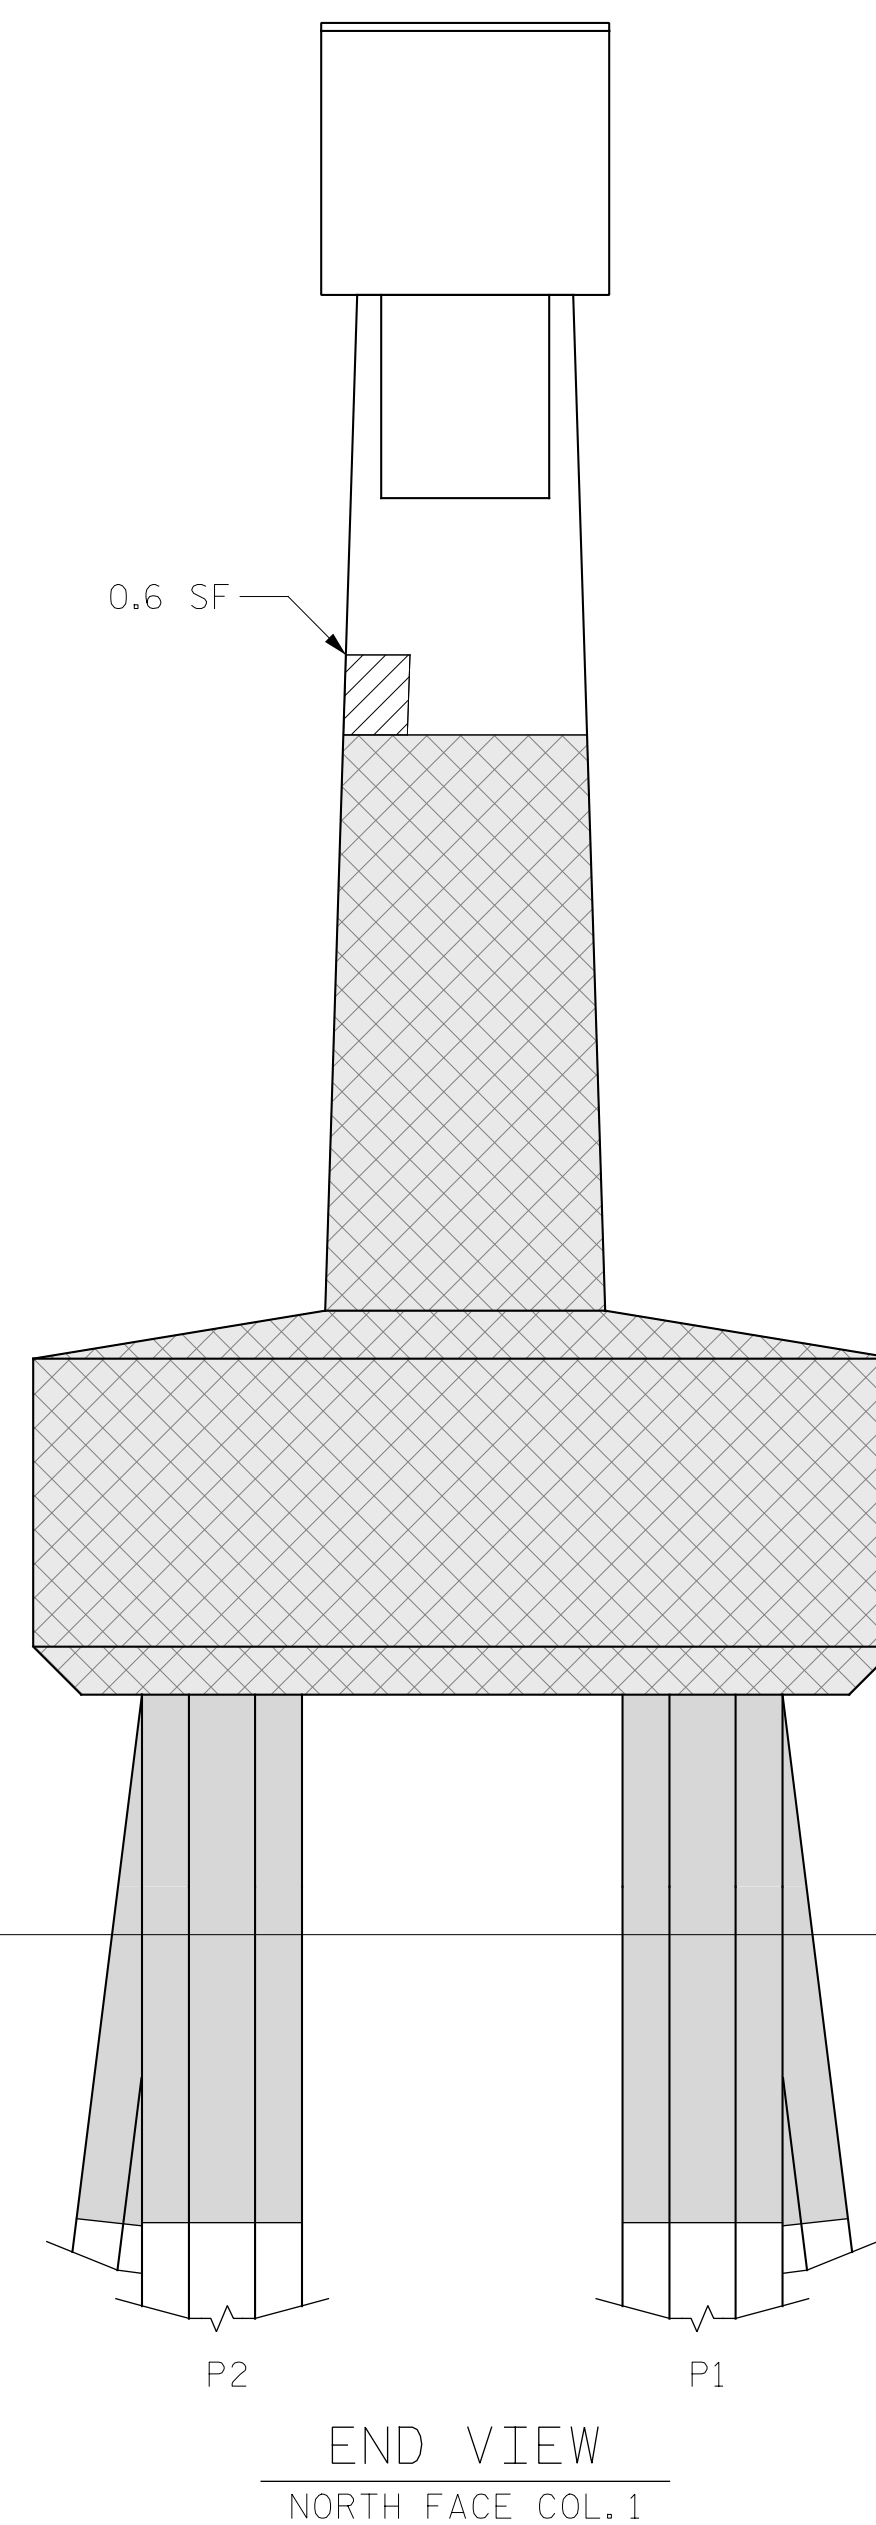
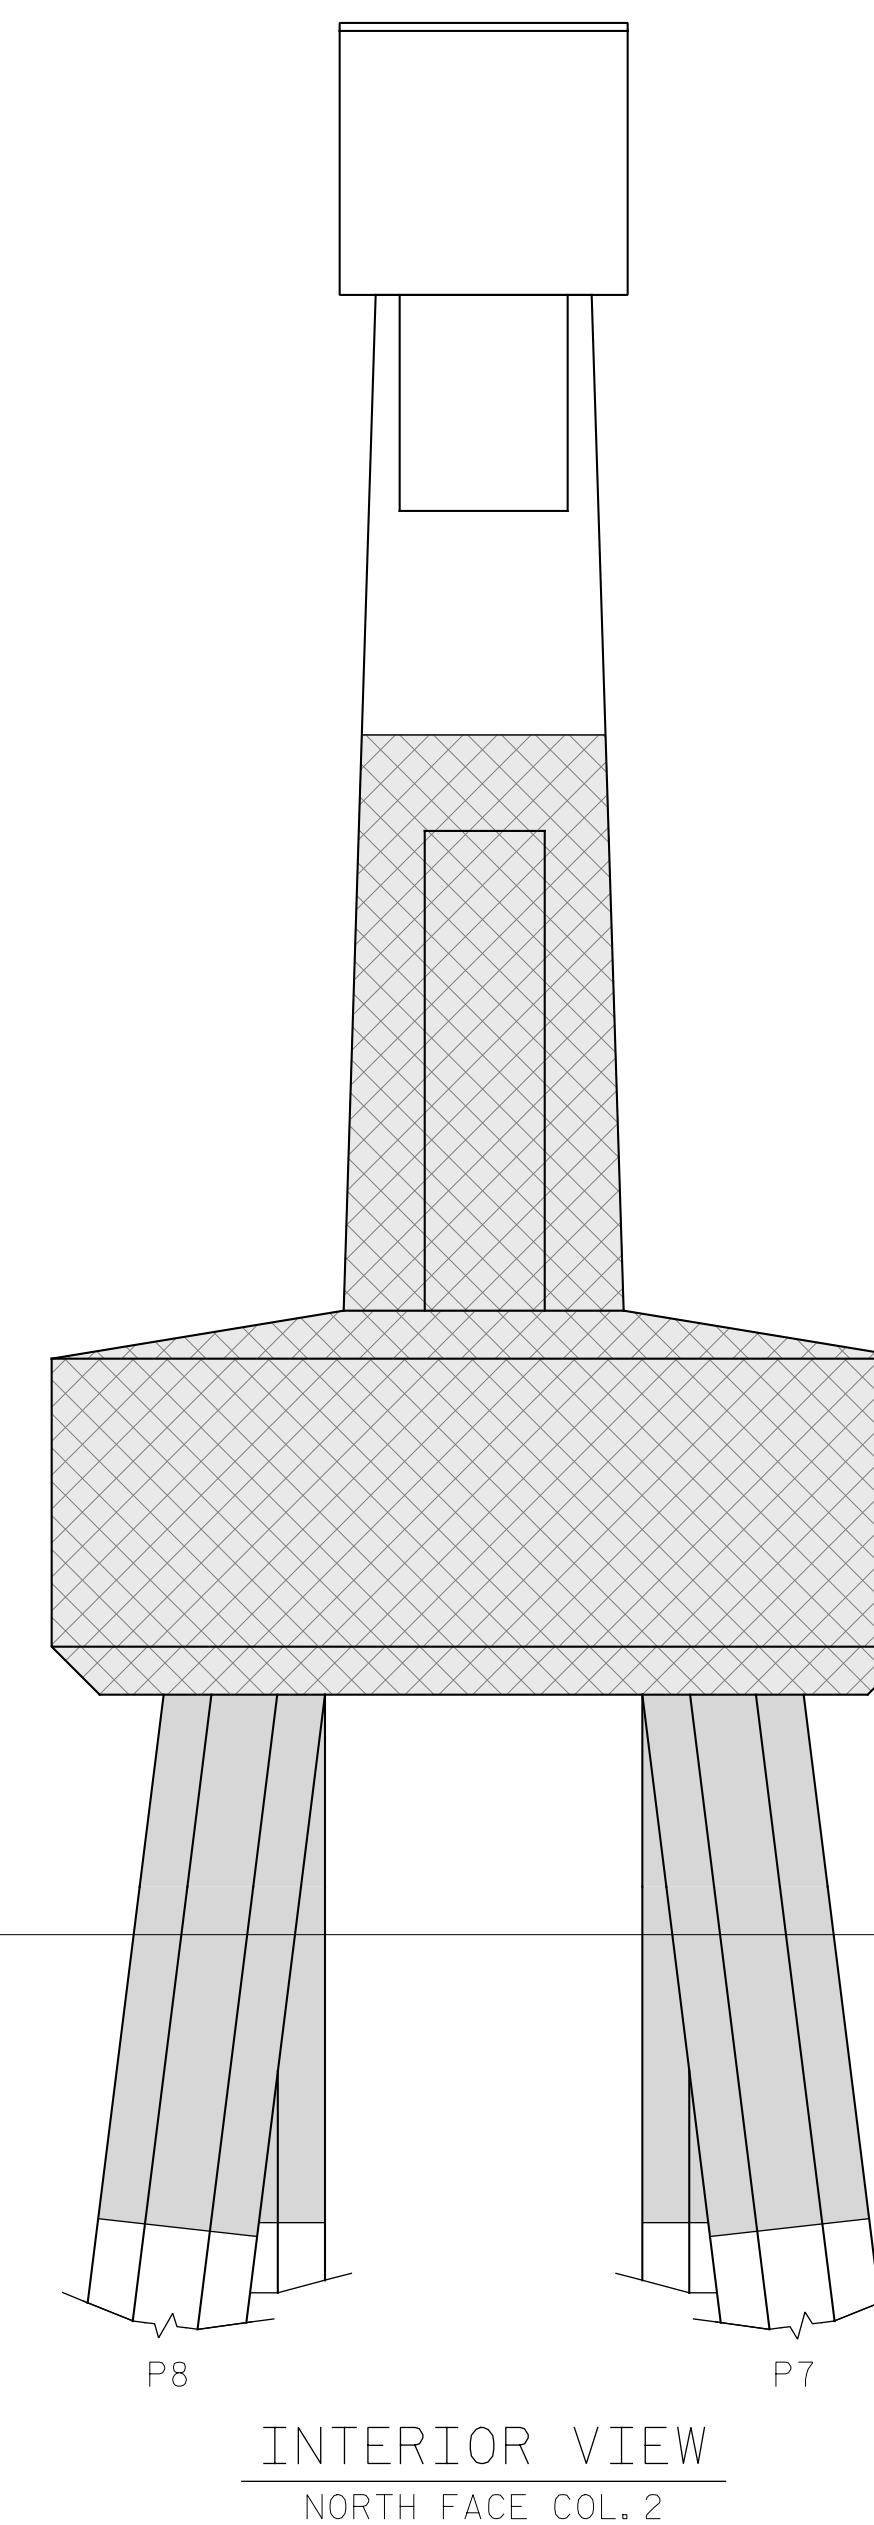
APPROX. NORMAL WATER SURFACE

- ERI - EPOXY RESIN INJECTION
- FRP - FRP PROTECTIVE SYSTEM
- SHOTCRETE - SHOTCRETE REPAIRS
- PILE FOOTING - PILE FOOTING RESTORATION

▲ FRP PROTECTIVE SYSTEM BELOW WATERLINE MAY INCLUDE APPROVED UNDERWATER MORTAR REPAIRS
