PROJECT NO. HB-0017
DARE COUNTY
 BRIDGE NO. 270009

**BENT 123
 EAST FACE**

BENT 123
 (AWL = ABOVE WATERLINE)
 (BWL = BELOW WATERLINE)

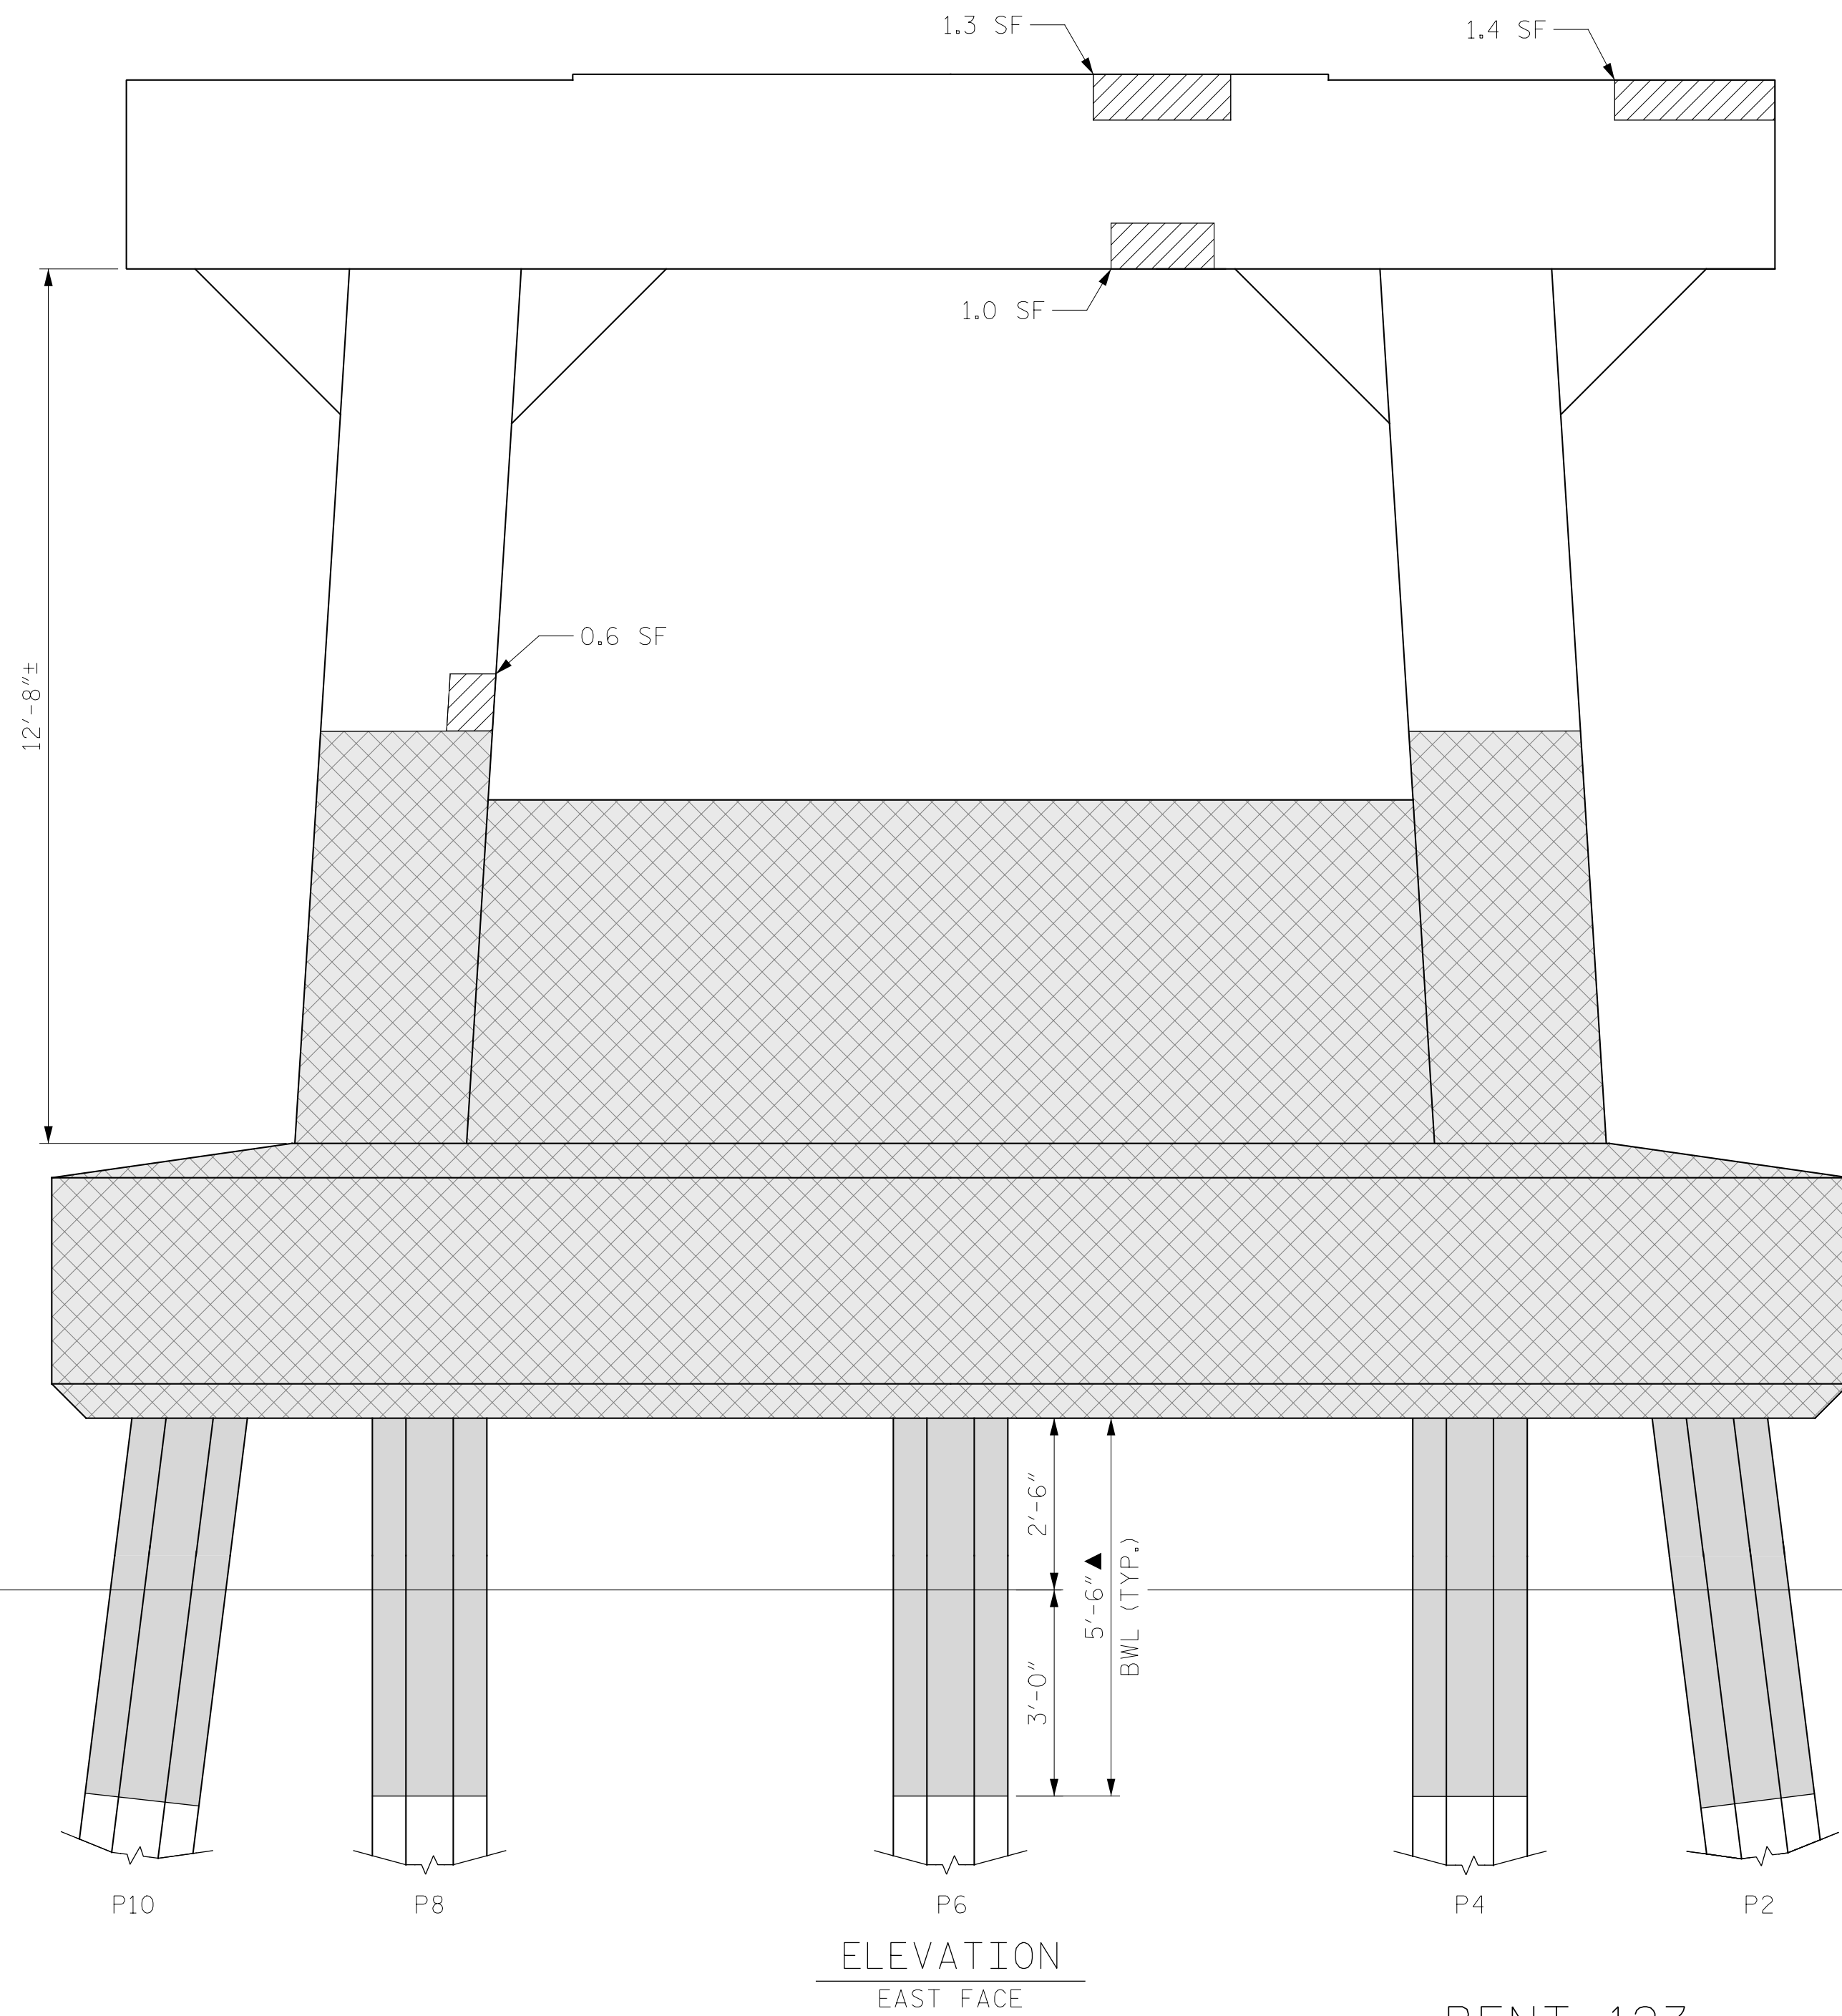
ELEVATION
EAST FACE

- ERI - EPOXY RESIN INJECTION
- FRP - FRP PROTECTIVE SYSTEM
- SHOTCRETE - SHOTCRETE REPAIRS
- PILE FOOTING RESTORATION - PILE FOOTING RESTORATION

▲ FRP PROTECTIVE SYSTEM BELOW WATERLINE MAY INCLUDE APPROVED UNDERWATER MORTAR REPAIRS
