PROJECT NO. HB-0017
DARE COUNTY
 BRIDGE NO. 270009

STATE OF NORTH CAROLINA
 DEPARTMENT OF TRANSPORTATION
 RALEIGH
**BENT 124
 EAST FACE**

BENT 124
 (AWL = ABOVE WATERLINE)
 (BWL = BELOW WATERLINE)

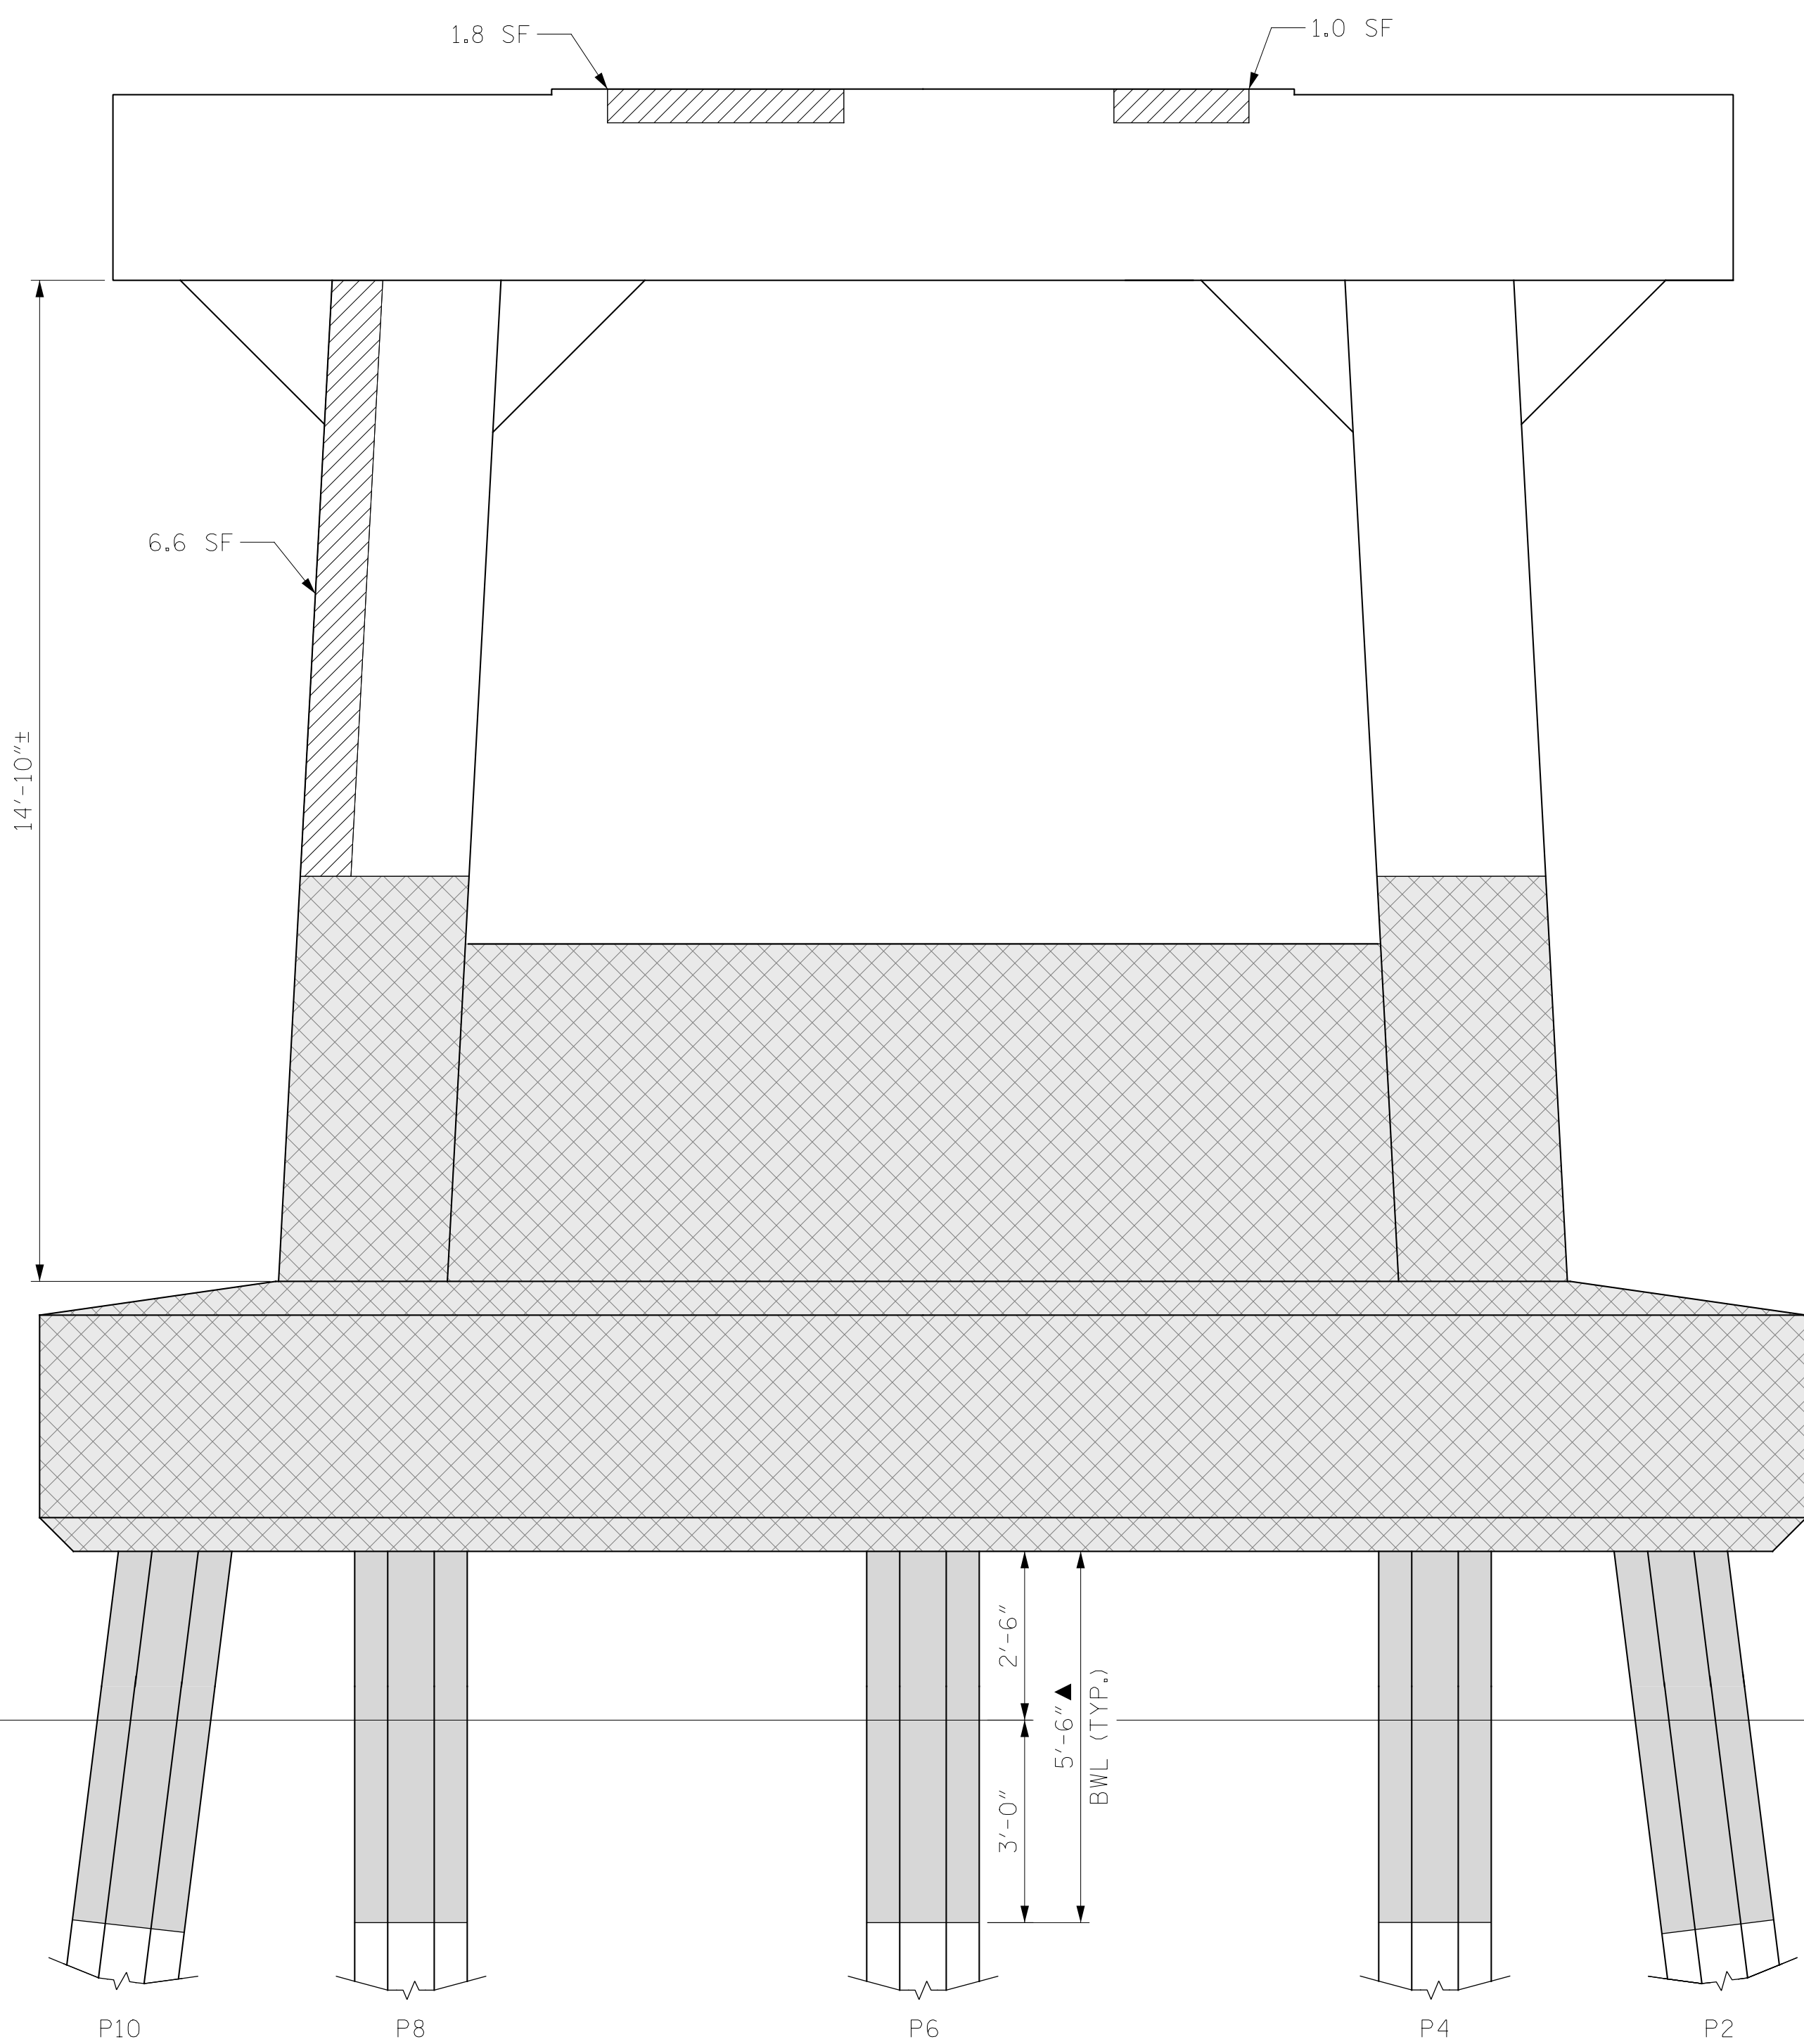
ELEVATION
EAST FACE

- ERI - EPOXY RESIN INJECTION
- FRP - FRP PROTECTIVE SYSTEM
- SHOTCRETE - SHOTCRETE REPAIRS
- PILE FOOTING RESTORATION - PILE FOOTING RESTORATION

▲ FRP PROTECTIVE SYSTEM BELOW WATERLINE MAY INCLUDE APPROVED UNDERWATER MORTAR REPAIRS

APPROX. NORMAL WATER SURFACE
