PROJECT NO. HB-0017  
DARE COUNTY  
 BRIDGE NO. 270009

BENT 128  
 EAST FACE

BENT 128  
 (AWL = ABOVE WATERLINE)  
 (BWL = BELOW WATERLINE)

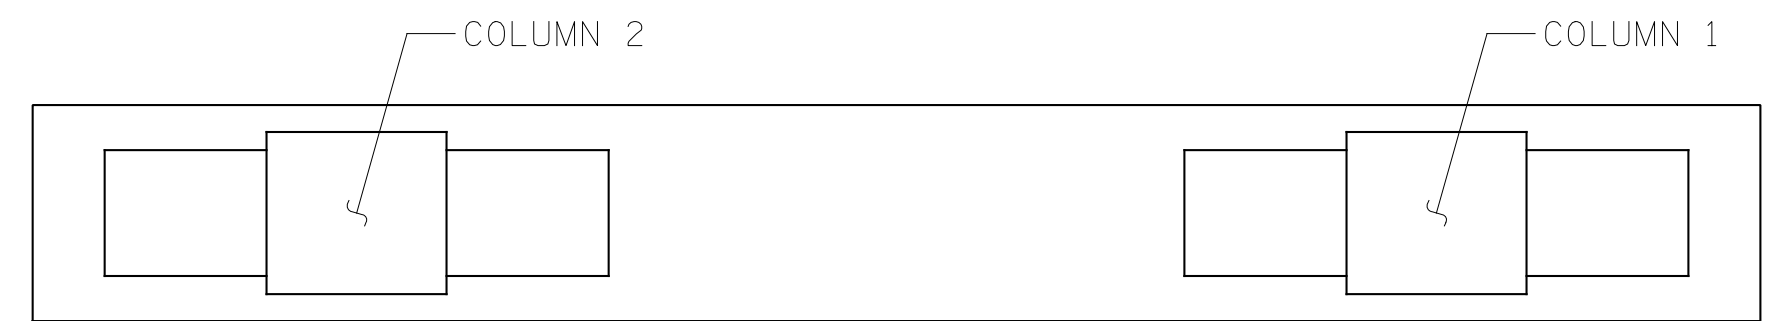
EAST FACE

WEST FACE

BOTTOM OF CAP

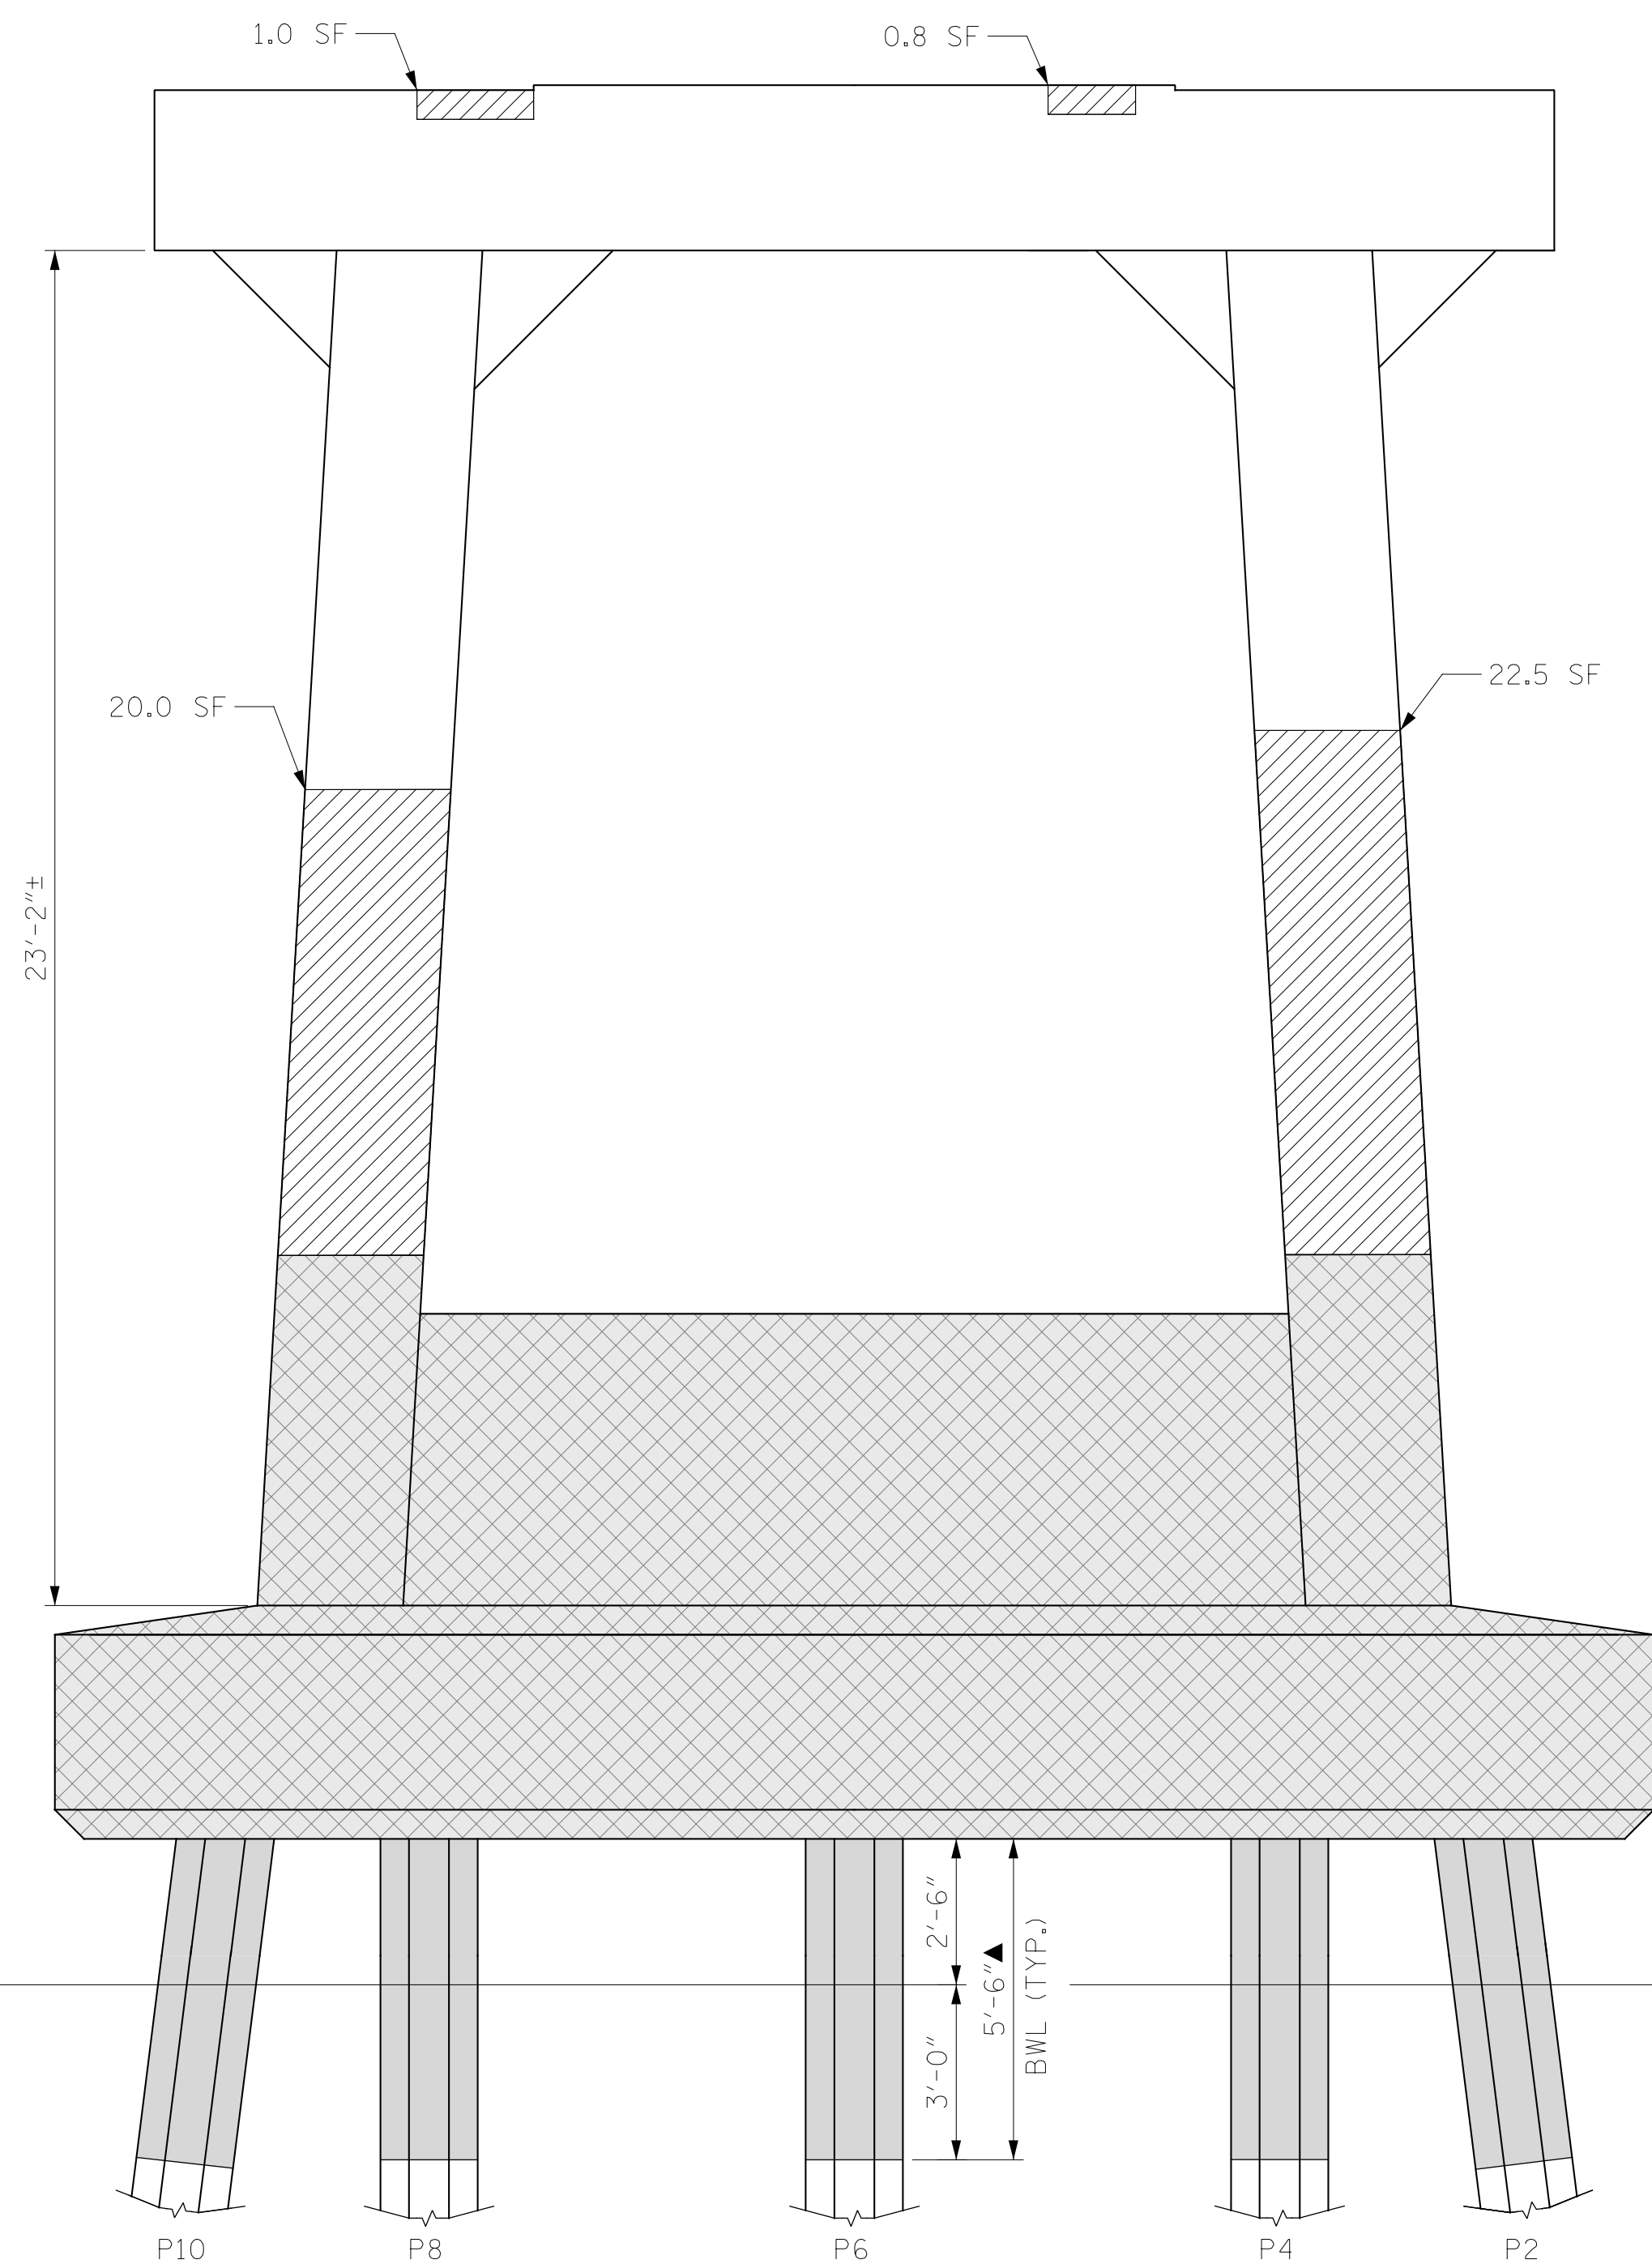
ELEVATION  
EAST FACE

- ERI - EPOXY RESIN INJECTION
- FRP - FRP PROTECTIVE SYSTEM
- SHOTCRETE - SHOTCRETE REPAIRS
- PILE FOOTING - PILE FOOTING RESTORATION

▲ FRP PROTECTIVE SYSTEM BELOW WATERLINE MAY INCLUDE APPROVED UNDERWATER MORTAR REPAIRS
