PROJECT NO. HB-0017  
DARE COUNTY  
 BRIDGE NO. 270009

**BENT 130  
 EAST FACE**

**BENT 130**  
 (AWL = ABOVE WATERLINE)  
 (BWL = BELOW WATERLINE)

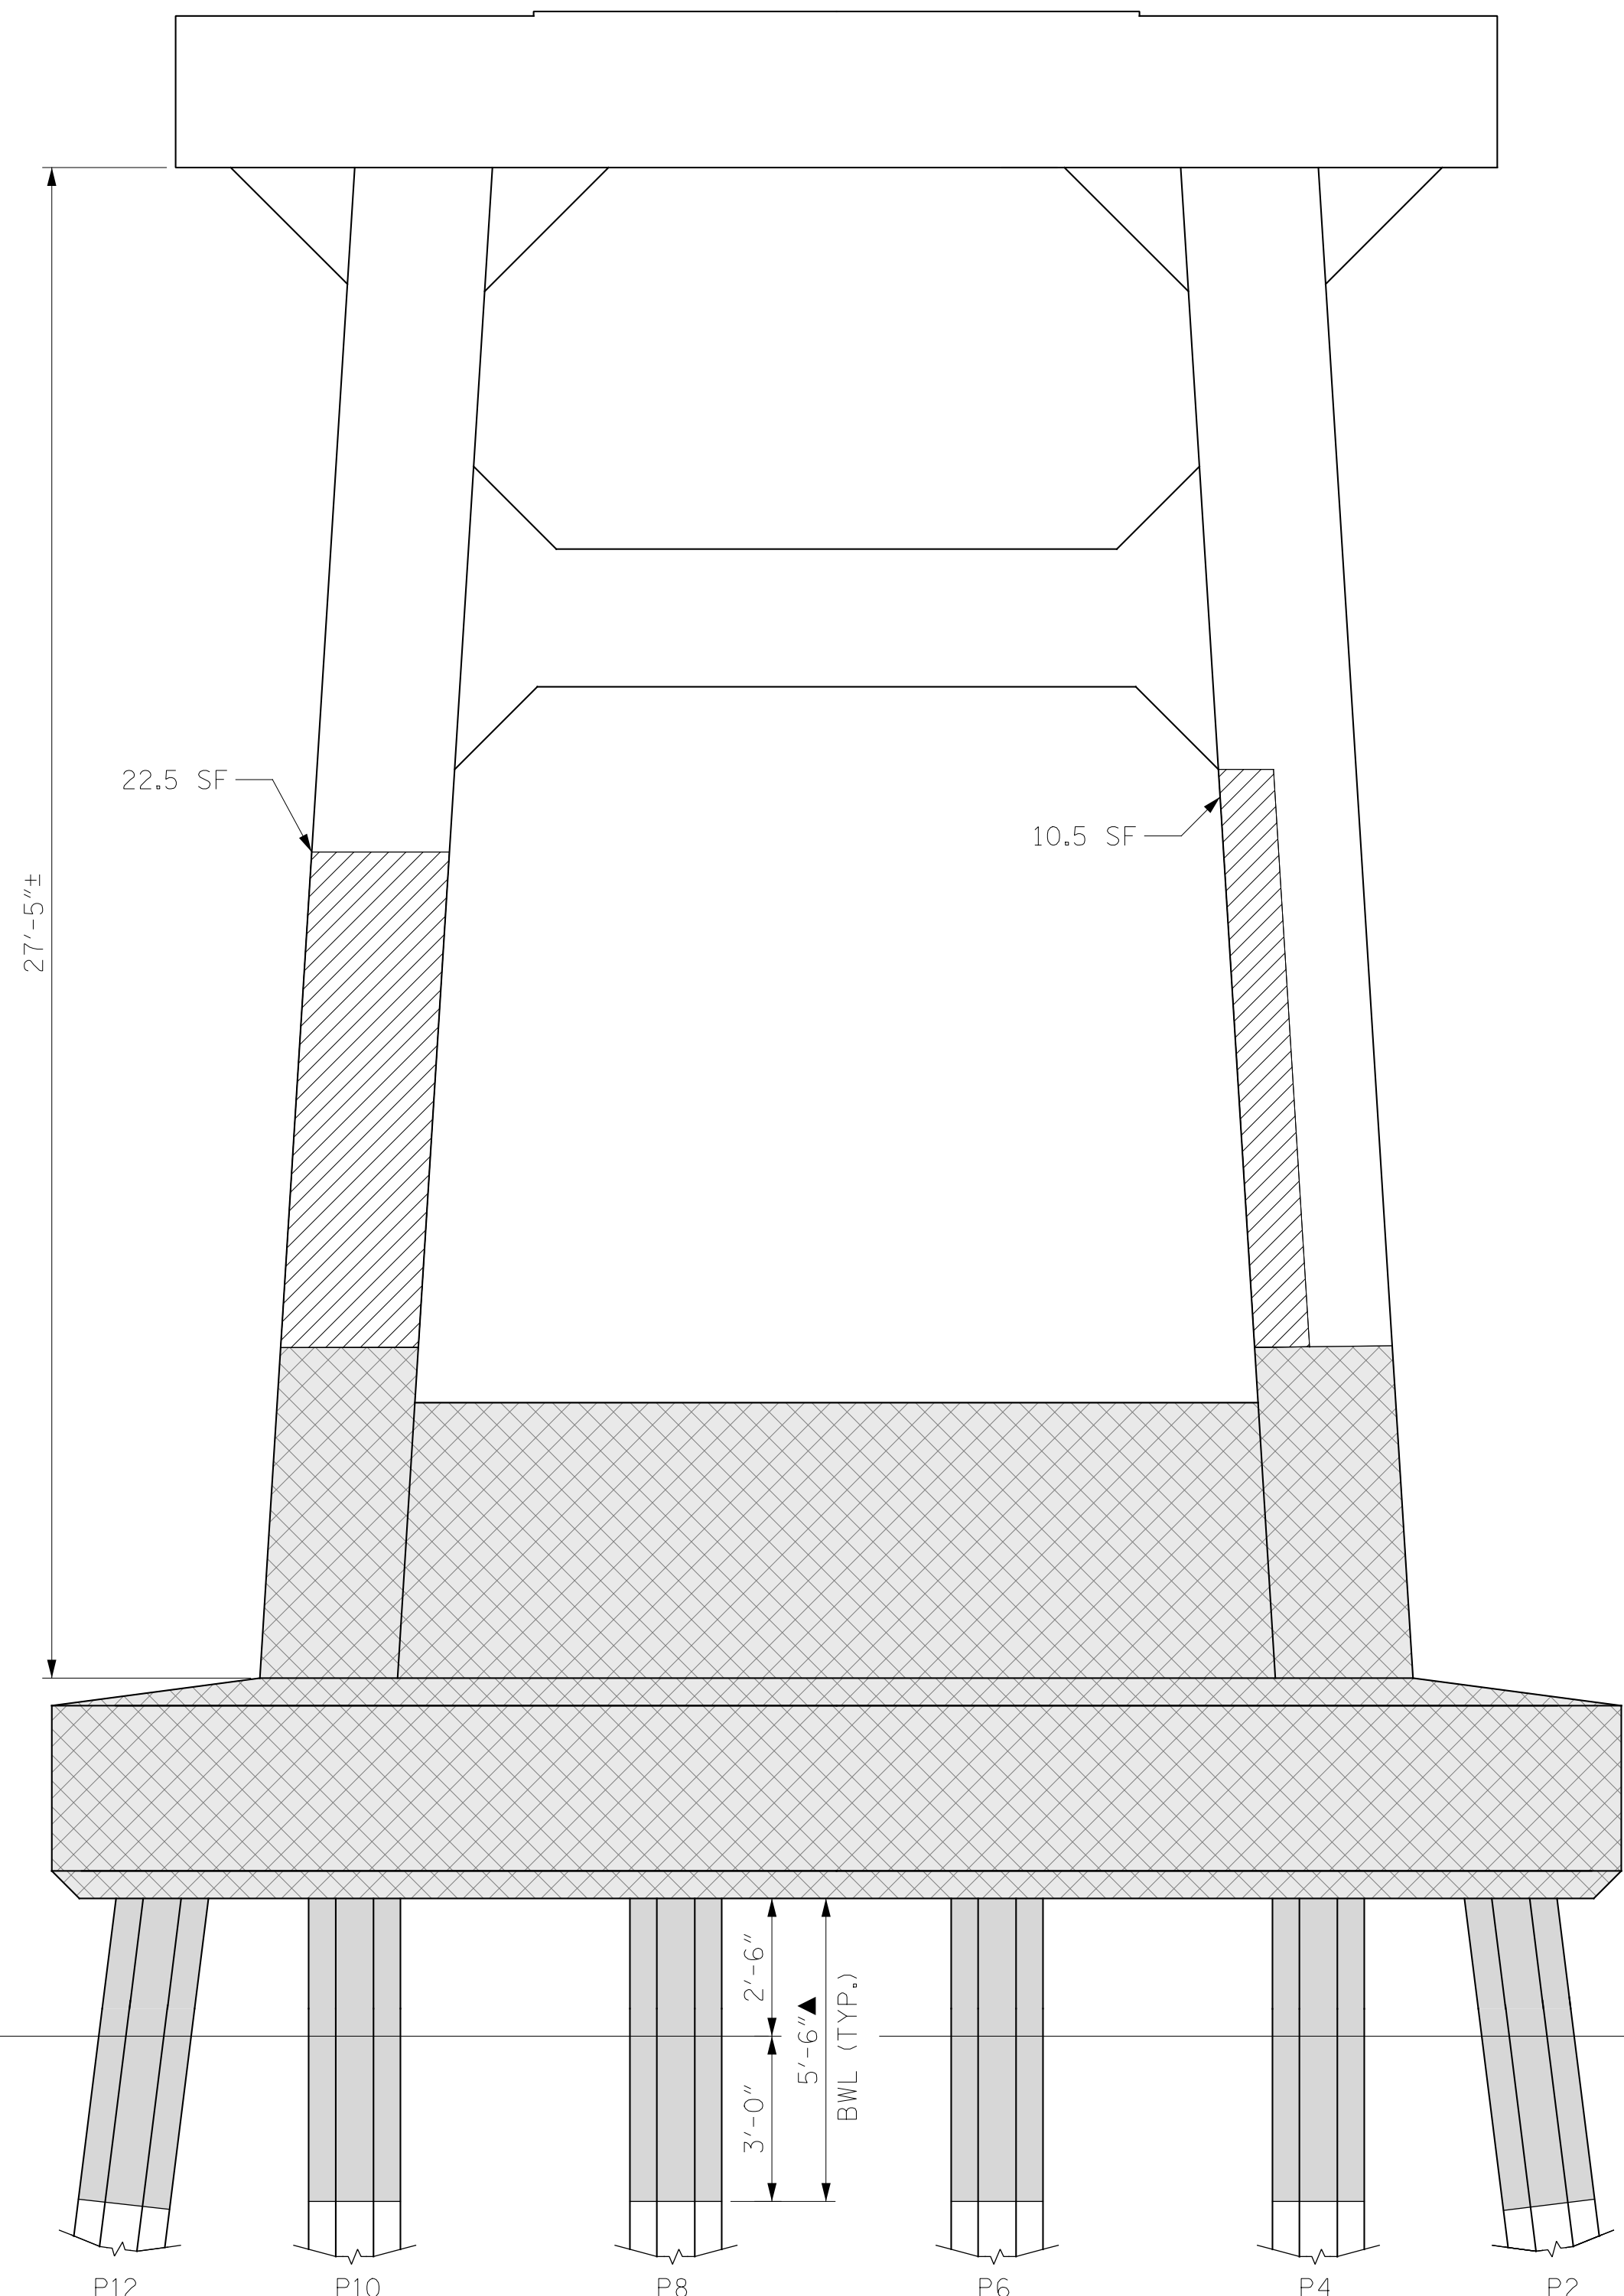
ELEVATION  
EAST FACE

- ERI - EPOXY RESIN INJECTION
- FRP - FRP PROTECTIVE SYSTEM
- SHOTCRETE - SHOTCRETE REPAIRS
- PILE FOOTING RESTORATION - PILE FOOTING RESTORATION

▲ FRP PROTECTIVE SYSTEM BELOW WATERLINE MAY INCLUDE APPROVED UNDERWATER MORTAR REPAIRS
