PROJECT NO. HB-0017  
DARE COUNTY  
 BRIDGE NO. 270009

**BENT 131  
 EAST FACE**

**BENT 131**  
 (AWL = ABOVE WATERLINE)  
 (BWL = BELOW WATERLINE)

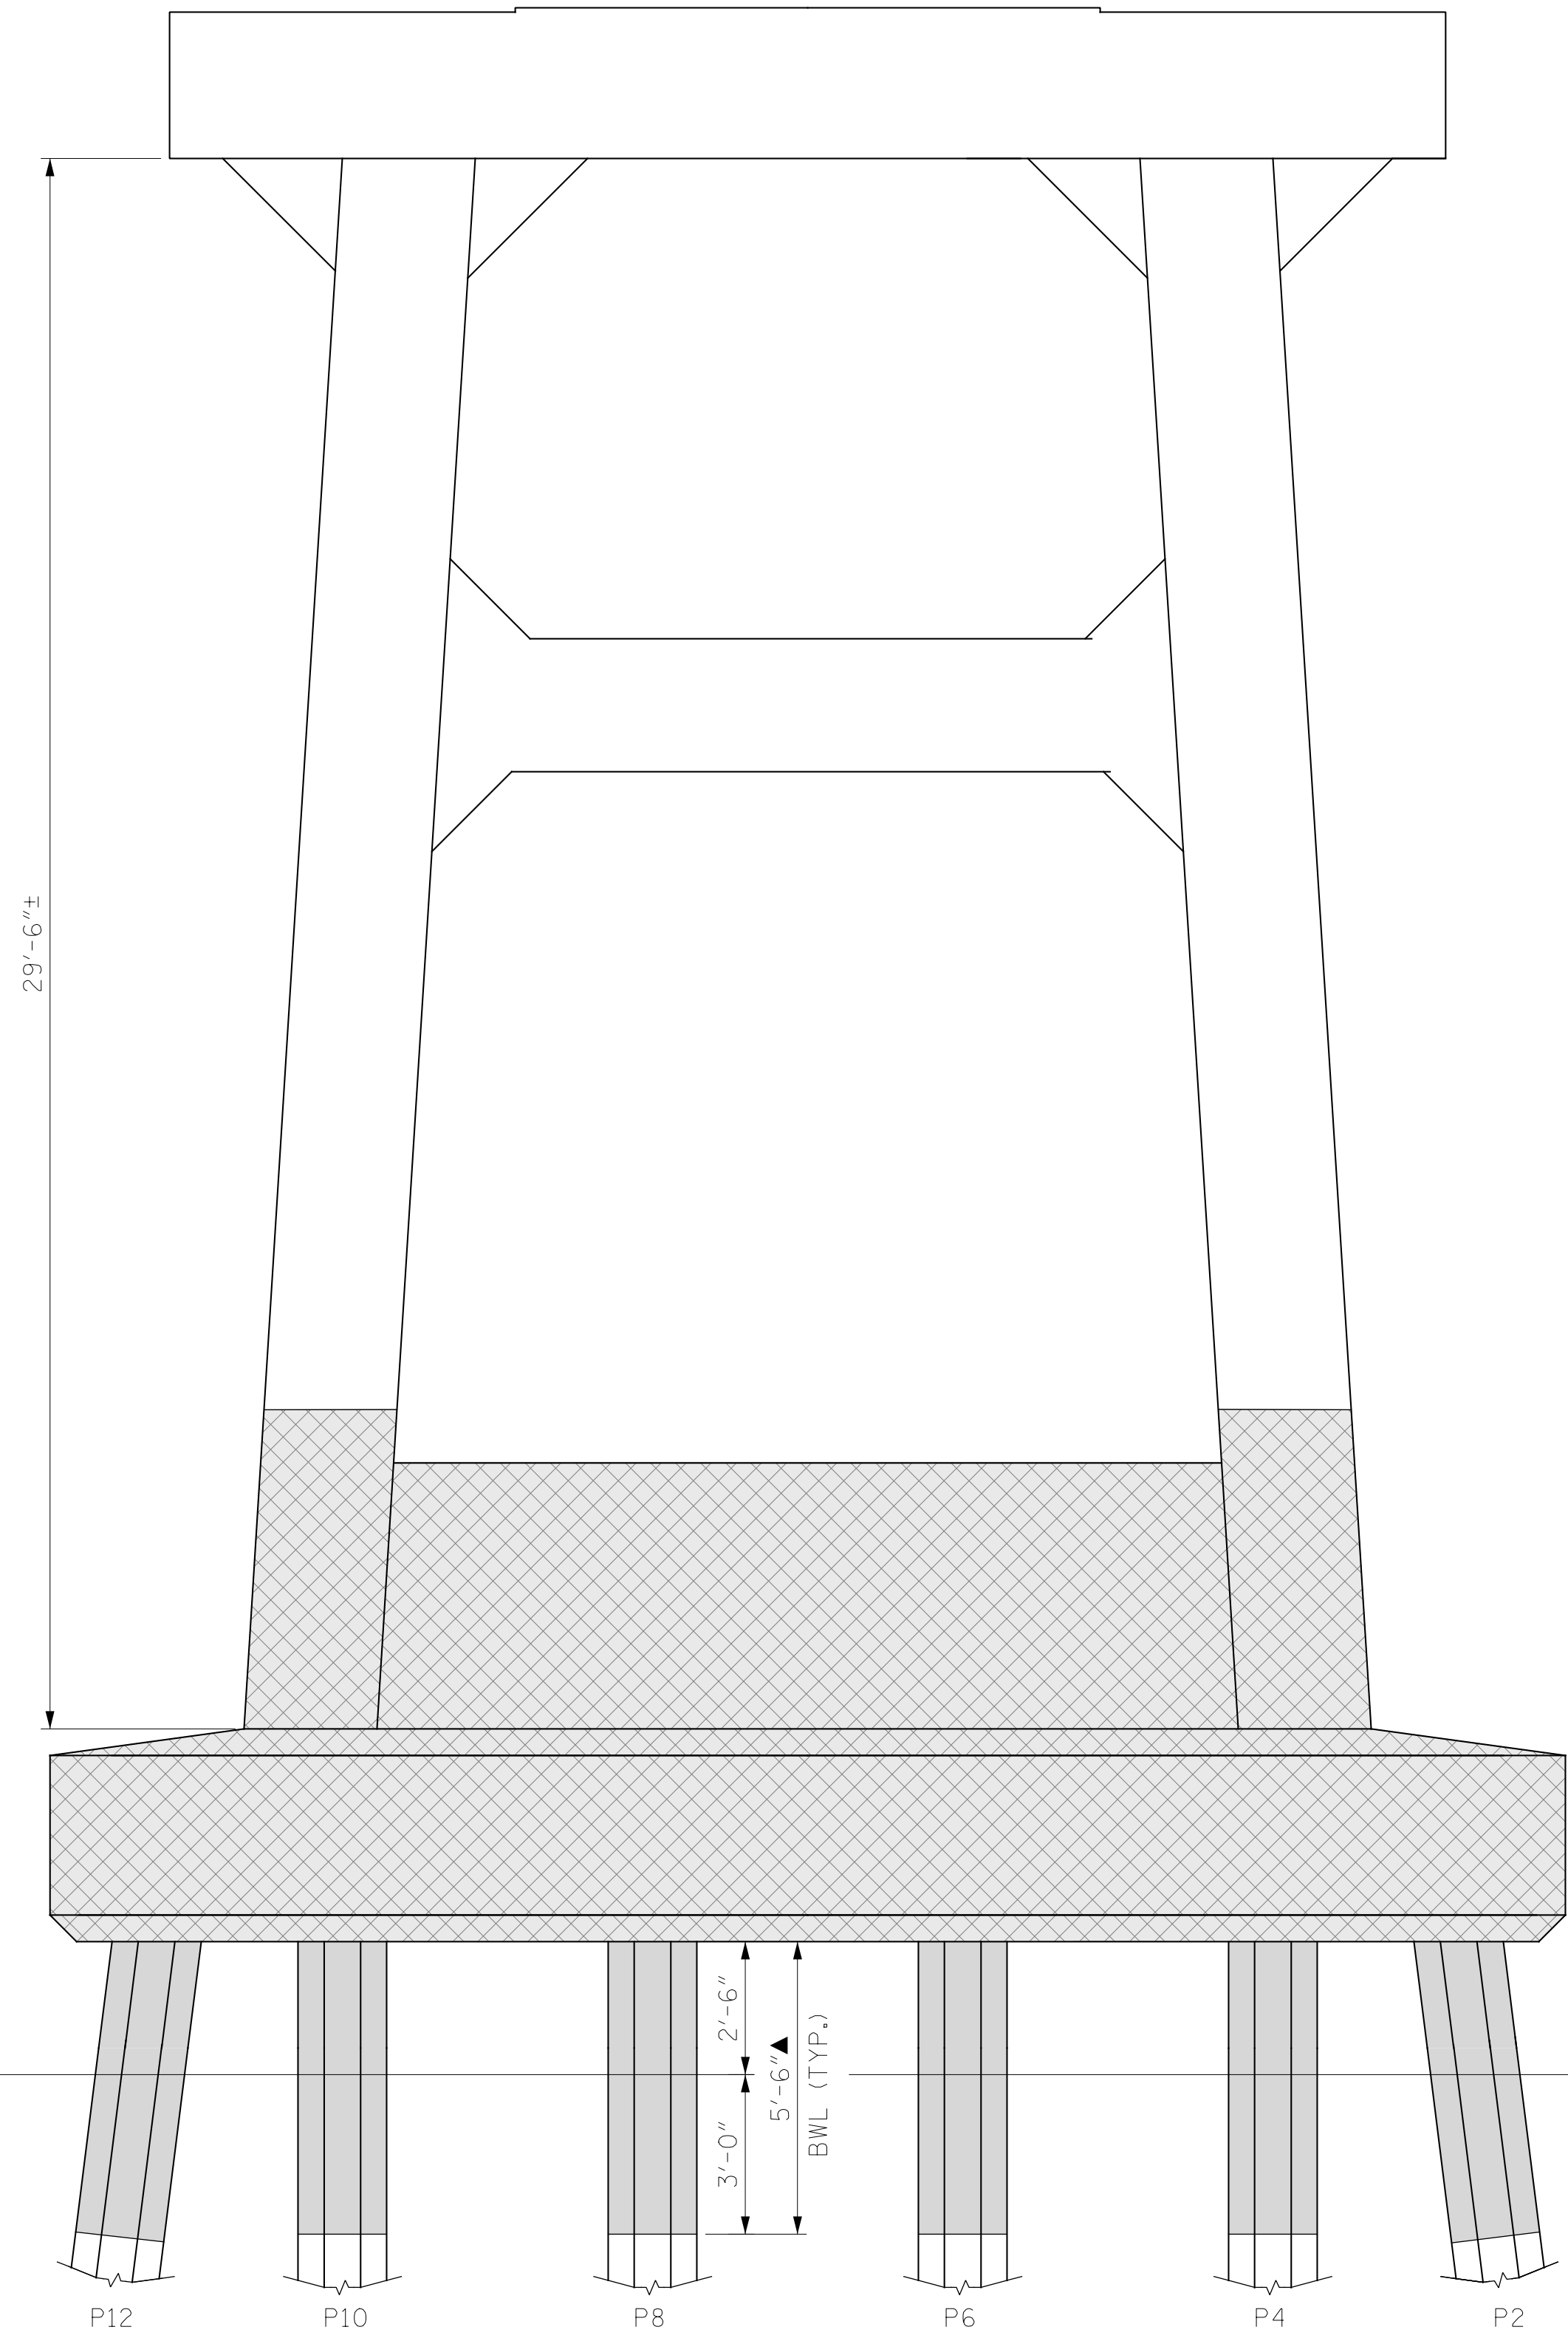
ELEVATION EAST FACE

- ERI - EPOXY RESIN INJECTION
- FRP - FRP PROTECTIVE SYSTEM
- SHOTCRETE - SHOTCRETE REPAIRS
- PILE - PILE FOOTING RESTORATION

▲ FRP PROTECTIVE SYSTEM BELOW WATERLINE MAY INCLUDE APPROVED UNDERWATER MORTAR REPAIRS
