PROJECT NO. HB-0017
DARE COUNTY
 BRIDGE NO. 270009

BENT 133
 EAST FACE

BENT 133
 (AWL = ABOVE WATERLINE)
 (BWL = BELOW WATERLINE)

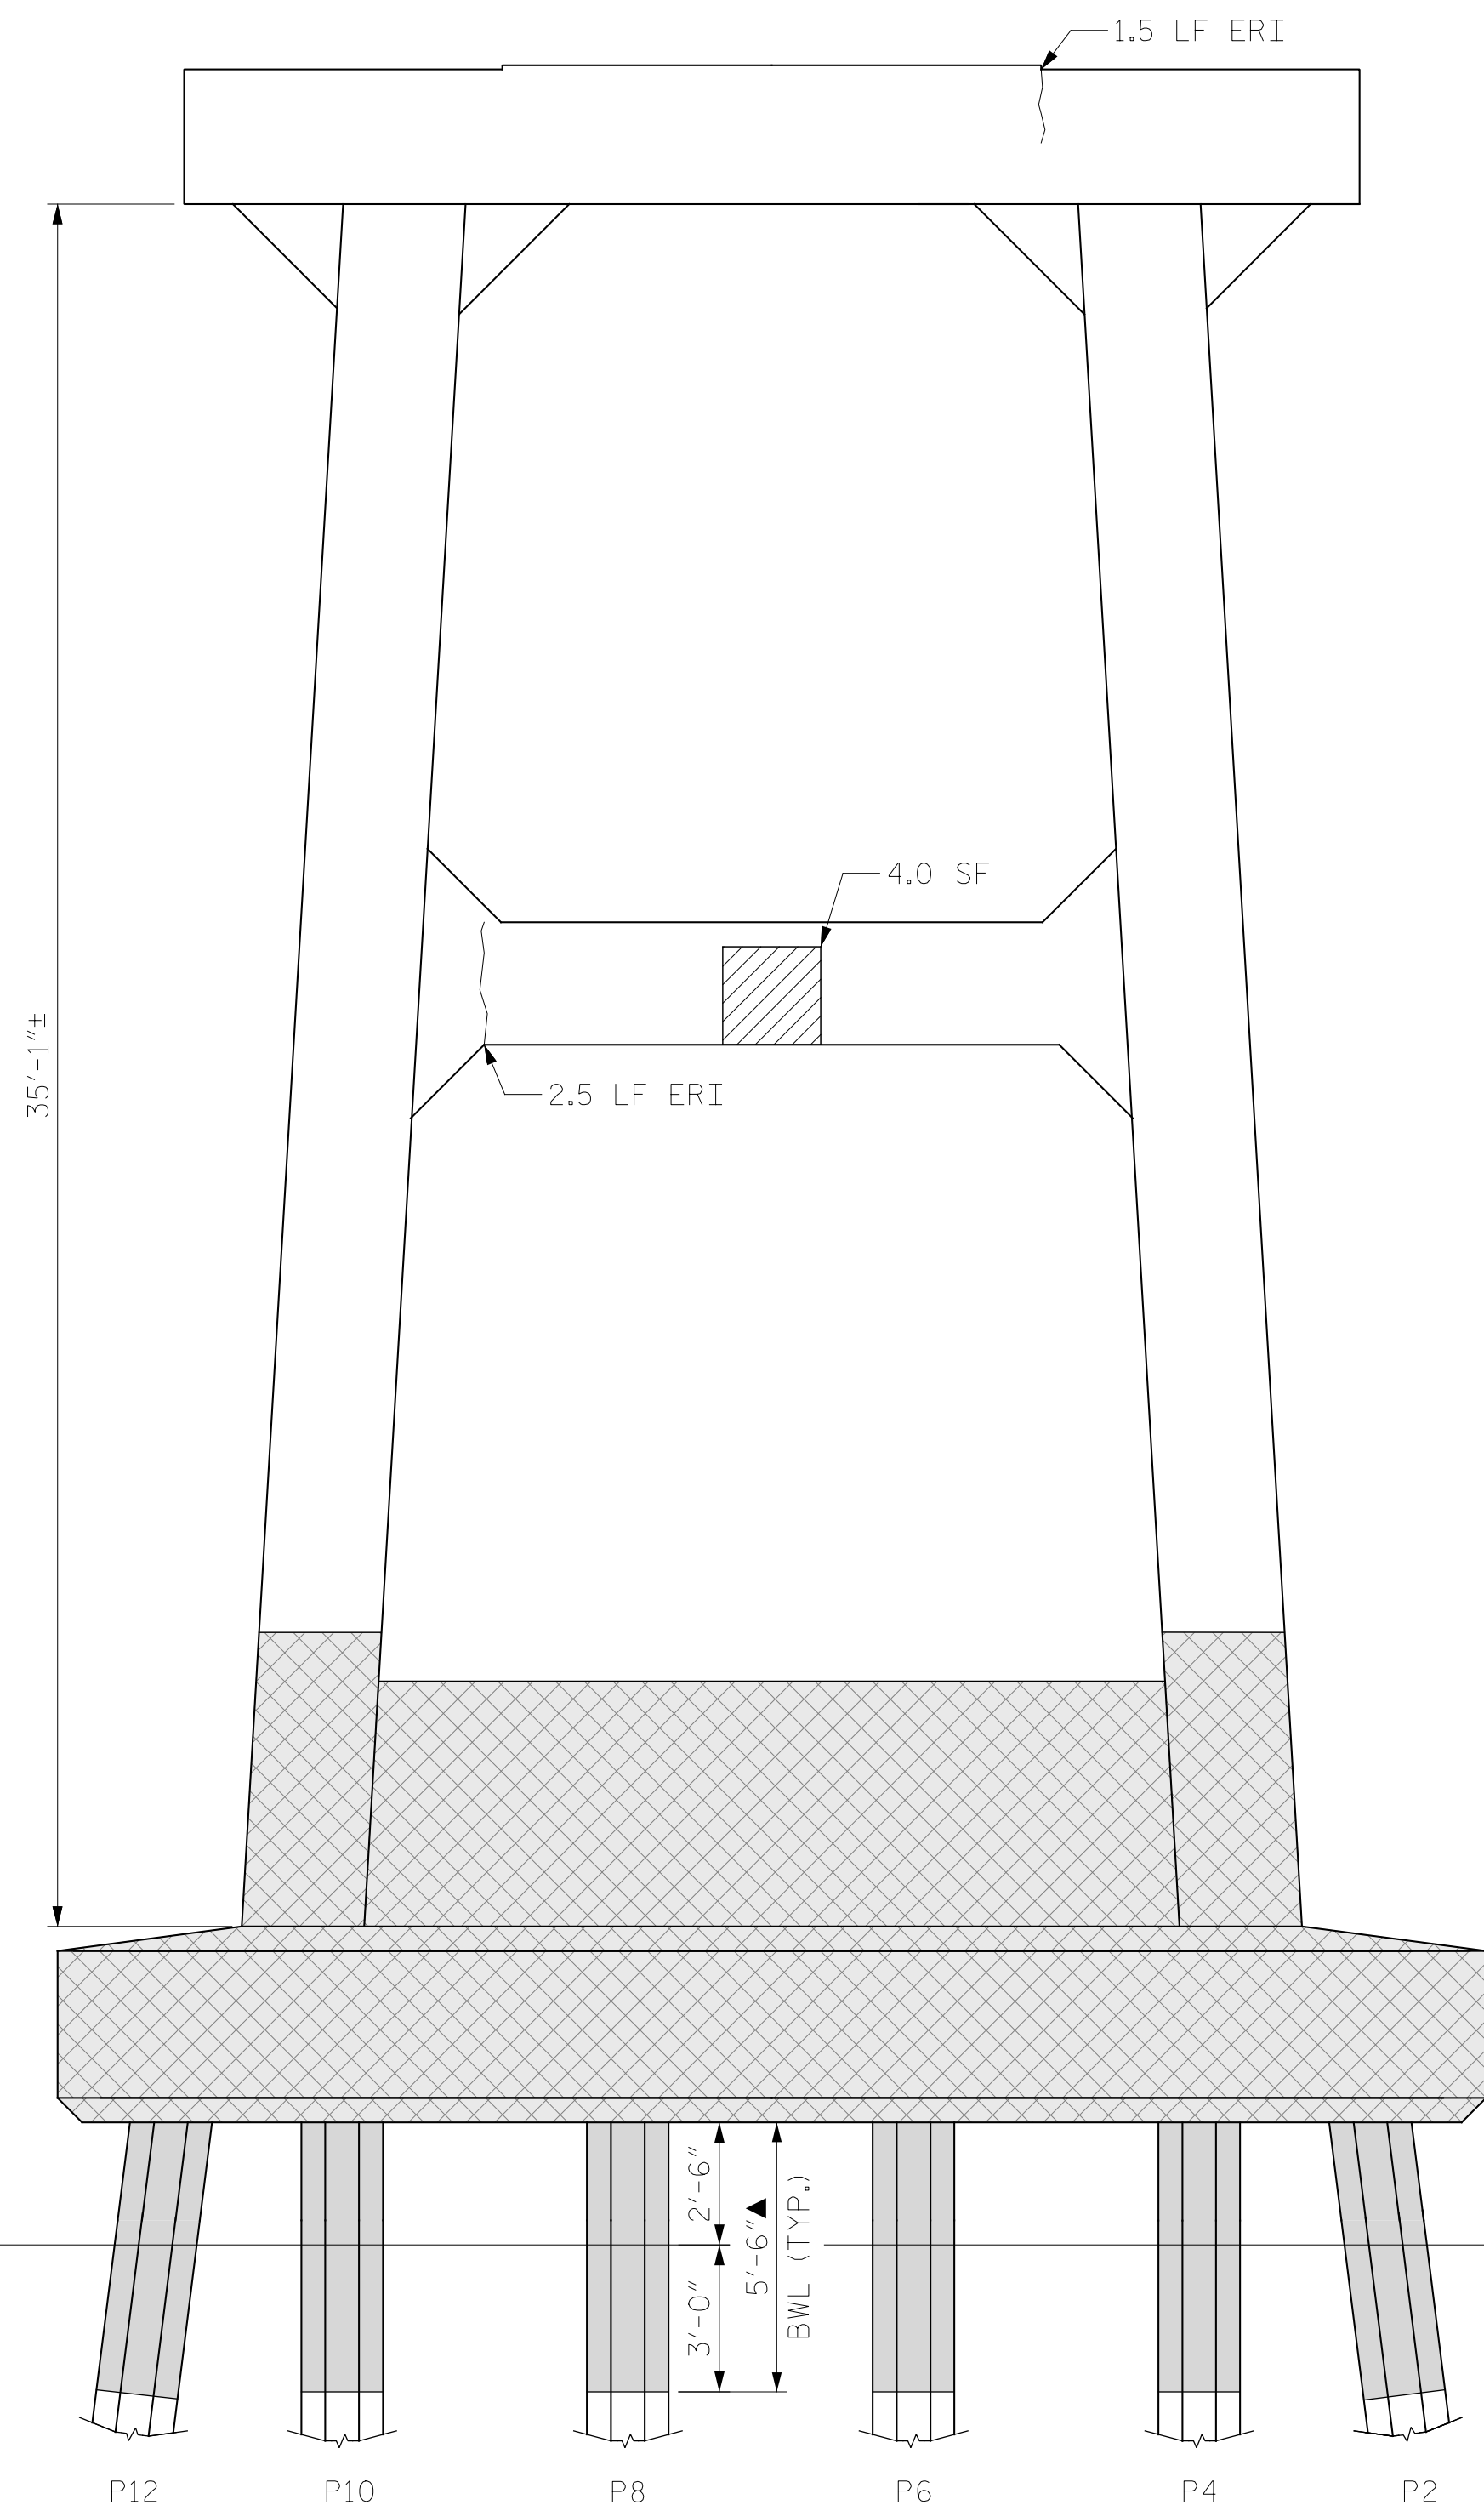
ELEVATION
EAST FACE

- ERI - EPOXY RESIN INJECTION
- FRP PROTECTIVE SYSTEM
- SHOTCRETE REPAIRS
- PILE FOOTING RESTORATION

▲ FRP PROTECTIVE SYSTEM BELOW WATERLINE MAY INCLUDE APPROVED UNDERWATER MORTAR REPAIRS
