PROJECT NO. HB-0017  
DARE COUNTY  
BRIDGE NO. 270009

BENT 135  
(AWL = ABOVE WATERLINE)  
(BWL = BELOW WATERLINE)

SHEET NO.  
S-208  
TOTAL SHEETS  
355

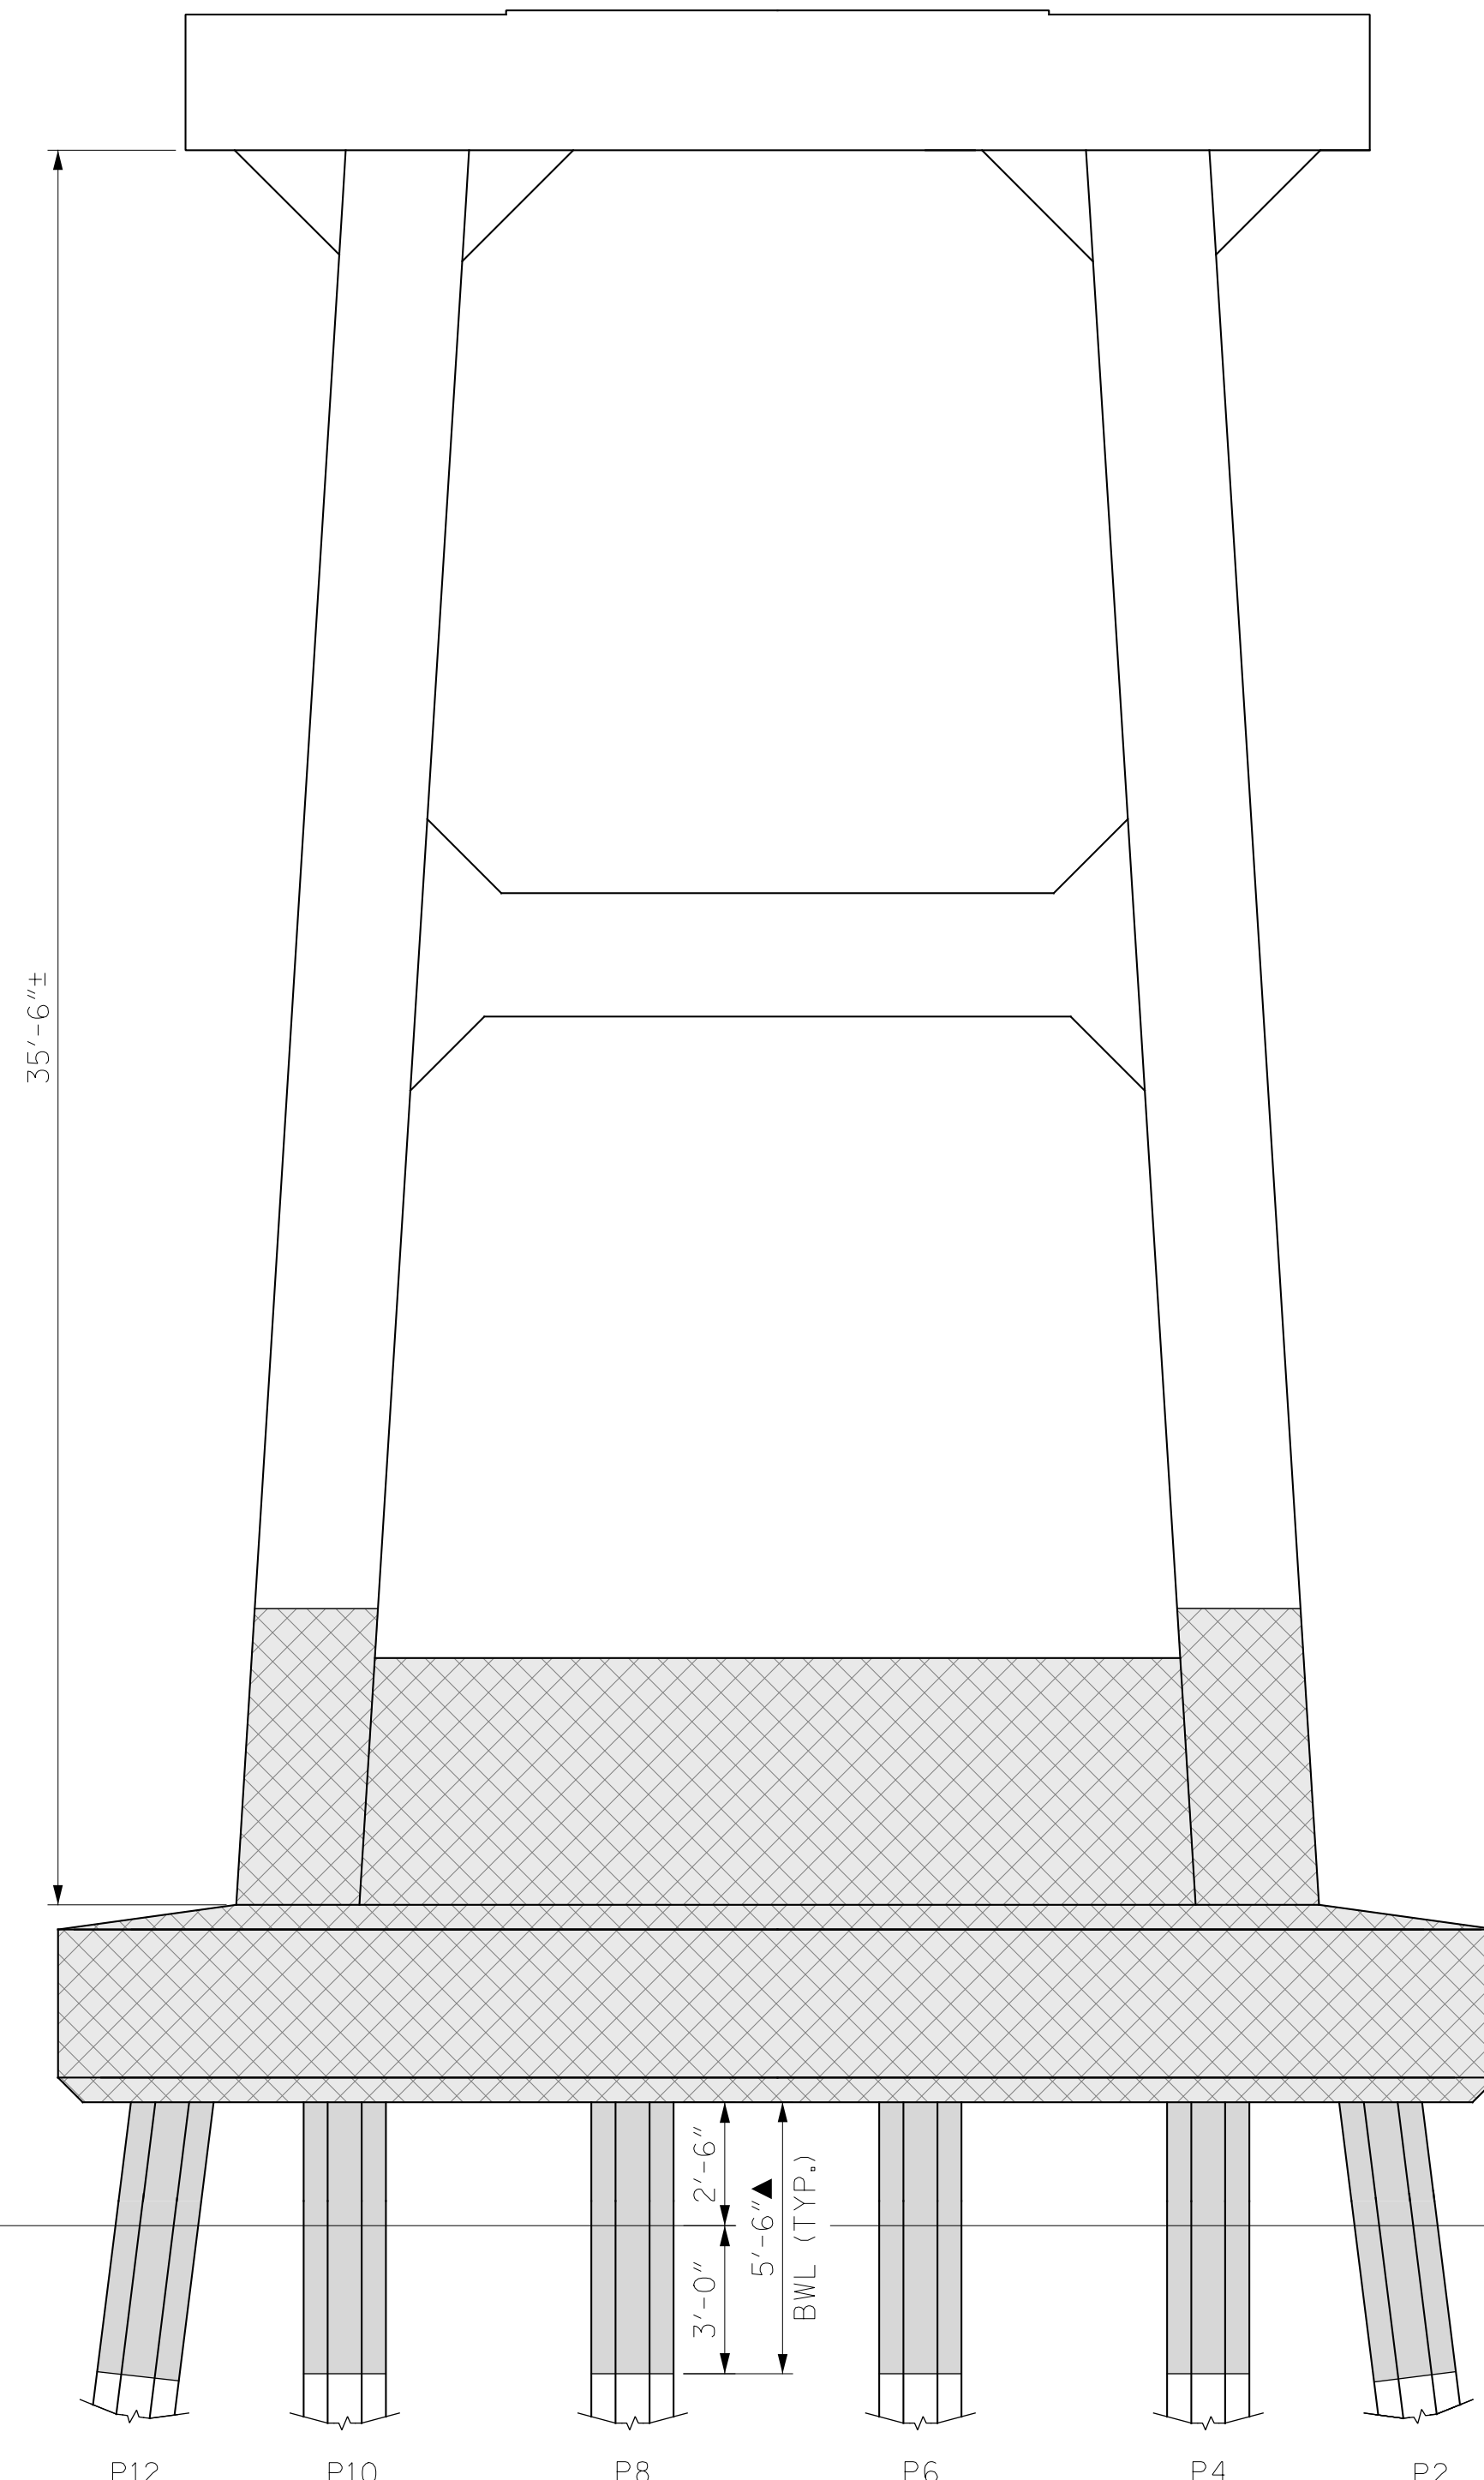
ELEVATION  
EAST FACE

- ERI - EPOXY RESIN INJECTION
- FRP PROTECTIVE SYSTEM
- SHOTCRETE REPAIRS
- PILE FOOTING RESTORATION

▲ FRP PROTECTIVE SYSTEM BELOW WATERLINE MAY INCLUDE APPROVED UNDERWATER MORTAR REPAIRS

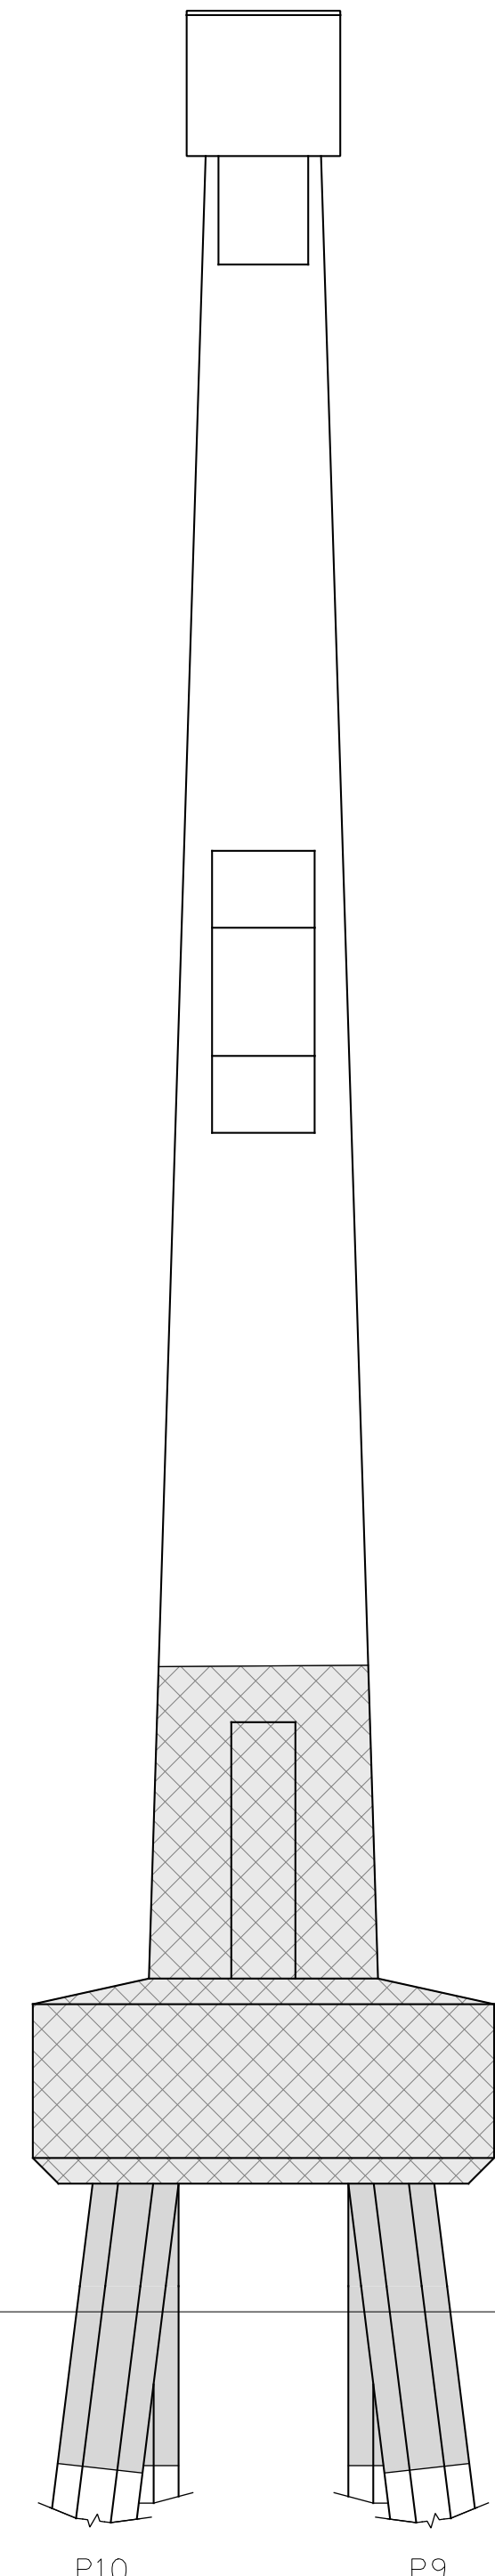
INTERIOR VIEW  
NORTH FACE COL.2

APPROX.  
NORMAL  
WATER  
SURFACE
