PROJECT NO. HB-0017
DARE COUNTY
BRIDGE NO. 270009

**BENT 138
EAST FACE**

BENT 138
(AWL = ABOVE WATERLINE)
(BWL = BELOW WATERLINE)

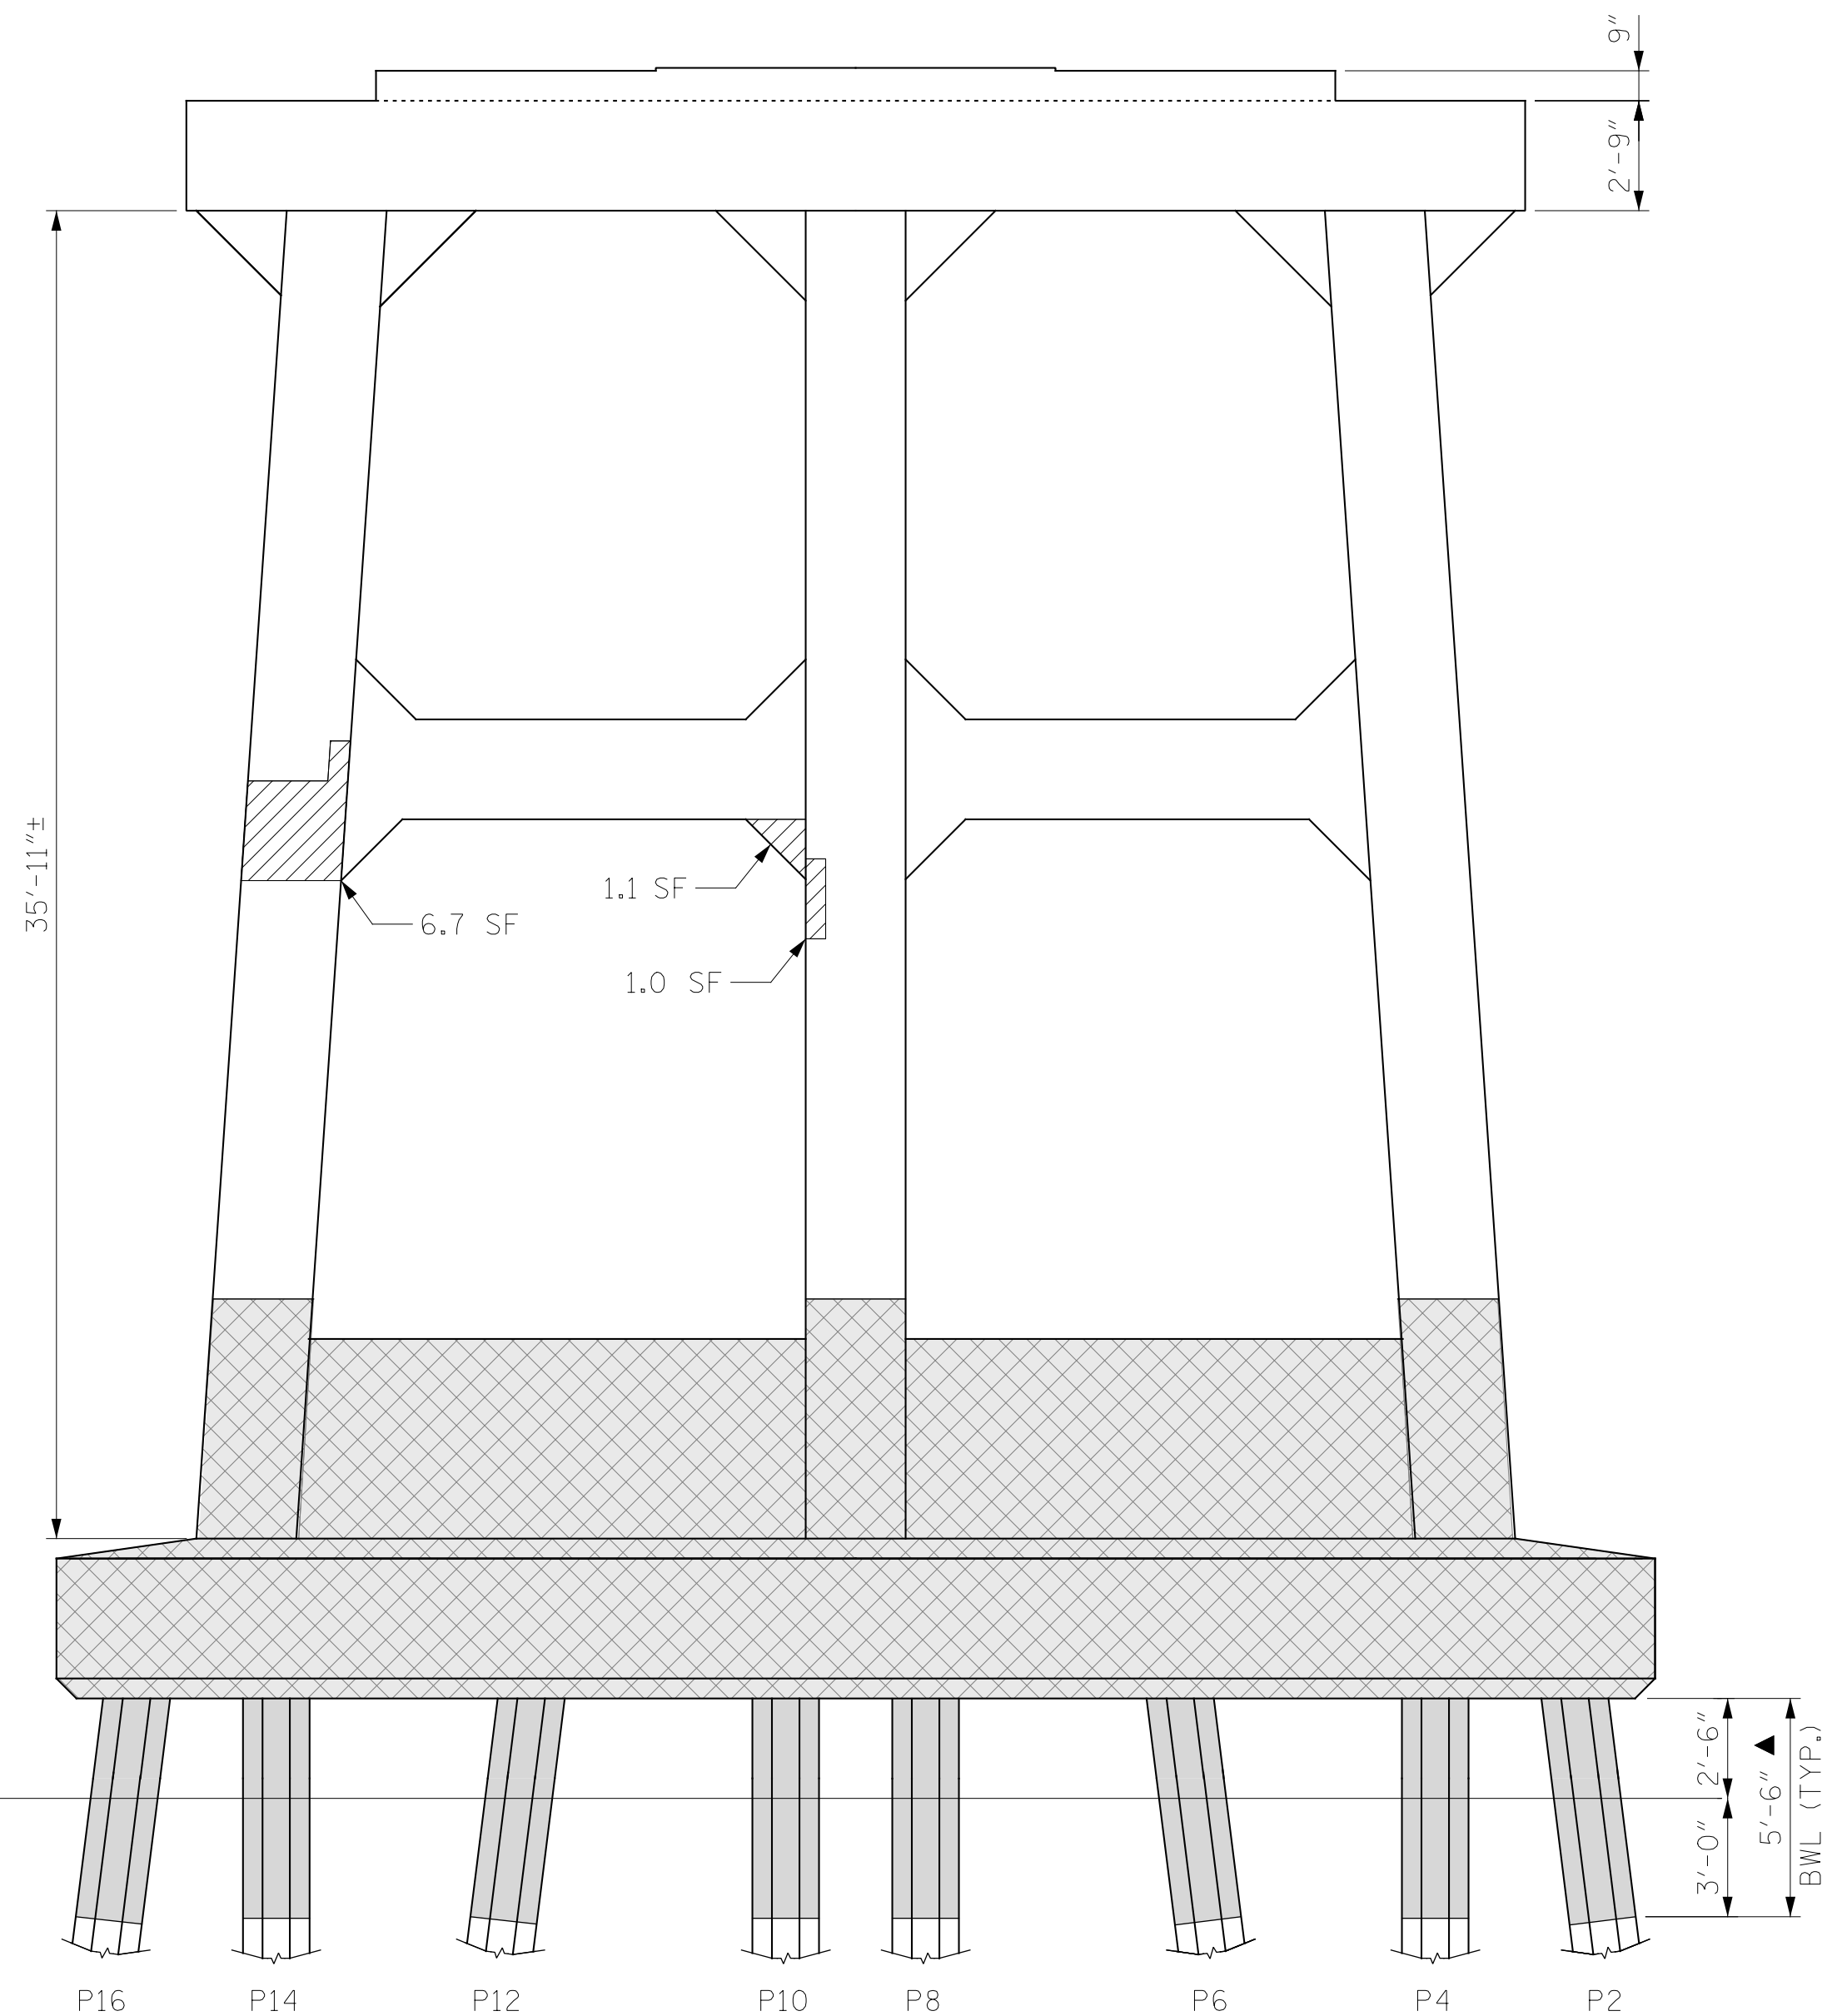
ELEVATION
EAST FACE

- ERI - EPOXY RESIN INJECTION
- FRP - FRP PROTECTIVE SYSTEM
- SHOTCRETE - SHOTCRETE REPAIRS
- PILE FOOTING RESTORATION - PILE FOOTING RESTORATION

▲ FRP PROTECTIVE SYSTEM BELOW WATERLINE MAY INCLUDE APPROVED UNDERWATER MORTAR REPAIRS
