PROJECT NO. HB-0017
DARE COUNTY
 BRIDGE NO. 270009

**BENT 139
 EAST FACE**

BENT 139
 (AWL = ABOVE WATERLINE)
 (BWL = BELOW WATERLINE)

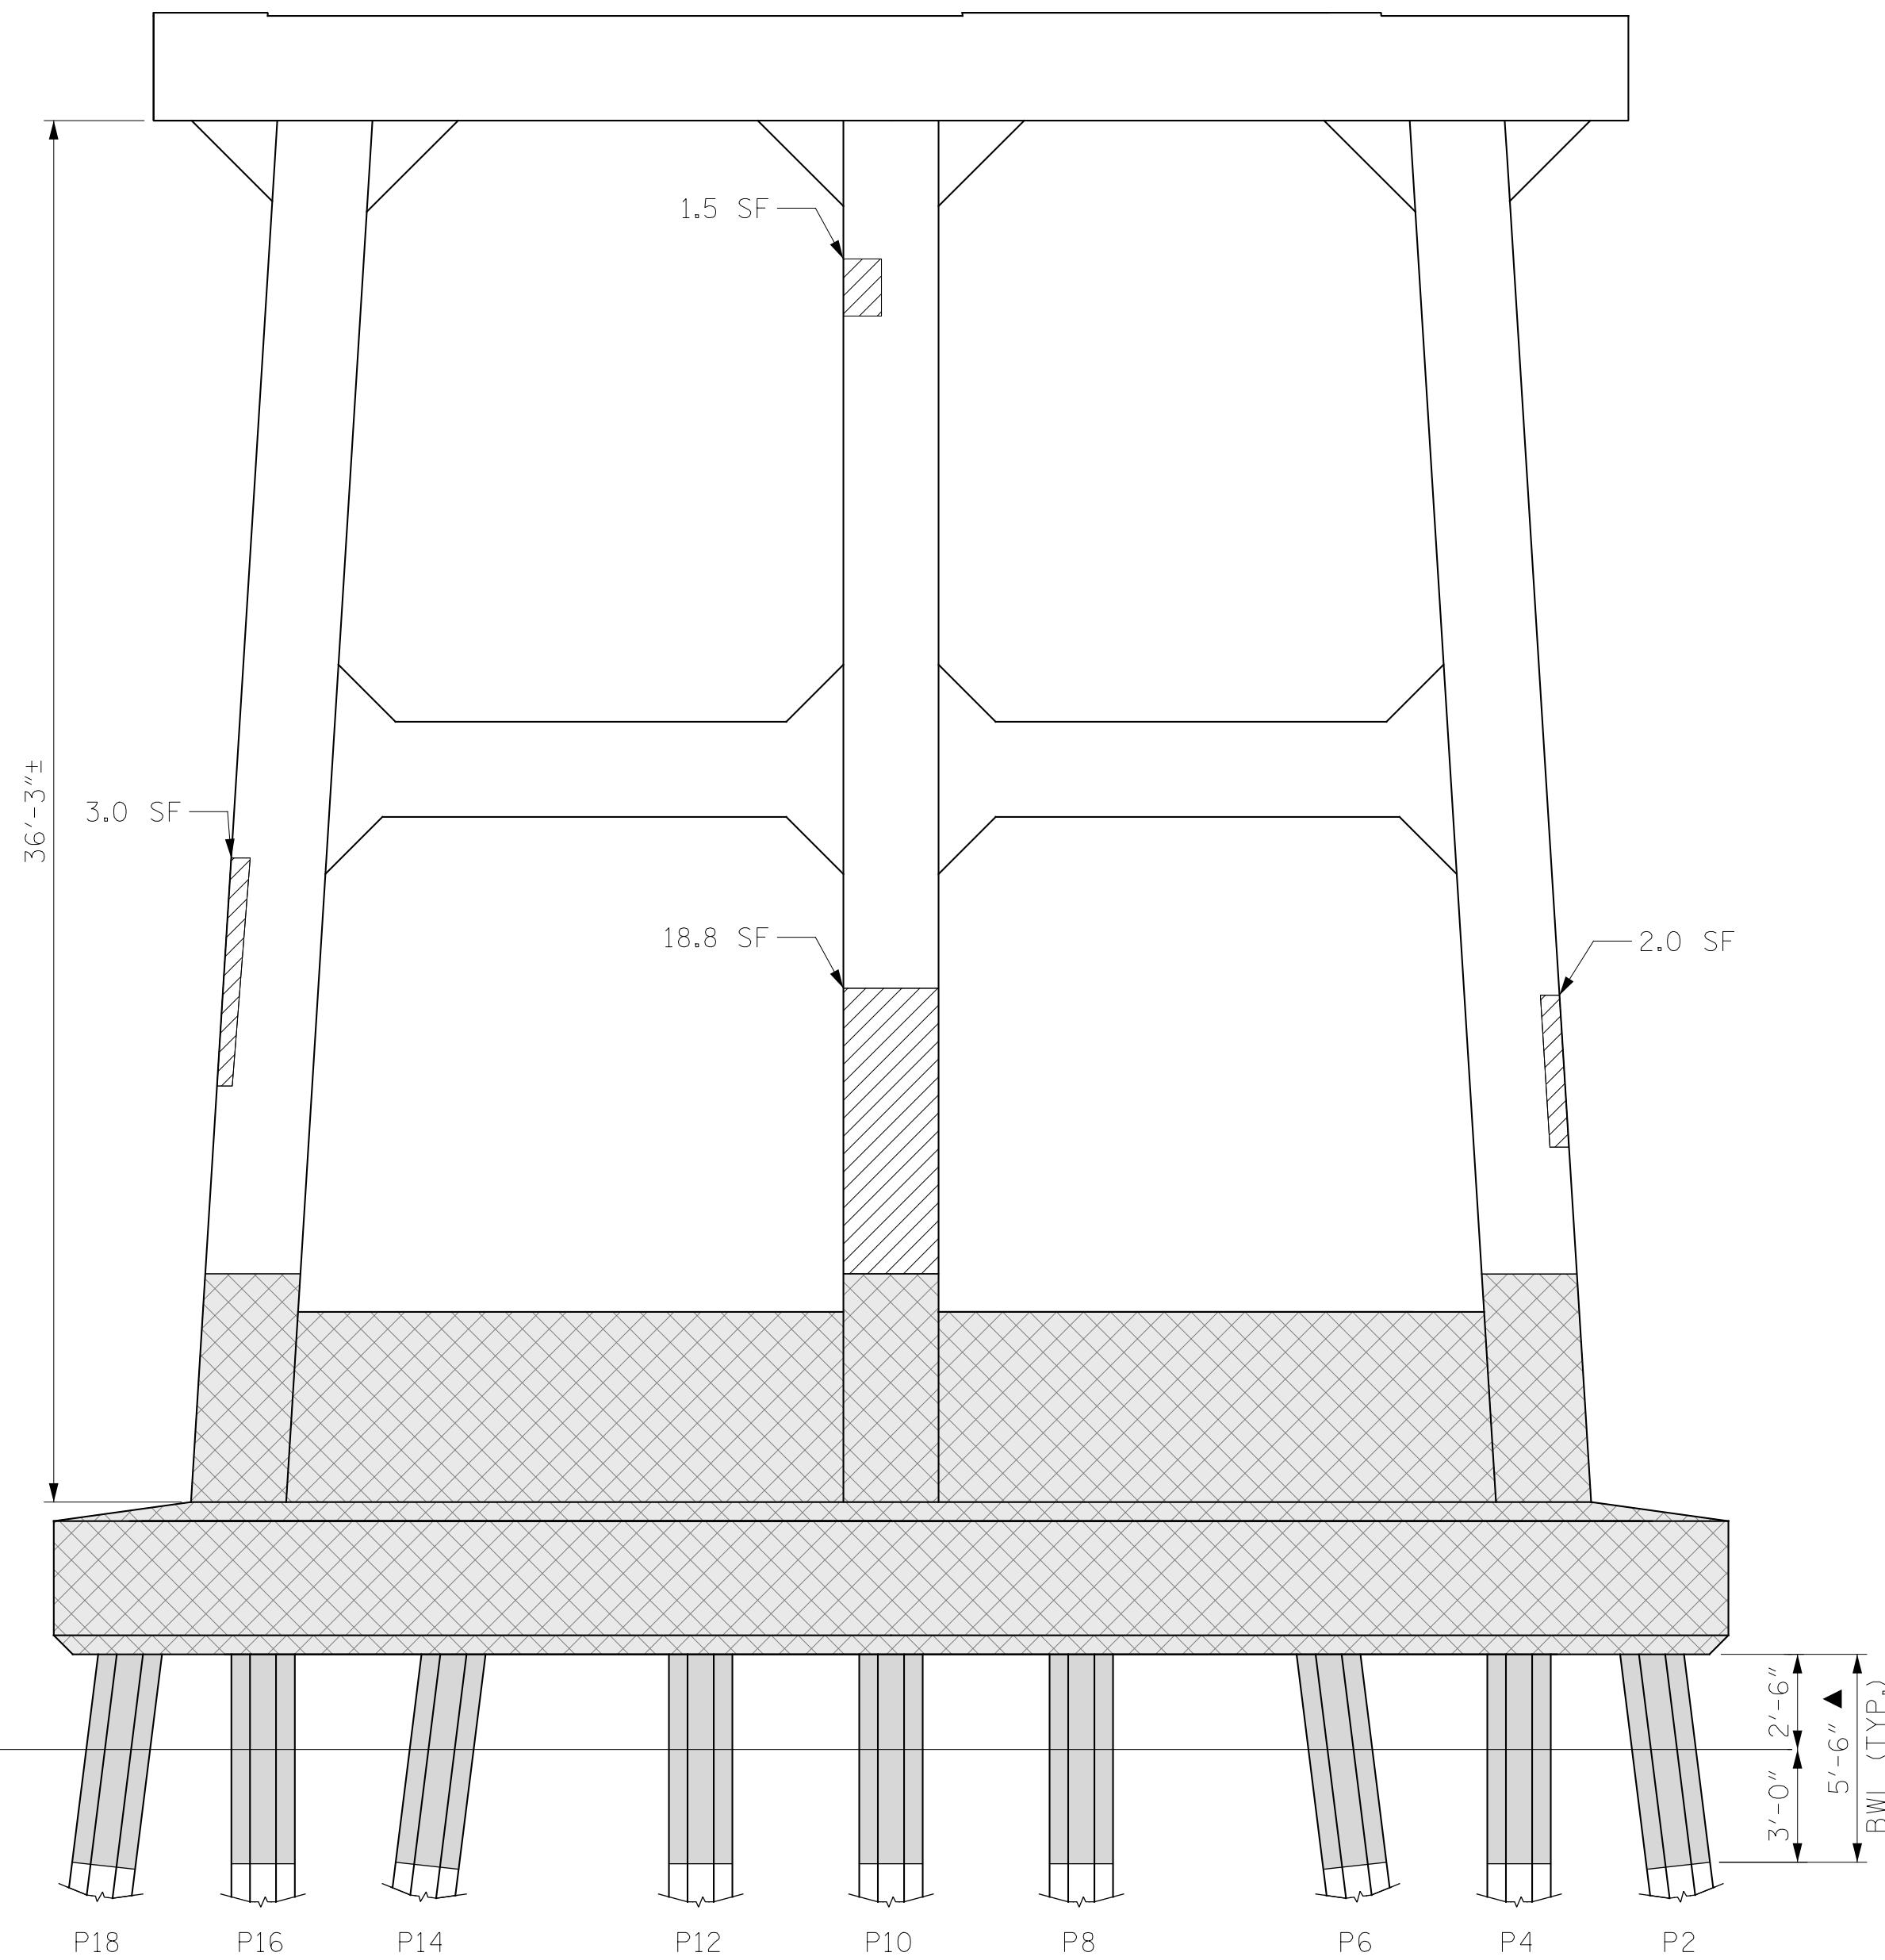
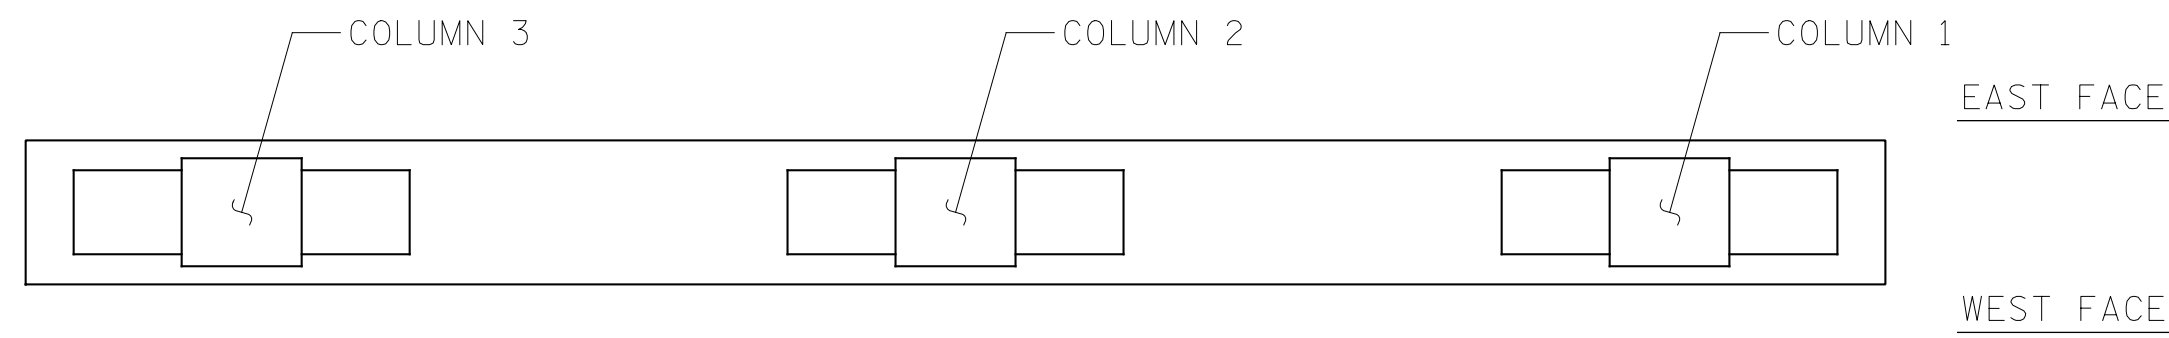
ELEVATION
EAST FACE

- ERI - EPOXY RESIN INJECTION
- FRP - FRP PROTECTIVE SYSTEM
- SHOTCRETE - SHOTCRETE REPAIRS
- PILE FOOTING RESTORATION - PILE FOOTING RESTORATION

▲ FRP PROTECTIVE SYSTEM BELOW WATERLINE MAY INCLUDE APPROVED UNDERWATER MORTAR REPAIRS
