AS-BUILT REPA	IR QU	JANTI	TY TA	BLE					
BENT 142									
CAP REPAIRS	ESTI	МАТЕ	ACTUAL						
SHOTCRETE REPAIRS	3.0 SF	1.5 CF	SF	CF					
EPOXY RESIN INJECTION	_	LF		LF					
COLUMN REPAIRS	ESTI	МАТЕ	ACTUAL						
SHOTCRETE REPAIRS	55.6 SF	27.8 CF	SF	CF					
EPOXY RESIN INJECTION	- LF		LF						
PILE REPAIRS	ESTIMATE		ACTUAL						
FRP PROTECTIVE SYSTEM AWL	_	SF	SF						
FRP PROTECTIVE SYSTEM BWL		O SF	SF

PROJECT NO	HB-0017
DARE	COUNTY
BRIDGE NO	270009

STATE OF NORTH CAROLINA DEPARTMENT OF TRANSPORTATION RALEIGH

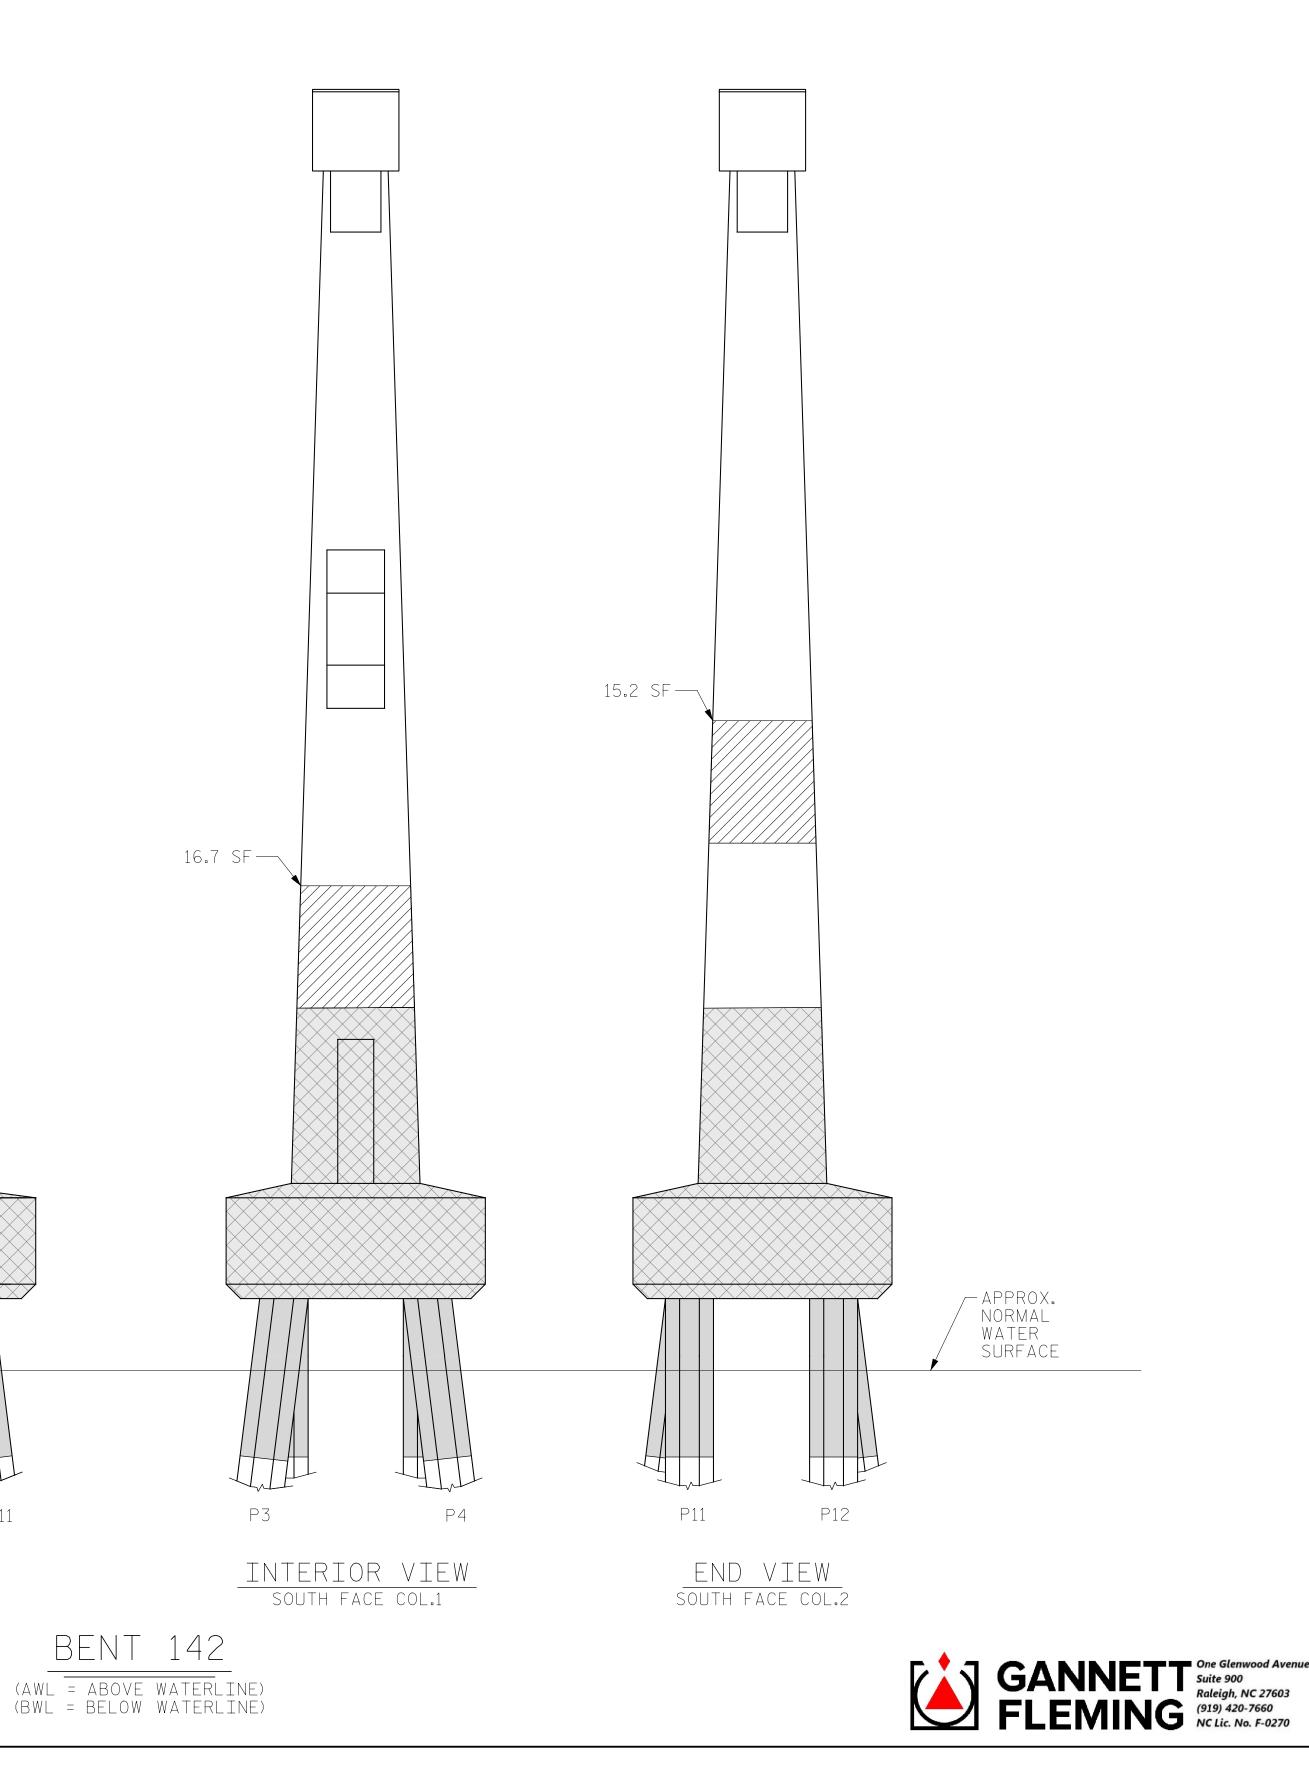
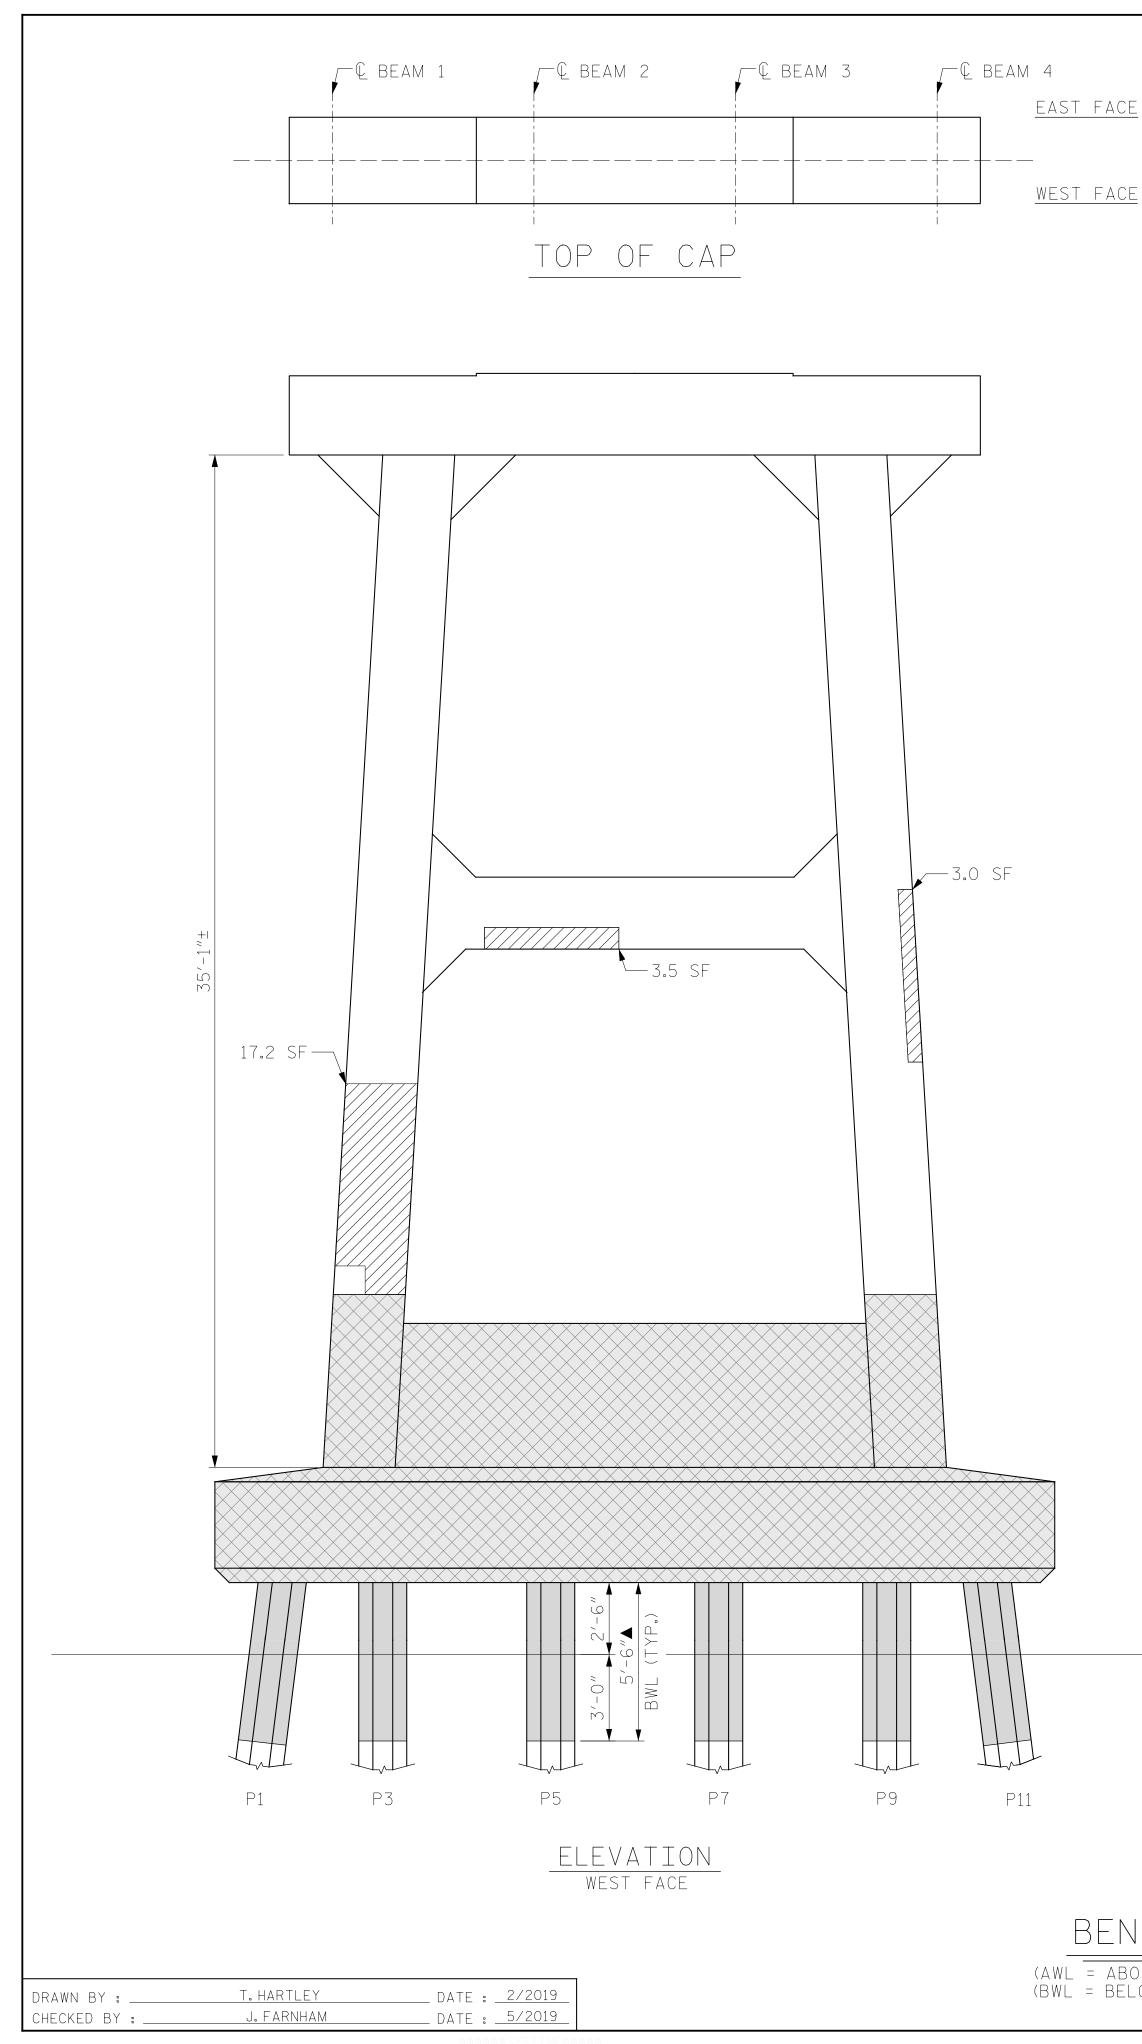
FOR CAP REPAIRS: VALUES IN CHART REPRESENT ESTIMATED REPAIR TOTALS AFTER REMOVAL OF UNSOUND CONCRETE, MIN. OF 1"BEHIND REBAR AND MIN. 2"CL TO SAWCUT. SEE REPAIR DETAILS.
