PROJECT NO. HB-0017
DARE COUNTY
 BRIDGE NO. 270009

STATE OF NORTH CAROLINA
 DEPARTMENT OF TRANSPORTATION
 RALEIGH

BENT 146
 (AWL = ABOVE WATERLINE)
 (BWL = BELOW WATERLINE)

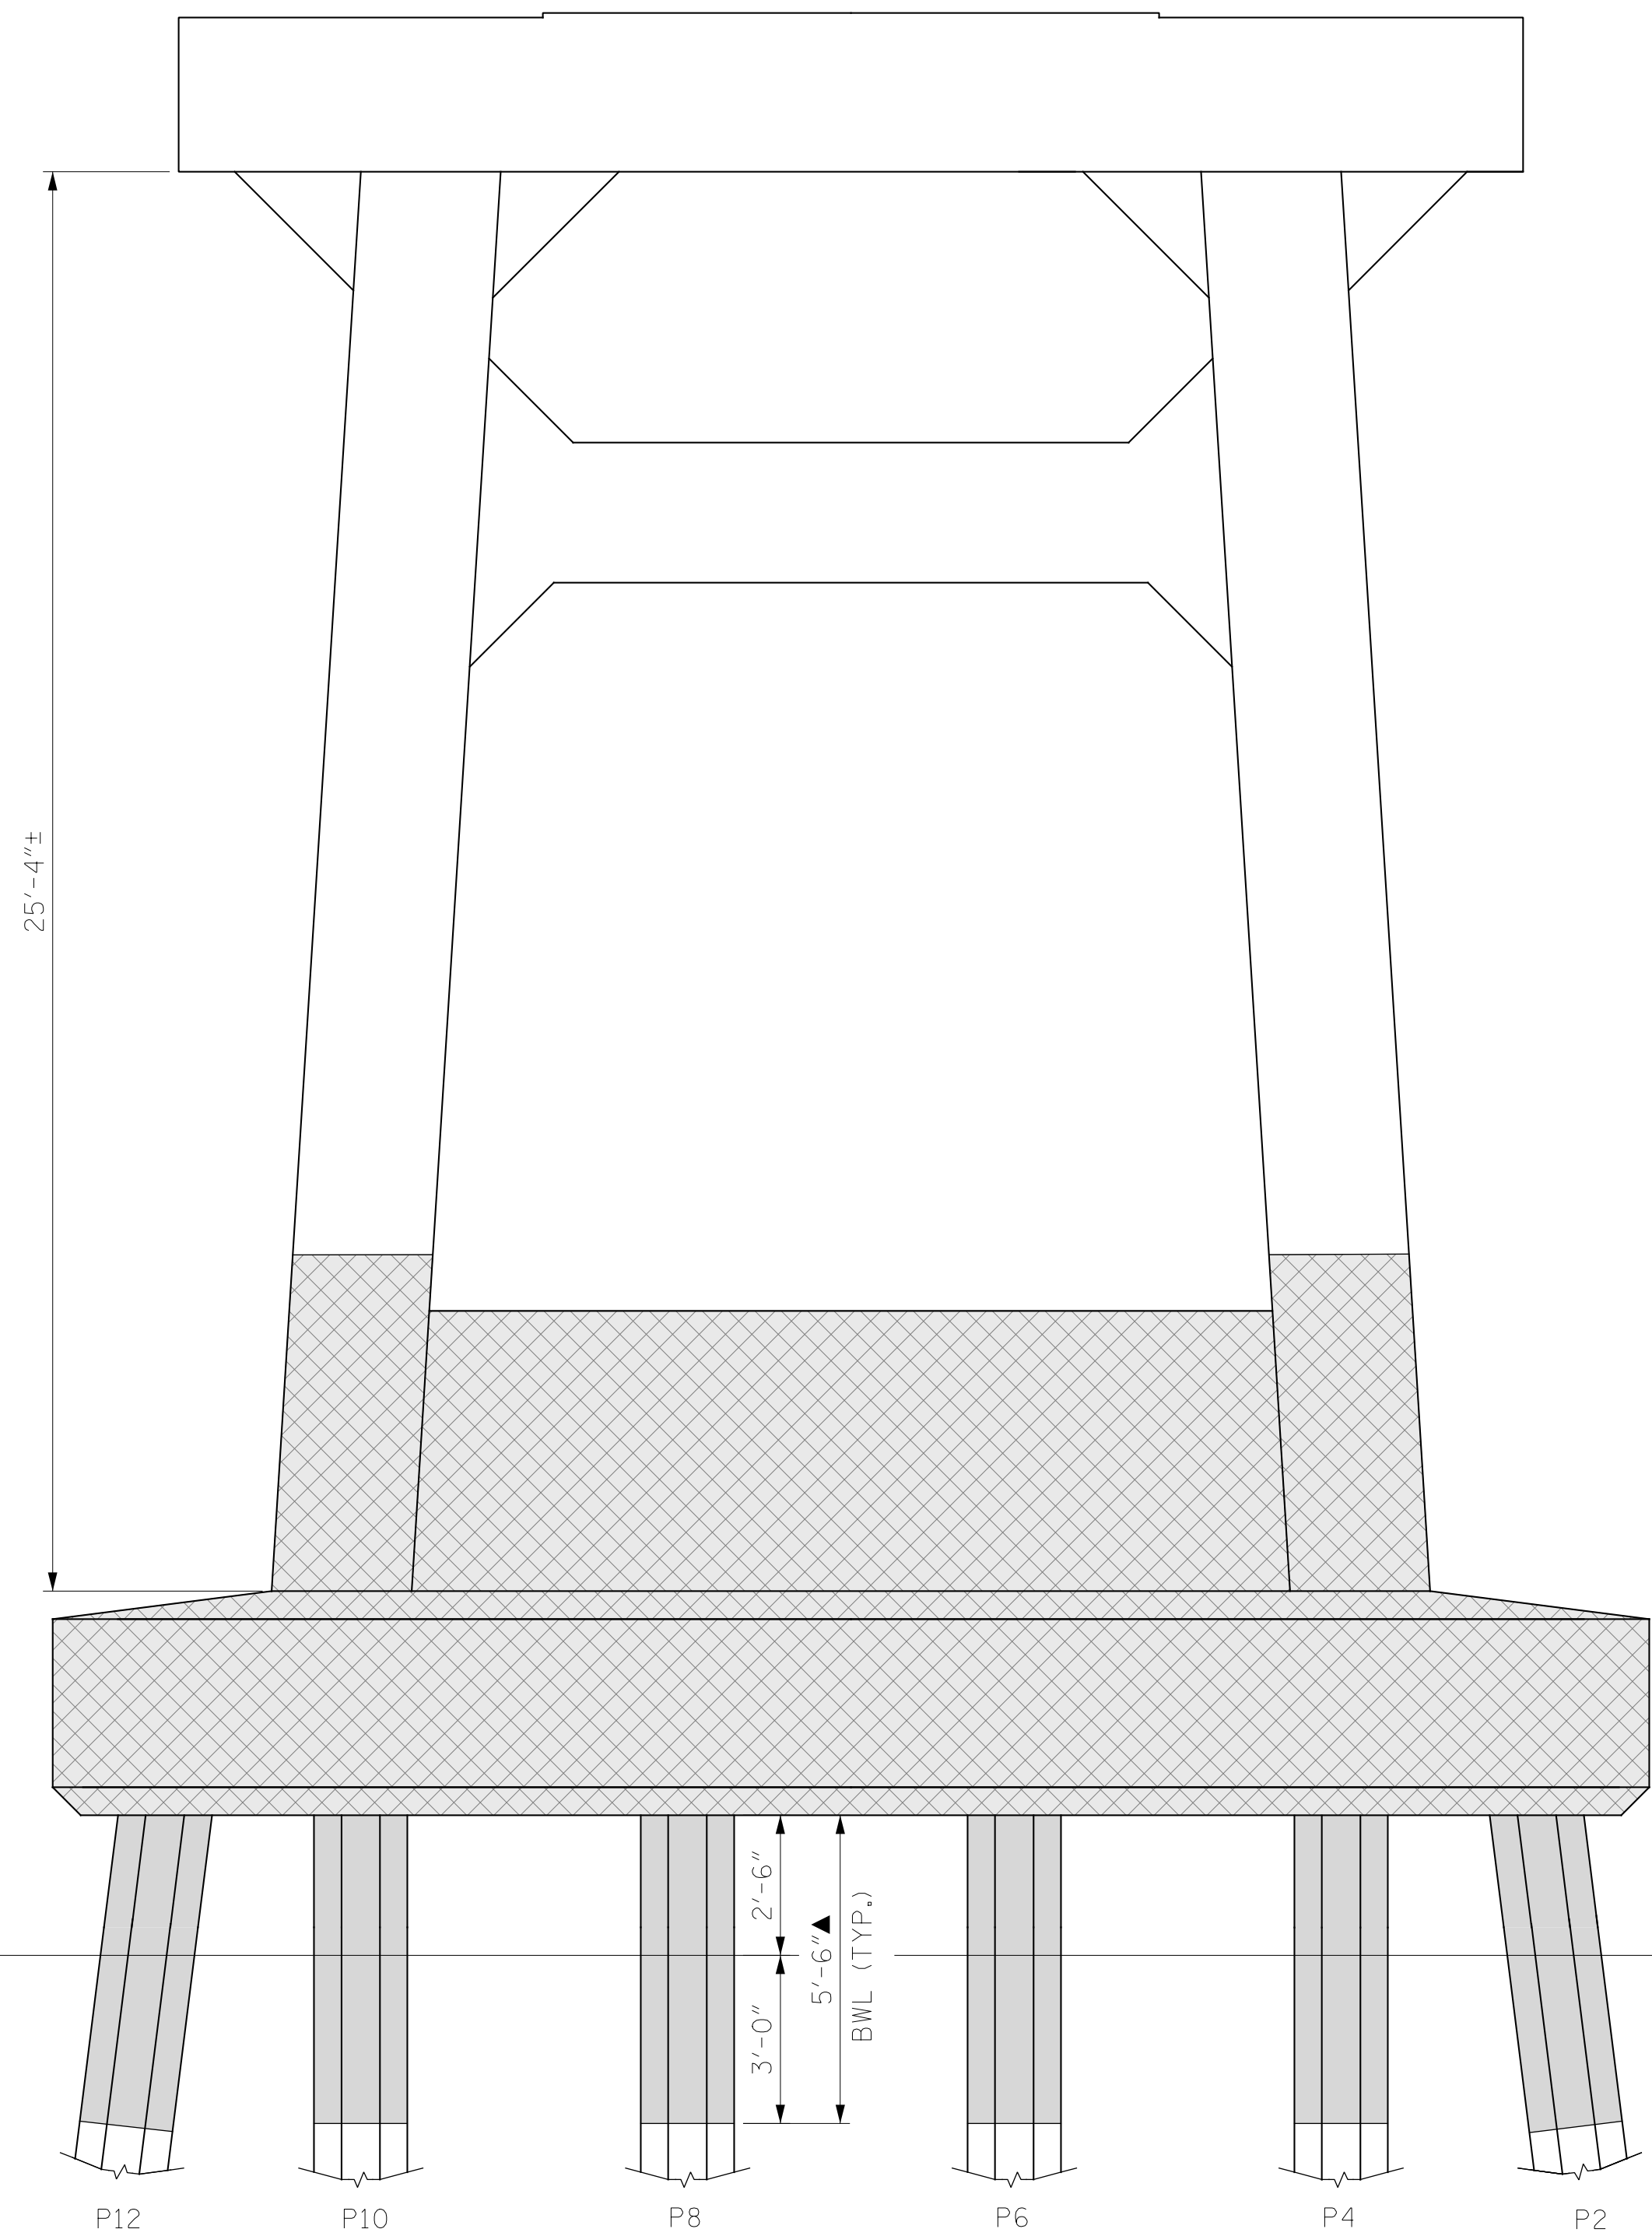
ELEVATION
EAST FACE

- ERI - EPOXY RESIN INJECTION
- FRP PROTECTIVE SYSTEM
- SHOTCRETE REPAIRS
- PILE FOOTING RESTORATION

▲ FRP PROTECTIVE SYSTEM BELOW WATERLINE MAY INCLUDE APPROVED UNDERWATER MORTAR REPAIRS

APPROX. NORMAL WATER SURFACE
