▲ FRP PROTECTIVE SYSTEM BELOW WATERLINE MAY INCLUDE APPROVED UNDERWATER MORTAR REPAIRS		
	APPROX. Normal Water Surface	DARE	<u>B-0017</u> COUNTY 70009
7	SEAL O20208 DocuSigned by: Exi BML A 7/14/2022	EAST FACE	
	UMENT NOT CONSIDERED FINAL UNLESS ALL IGNATURES COMPLETED	REVISIONS NO. BY: DATE: NO. BY: 1 3 2 4	DATE: SHEET NO. DATE: S-240 TOTAL SHEETS 355

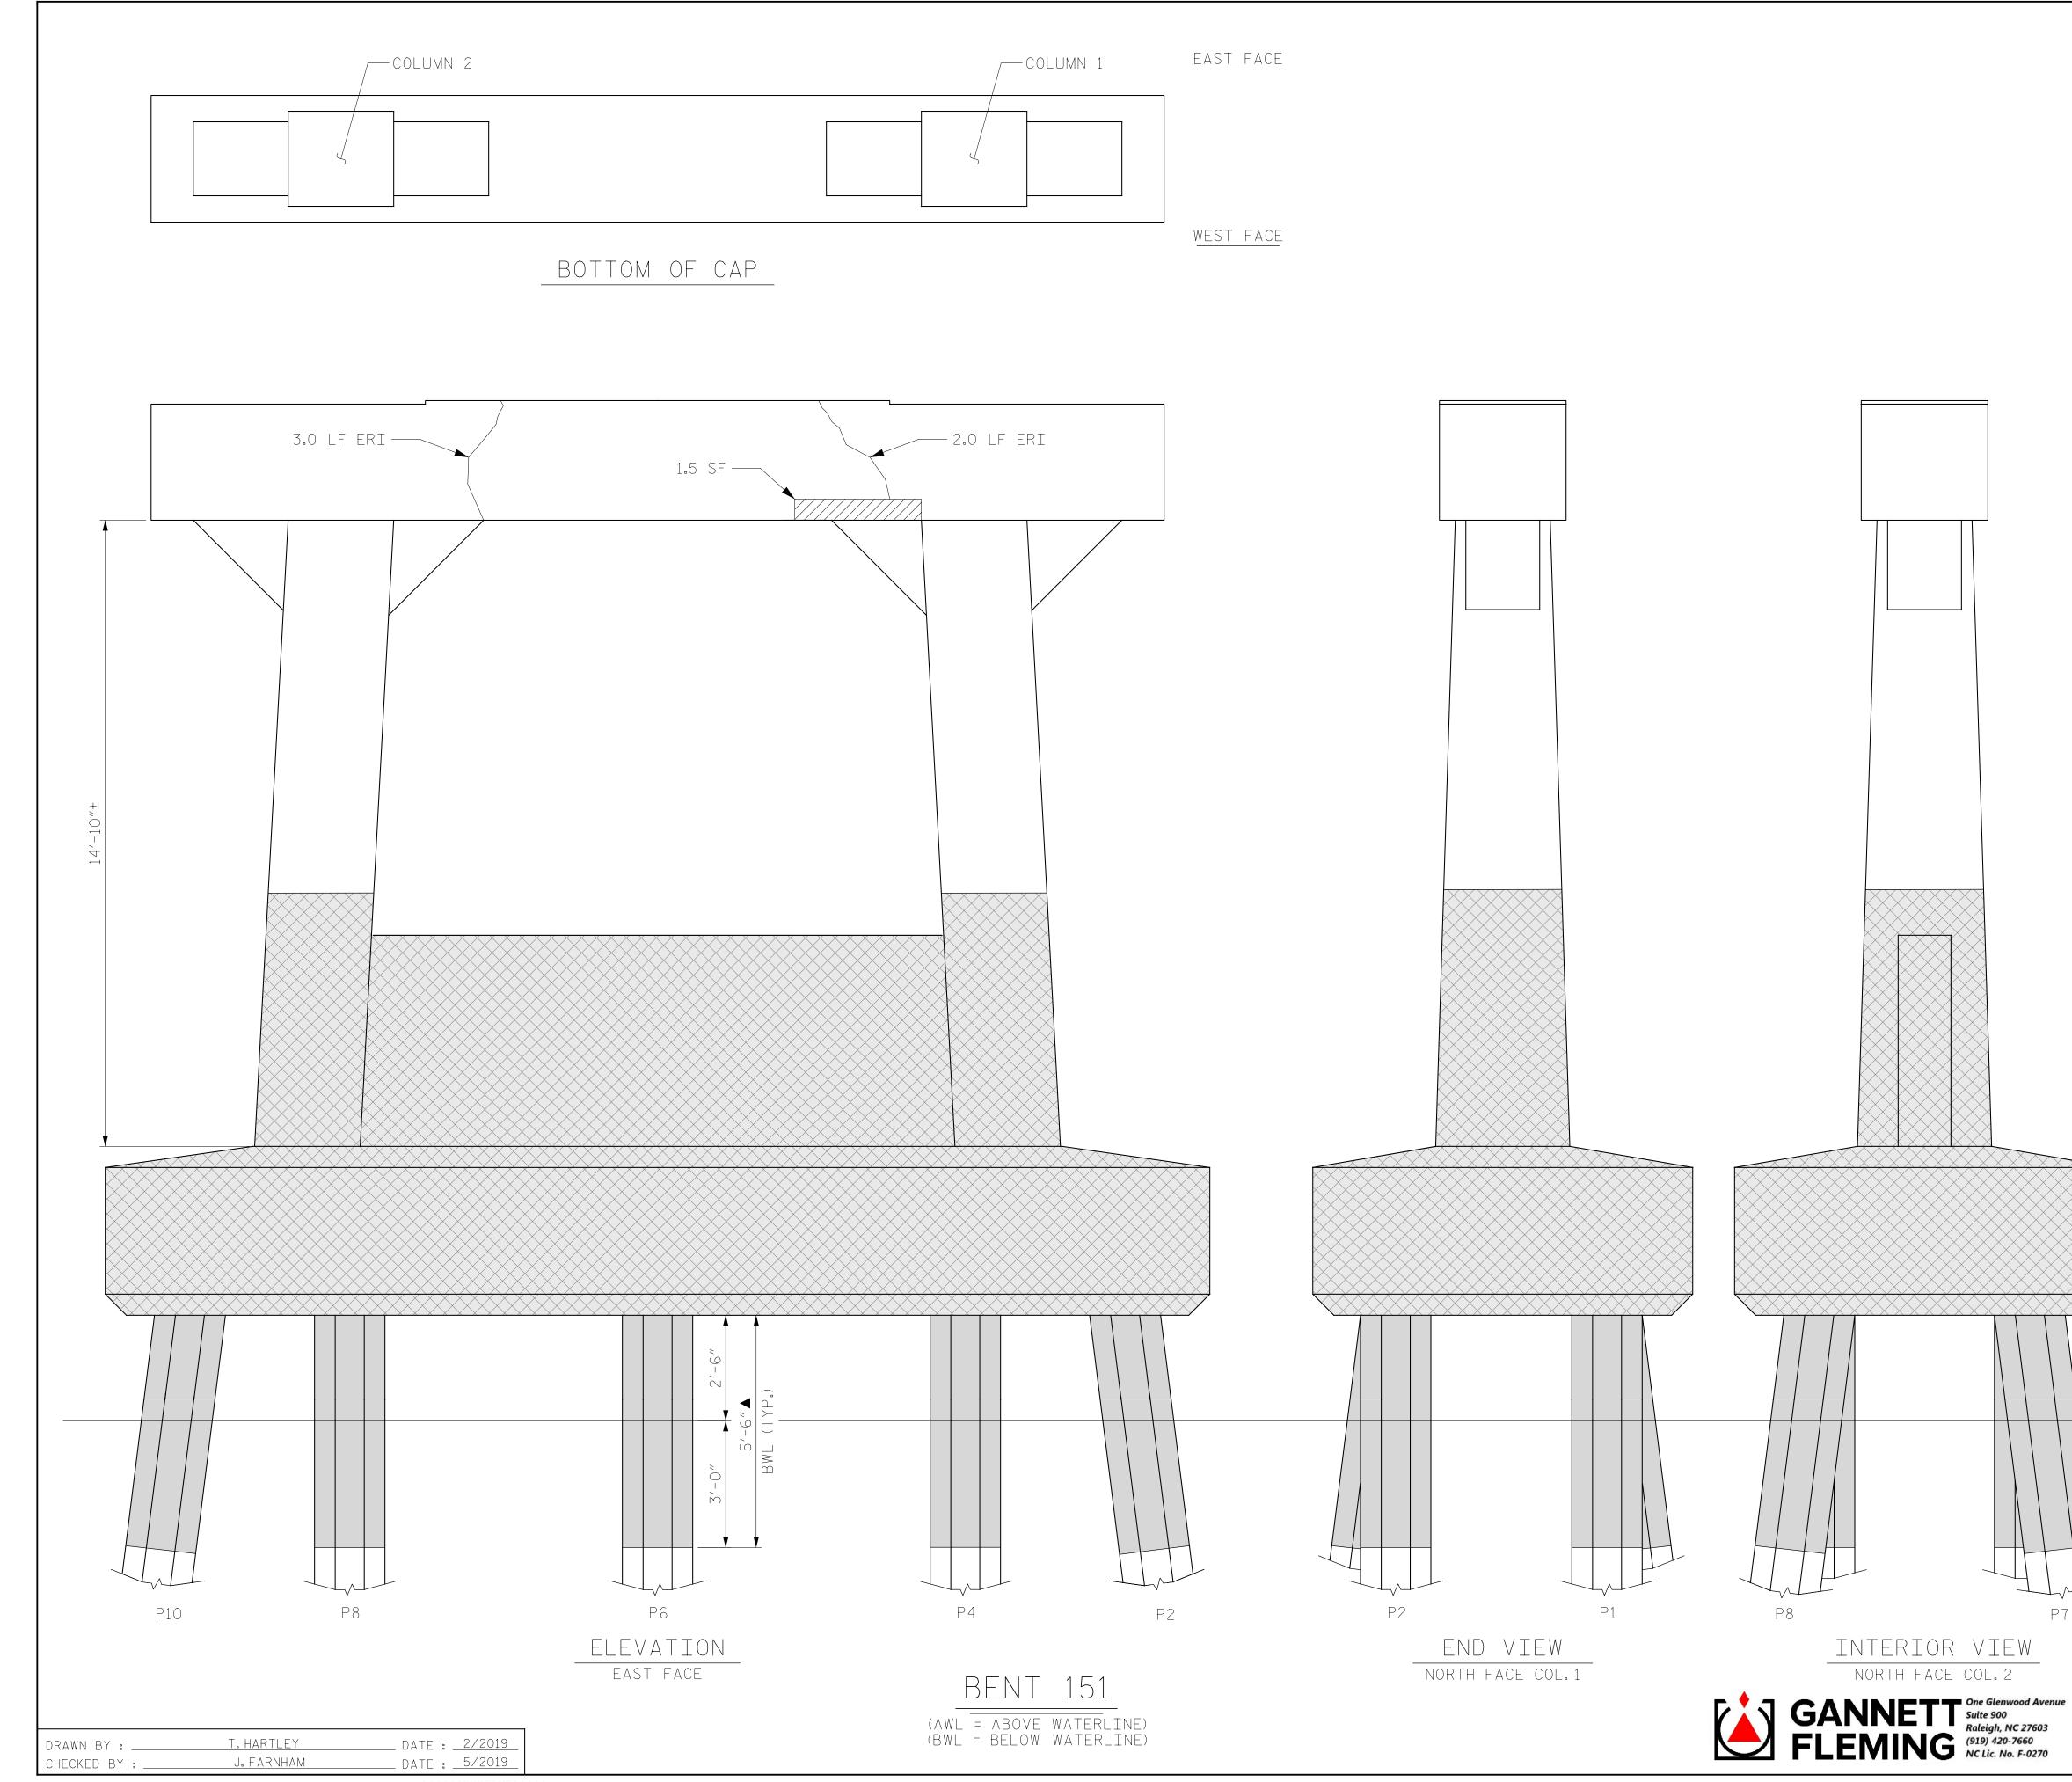
ERI	- EPOXY RESIN INJECTION
	- FRP PROTECTIVE SYSTEM
	- SHOTCRETE REPAIRS
	- PILE FOOTING RESTORATION
