PROJECT NO. HB-0017
DARE COUNTY
 BRIDGE NO. 270009

STATE OF NORTH CAROLINA
 DEPARTMENT OF TRANSPORTATION
 RALEIGH

**BENT 154
 WEST FACE**

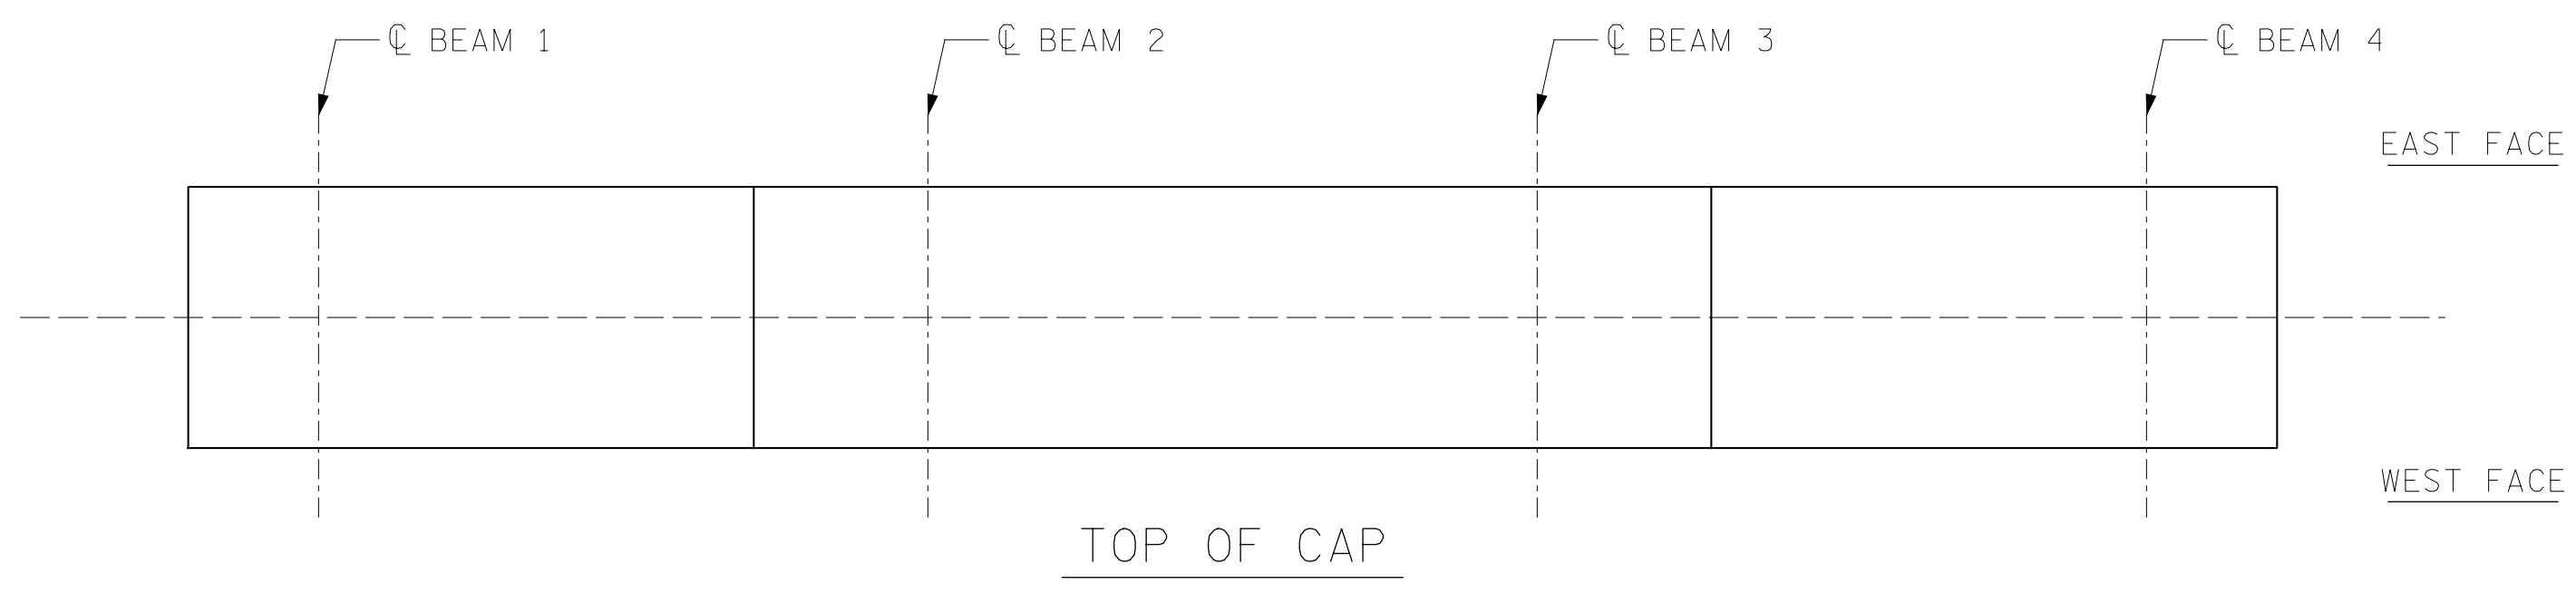
AS-BUILT REPAIR QUANTITY TABLE				
BENT 154				
CAP REPAIRS		ESTIMATE		ACTUAL
SHOTCRETE REPAIRS	- SF	- CF	SF	CF
EPOXY RESIN INJECTION	- LF		LF	
COLUMN REPAIRS		ESTIMATE		ACTUAL
SHOTCRETE REPAIRS	14.4 SF	7.2 CF	SF	CF
EPOXY RESIN INJECTION	- LF		LF	
PILE REPAIRS		ESTIMATE		ACTUAL
FRP PROTECTIVE SYSTEM AWL	- SF		SF	
FRP PROTECTIVE SYSTEM BWL	302.5 SF		SF

FOR CAP REPAIRS; VALUES IN CHART REPRESENT ESTIMATED REPAIR TOTALS AFTER REMOVAL OF UNSOUND CONCRETE, MIN. OF 1" BEHIND REBAR AND MIN. 2" CL TO SAWCUT. SEE REPAIR DETAILS.

FOR SHOTCRETE REPAIRS, SEE SPECIAL PROVISIONS.
 FOR CONCRETE REPAIR DETAILS, SEE "TYPICAL CAP, COLUMN & UNDERDECK REPAIR DETAILS" & "PILE CONCRETE RESTORATION DETAILS" SHEETS.
 FOR FOOTING, COLUMN, AND STRUT REPAIR DETAILS, SEE "PILE FOOTING RESTORATION" SHEET.
 FOR PILE CONCRETE RESTORATION, SEE SPECIAL PROVISIONS.
 FOR FRP PROTECTIVE SYSTEM, SEE SPECIAL PROVISIONS.
 FOR FRP PROTECTIVE SYSTEM DETAILS AND UNDERWATER MORTAR REPAIRS, SEE "PILE FRP PROTECTIVE SYSTEM DETAILS" SHEET.

▲ FRP PROTECTIVE SYSTEM BELOW WATERLINE MAY INCLUDE APPROVED UNDERWATER MORTAR REPAIRS

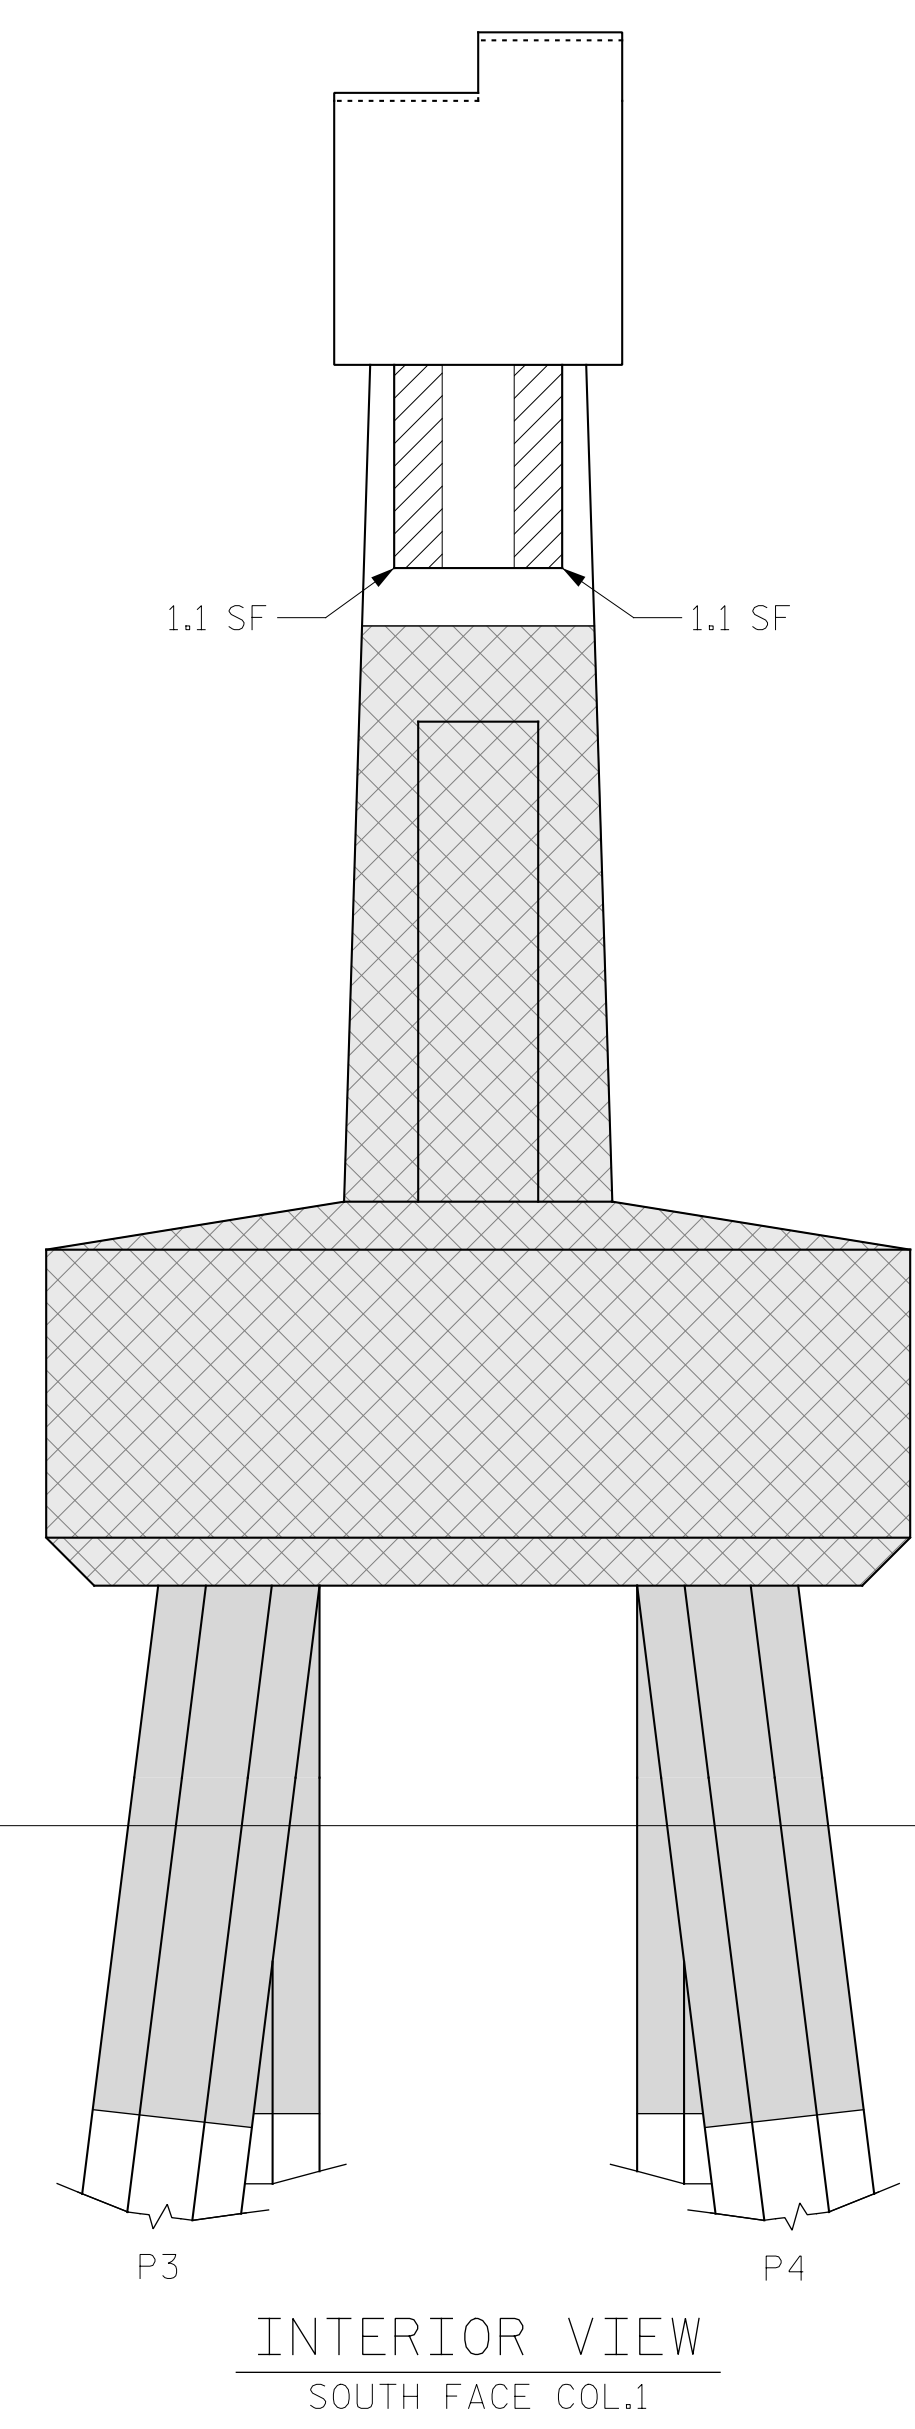
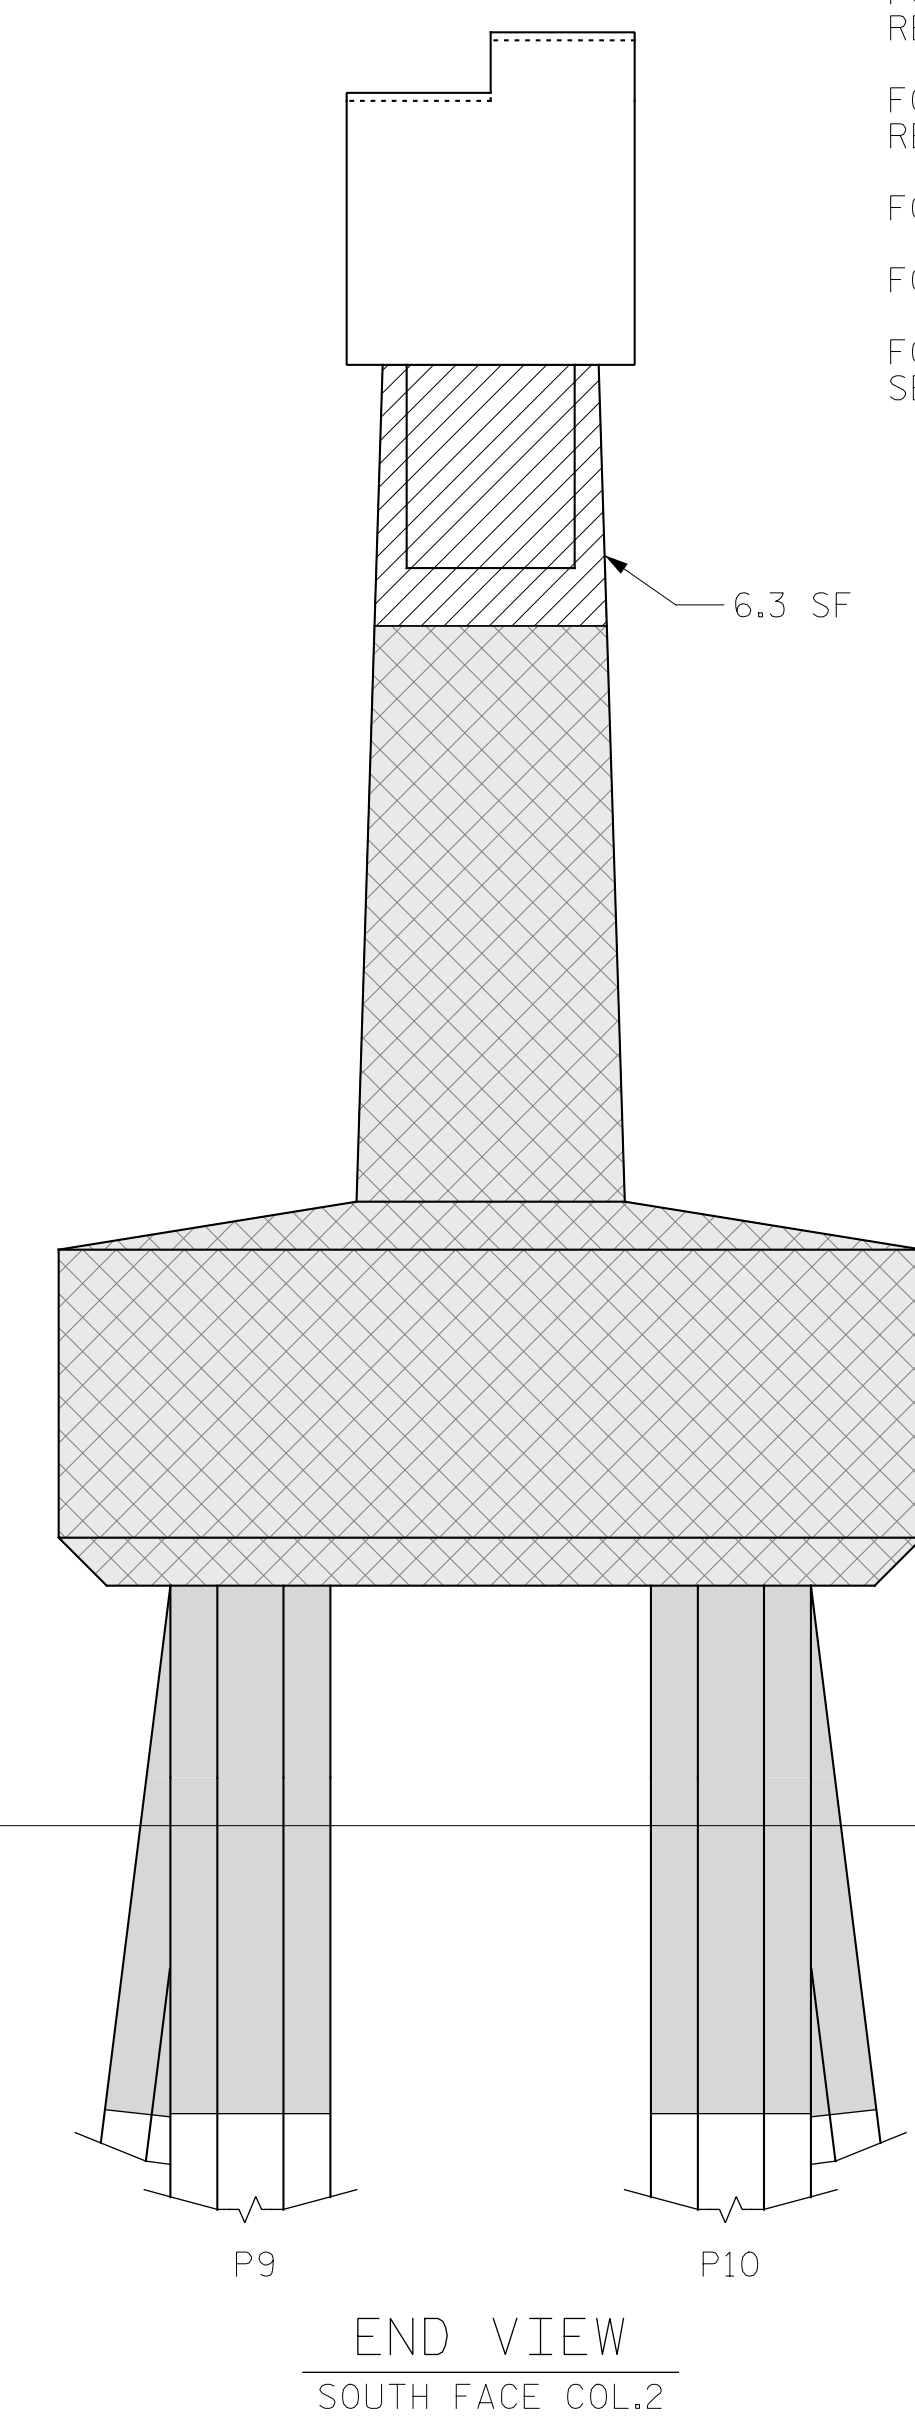
- ERI - EPOXY RESIN INJECTION
- FRP PROTECTIVE SYSTEM
- SHOTCRETE REPAIRS
- PILE FOOTING RESTORATION

BENT 154
 (AWL = ABOVE WATERLINE)
 (BWL = BELOW WATERLINE)
